PROGRESSIVE COLLAPSE ANALYSIS OF EXISTING BUILDINGS A PERFORMANCE BASED APPROACH

I. Prionas⁽¹⁾, J. Jing⁽²⁾, M. Seifi⁽³⁾, J. Tahir⁽⁴⁾

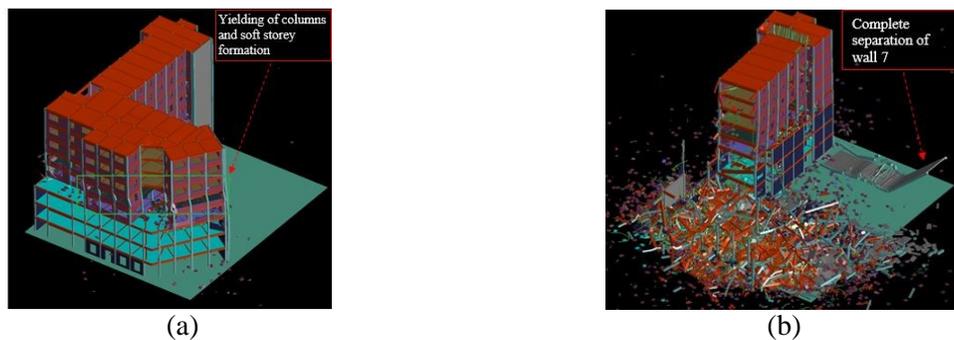
Upon completion of the analysis of the existing building subjected to 100% of the selected ground motions it was found that the existence of critical structural weaknesses such as plan irregularity and vertical stiffness irregularity led to global or significant partial collapse of the building (Fig. 6 and 7).

Fig. 6 – (a) Formation of Soft Storey Mechanism

(b) Global Collapse-100% Duzce Ground Motion

Following the analysis of the existing structure it was crucial to develop a strengthening scheme that would address the soft storey mechanism as well as the diaphragm deficiencies.

Exploring several different options for the seismic strengthening of the building resulted with the continuation of the existing RC shear walls up to the 8th floor as the most effective solution. A comprehensive set of progressive collapse analyses using NITH method and the records mentioned in Table 1 were performed.

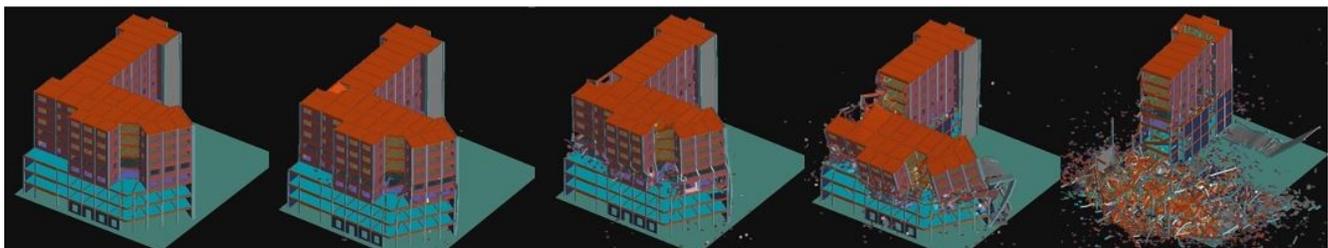
Fig. 7 – Sequence of the Existing Building Collapse Subjected to 100% Duzce Ground Motion

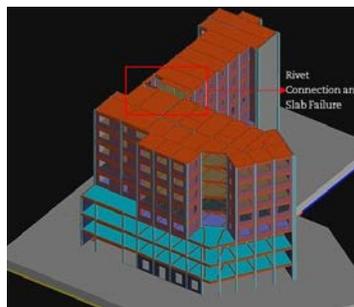
Despite the strengthening scheme mentioned above, we observed tension failure of the riveted connections in levels 7 and 8 between the beams and the column in the corner where the two wings of the building join, initiating damage. As a result of this loss of support the slab-diaphragm in this area fails and caused a partial local collapse (Fig. 8). Therefore, strengthening was required to the slab-diaphragm over the localised area where the two wings of the building meet.

Fig. 8 – Partial Collapse after Continuing up the Shear Walls-70% Duzce Ground Motion

The final scheme includes the strengthening of the slab-diaphragm in this area to all levels above the ground level using 80mm shotcrete adequately connected to the existing structure.

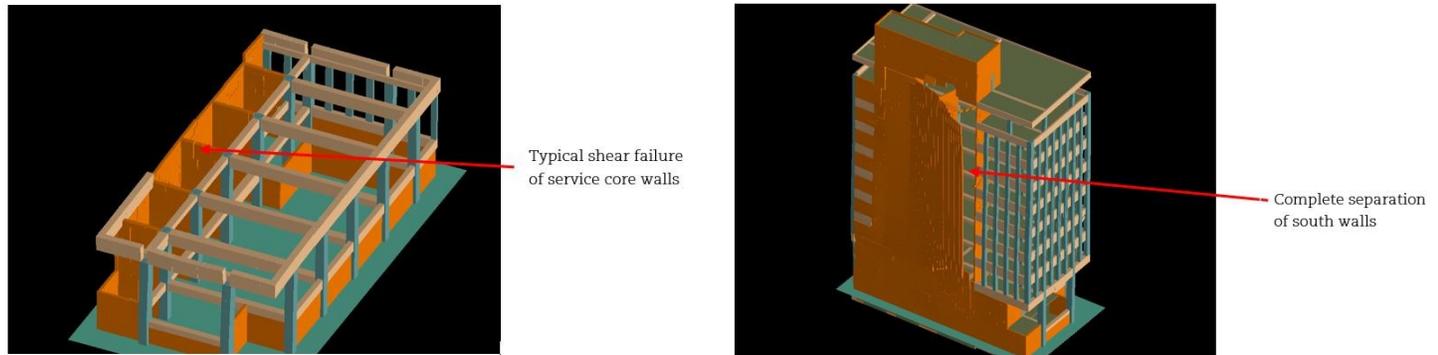
Initially, the structure was analysed at 100% of the Denali ground motion with H1 applied in the X direction and H2 applied in the Y direction. From this initial analysis, it was found that the service core concrete walls failed in shear and separated at the rear of the building due to shear failure of the reinforcing bars connecting these walls. As a result, it was determined that the seismic rating of the building would be below 100%NBS. The critical factors were determined to be the lateral shear capacity of the service core walls located on the southern side of the building and the shear capacity of the reinforcing bars connecting the walls. Fig. 10 shows the separation of the service core walls of the building.

Fig. 10 – Shear wall failure (left) and complete wall separation (right)

Even though strengthening was not required due to the performance meeting minimum requirements, a concept strengthening scheme was proposed for the building based on its seismic performance. As part of the scheme, the existing concrete service core walls would be thickened with additional reinforcement to increase lateral shear capacity, and new bolted steel bracket connections would be added between existing walls to prevent wall separation. Also, additional reinforced concrete shear walls would be constructed in the north-south direction to reduce plastic rotations of columns. The proposed scheme aimed to upgrade the seismic rating to 100%NBS (New Building Standard or 100% of current code requirements).

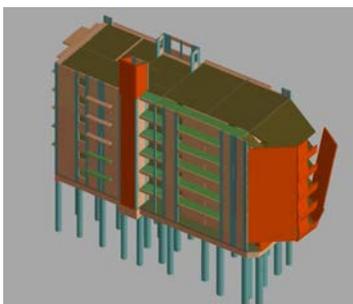
Under all ground motions it was observed that the cantilevered part to the rear of the building collapsed. The collapse propagated from one of the precast walls due to the failure of the connections between the wall and the slab (see fig. 14). This was followed by the collapse of the cantilever slab at level 1 (see fig. 15) which propagated the total collapse of the cantilever part of the building (see fig. 16).

Fig. 14 – Collapse initiation

Even though strengthening was not required for the remaining part of the building, we have been asked to redesign the cantilever part of the building. The remodelling of the building, including the new part indicated the successful choice of the new structural system in regards to the overall performance under the real ground motions.

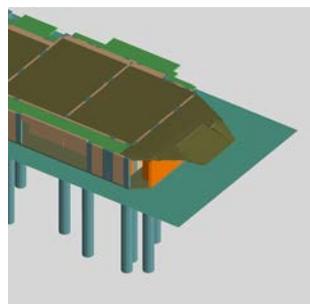
Fig. 15 – Level 1 slab collapse

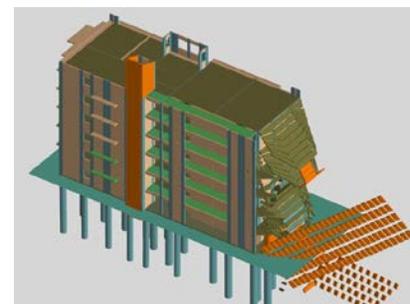
The damaged observed on site indicated a significant validation of our model under the real ground motion causing the collapse of the cantilever part of the building. The mode of collapse of our model was similar to the observed damage and crack patterns of the building due to the Canterbury Earthquake Sequence.

Fig. 16 – Full collapse of the cantiléver
