DAMAGE ASSESSMENT AND SEISMIC RETROFIT OF TRADITIONAL AND MODERN MIDRISE BUILDINGS IN THE AFTERMATH OF 2015 NEPAL EARTHQUAKE

H. Kit Miyamoto (1) and Amir SJ Gilani (2)

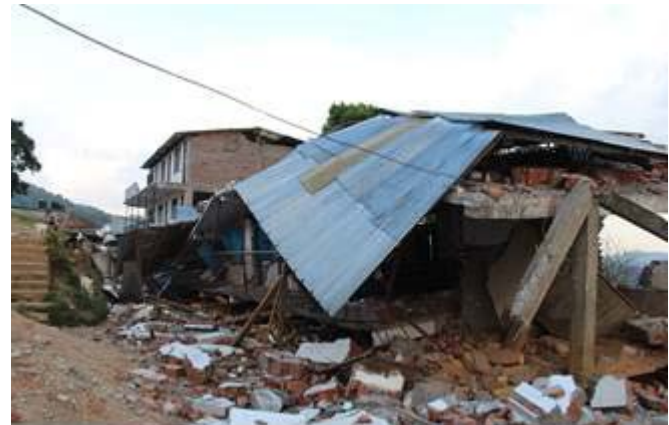
In the past earthquakes in developing countries, school buildings have been especially vulnerable to damage from earthquakes [2]. The same was the case in Nepal; see Fig. 5. In the aftermath of the 2015 main event, data from the Department of Education [3] was analyzed by the authors. Preliminary findings are shown in Table 1 -. It is noted that damage to school buildings was extensive ad widespread. The number of school casualties was, fortunately, limited because the earthquake occurred on Saturday when schools were not in session.

Fig. 5 Collapsed school building

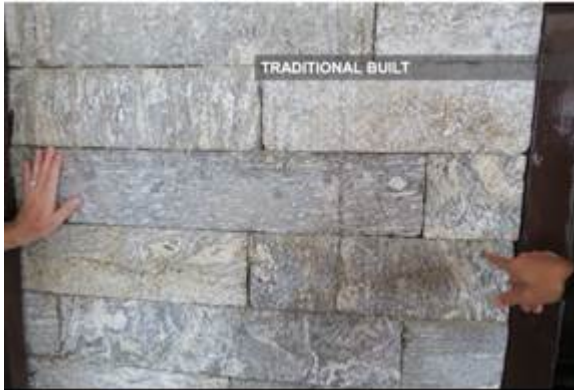
Fig. 7 Traditional bearing wall building

The level of damage in traditional construction was highly depended on the construction practice. The buildings with stone and mortar generally performed well. Although cracks were noticed in many of these buildings, these cracks did not pose a safety hazard. By contrast, in older buildings where either no mortar was used or when mud was used as mortar, there was significant damage. For these buildings, as shown in Fig. 8, the out-of-plane failure of walls was the most common mode of failure, where stone walls fell over or stones fell out, generally at the top of the walls. Since these bearing walls carry both seismic and gravity loading, their out-of-plane failure can compromise the gravity load path and can result in collapse of roofs and floors. For the surveyed buildings, a secondary wood beam supporting the roof was observed in many of the buildings. This member supported the roof after the failure of walls and prevented collapse of the roof. Visual observations also showed that, of the traditional buildings that experienced damage, the mud mortar appeared to be more brittle than the mud in other buildings. Accommodation structure built with cut rock, cement and ring beams that performed well; see Fig. 9.

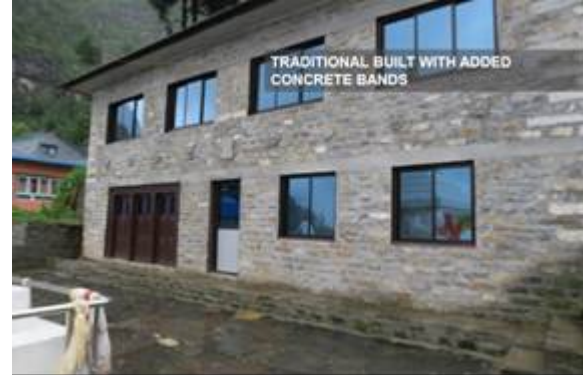
Fig. 8 Building with concrete band

Typical accommodation construction types included uncut stone with mortar and cut rectangular block stone with or without cement mortar. Older construction typically used mud as mortar and it was found that newer construction for the most part used cement. Newer construction that used cement as mortar typically performed well in the earthquake, while construction types with mud as mortar and uncut stone sustained substantial damage and collapse in the earthquakes.

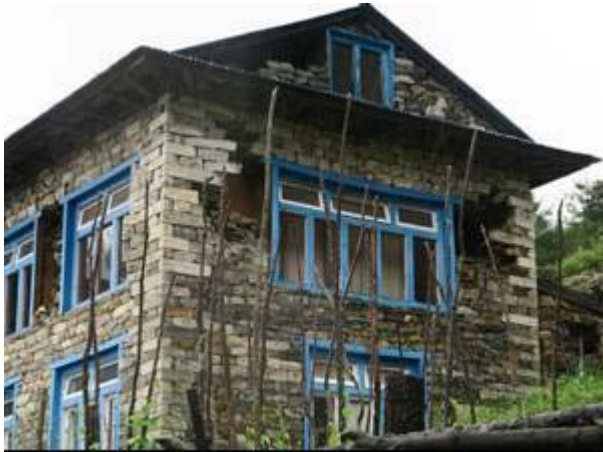
Fig. 9 Out-of-plane failure of bearing wall building

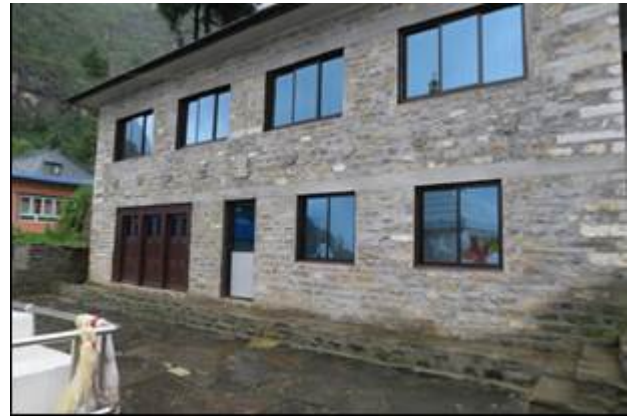
Wood structures were mostly small extensions of the stone hotels and were typically single-story units. Many of the wood structures were open with long bays of windows interrupted by wood posts and lacked a defined lateral load-resisting system. Despite this major shortcoming, no damage was observed for these buildings.

Fig. 10 Undamaged accommodation building

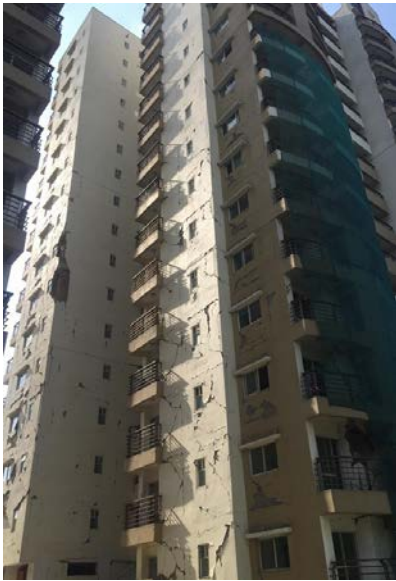
As mentioned previously, the soft soil underlying the Katmandu region produced large spectral accelerations in the 1-4 sec period range and excited mid-rise buildings. Many of these buildings are of newer construction vintage, had ductile detailing, and as such did not experience collapse. However, damage to these tower buildings was widespread; see Fig. 11. Most of the mid-rise buildings used reinforced concrete moment framing as the lateral force resisting system. In addition, unreinforced infill walls were used for these buildings. The damage to the infill walls was extensive; see Fig. 12, which caused the tenants to temporarily move of these units. It is noted that these are high-end condominium units.

Fig. 11 Exterior cracking, residential tower

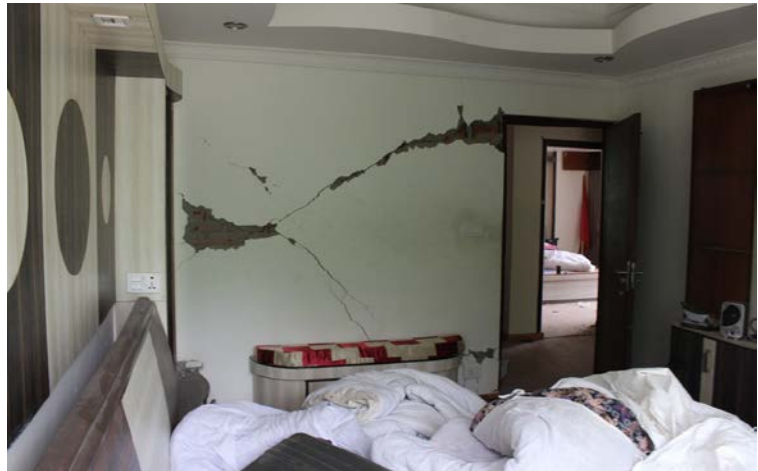
Fig. 12 Interior diagonal cracking of infill walls

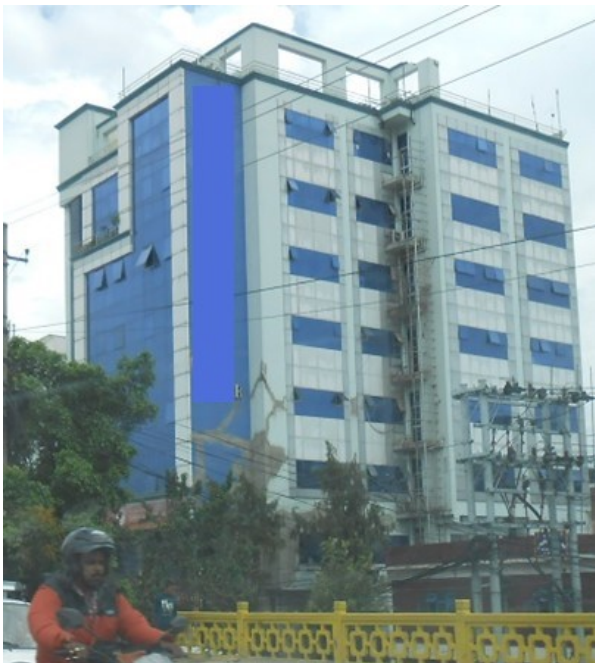
Fig. 13 Photograph of residential tower

The application of seismic dampers to an existing building was demonstrated after damage assessment of a residential tower was completed. The 10-story 32-m tall tower is approximately square in plan measuring 18 m on side; see Fig. 13. This tower was constructed using reinforced concrete moment frame system with masonry infill. Typical columns were 600x600 mm to 800x800 mm square and rectangular beams measured 300x600 mm. The mathematical model of the building is presented in Fig. 14. In this model, the diagonal viscous dampers are also shown. The building seismic weight is approximately 47 MN.

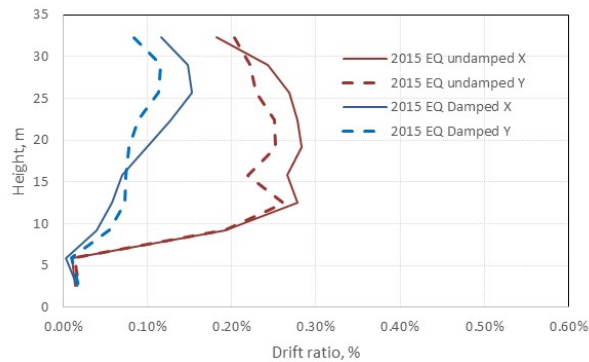
Fig. 15 2015-earthquake analysis

Fig. 15 and Fig. 16 present the computed drift ratios for the 2015 event and code-spectrum synthesized record analysis. It is noted that the addition of viscous dampers have significantly reduced the drift ratios and demand on the drift-sensitive reinforced concrete movement frame beams and columns.
