Study on damage to cast-in-place reinforced concrete piles during the 1995 Hyogo-ken Nanbu Earthquake in Japan

This paper reports the results of investigations into the cast-in-place reinforced concrete piles of an 8-story steel reinforced concrete structure that were damaged by the 1995 Hyogo-ken Nanbu Earthquake in Japan. The damage to the piles could be observed during seismic isolation retrofit work on the building 18 years after the earthquake. Almost all the piles were damaged. Initially, pile damage was classified into four categories based on the degree of cracks in the concrete and damage to the reinforcing bar. Each category of damage was explained in detail. Subsequently, the damage was summarized and the factors behind the damage to the piles were considered.

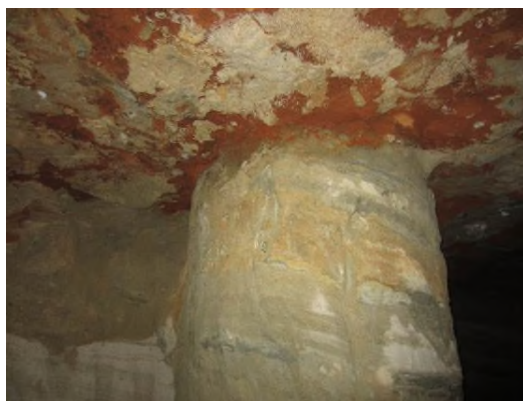
Photo 1 shows the example of bending failure at pile head joint. There were fragile parts of concrete at the pile head as shown in Photo 1 (b) to (d). Removing the fragile parts, local buckling of the main rebars at the pile head joint was found. This type of failure is most common type of damage. It was observed in 107 of 124 piles including those with combined failures. About 90 % of all piles had fragile concrete at their pile head joint.

(a) After excavating (Location; B-5)

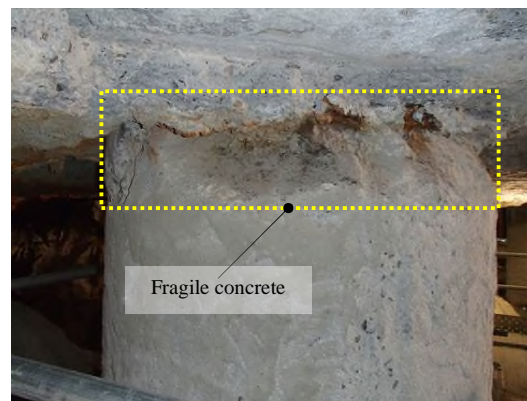
(b) After removing surface concrete (B-5)

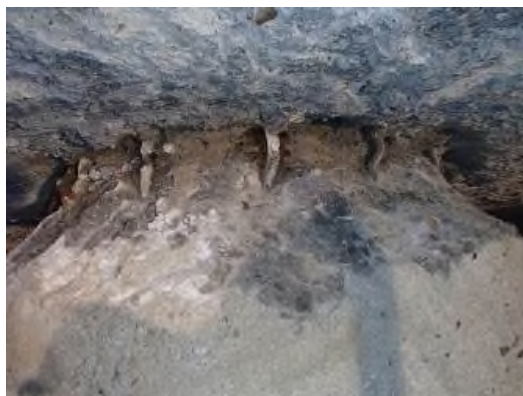
(c) After removing fragile part of concrete (B-5)

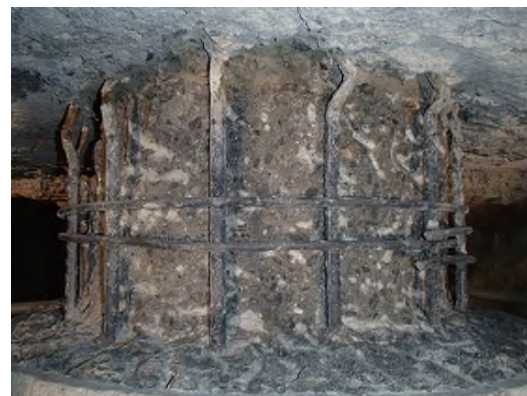
(d) After removing cover concrete of pile head (B-5)
Local buckling of main rebar at pilehead joint

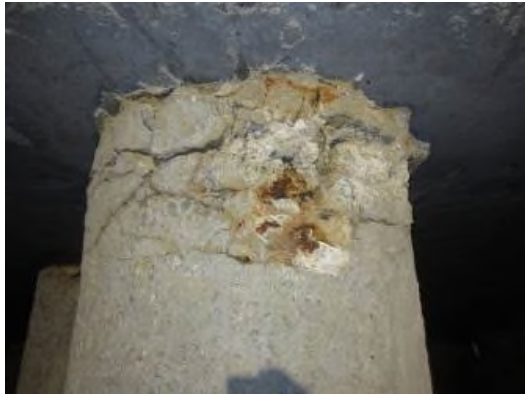
Bending failure was observed in 11 piles. Photo 2 shows an example of this type of damage. Damage was found to the cover concrete at the part of pile head, about 1-meter (almost same as the diameter of the pile). Removing the cover concrete, it was found that local buckling of main rebar was longer than that observed for Type A) as shown in Photo 2 (b) and (d).

(a) Damage of cover concrete at pile head (A-6)

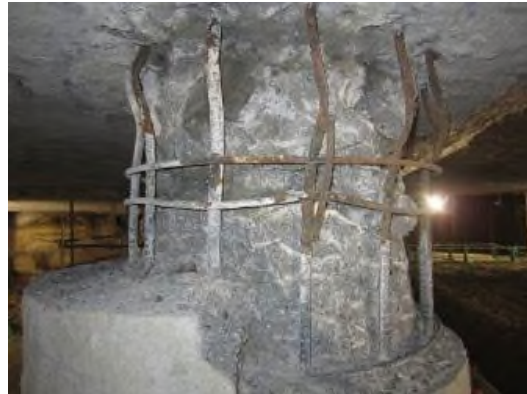
(b) After removing cover concrete of pile head (A-6)

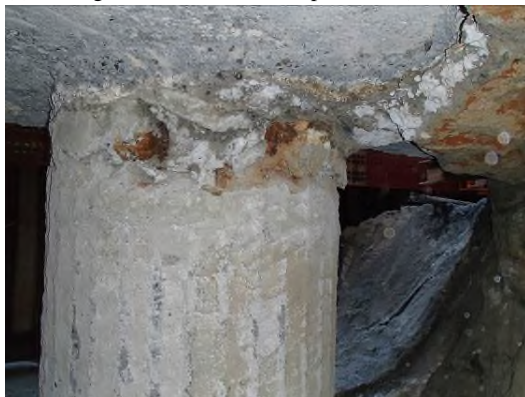
(c) Damage of cover concrete at pile head (D-5)

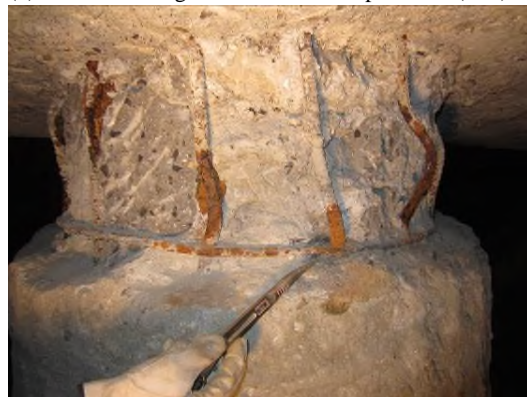
(d) After removing cover concrete of pile head (D-5)

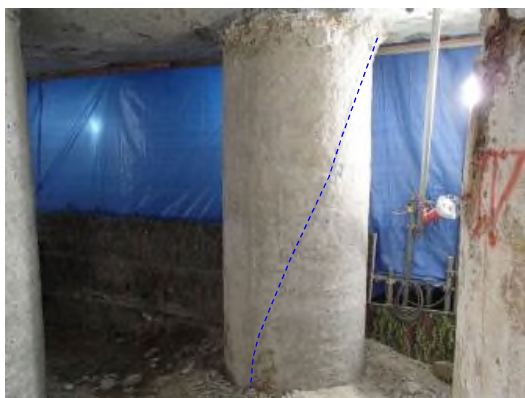
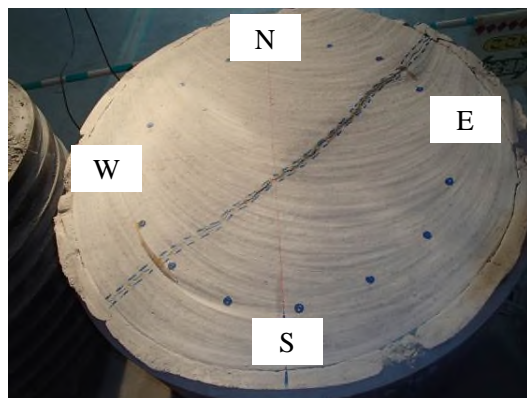
Photo 3 – Type C); Shear failure (Long shear span type)

Shear failure was observed in 9 piles. The failure can be grouped into two types; long shear span type and short shear span type. Photo 3 shows the long shear span type shear failure and Photo 4 shows the short shear span type. Additionally, Photo 5 shows an example of combined type with Type B) and Type C) failures. The long shear span type of failure had a shear crack of approx. 3-meter depth, whilst the short shear span type a crack of about 1-meter depth. The long shear span type was observed only on one pile. This pile is one of four piles located at C-4 right below to shear wall receiving a relatively large axial load and it is assumed that fluctuating axial to the pile during earthquake was large relatively.

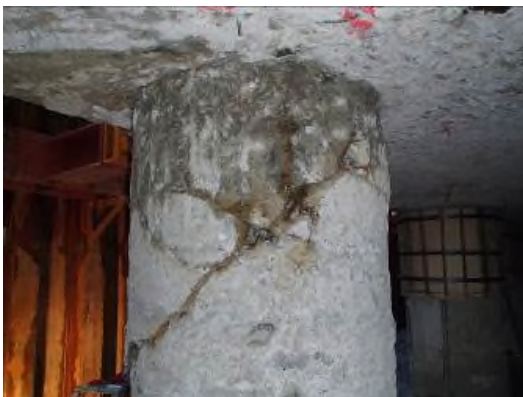
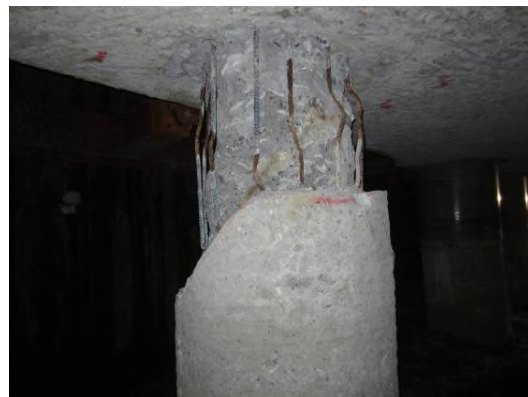
Photo 5 – Combined type with Type B) and Type C); Shear failure after bending yield

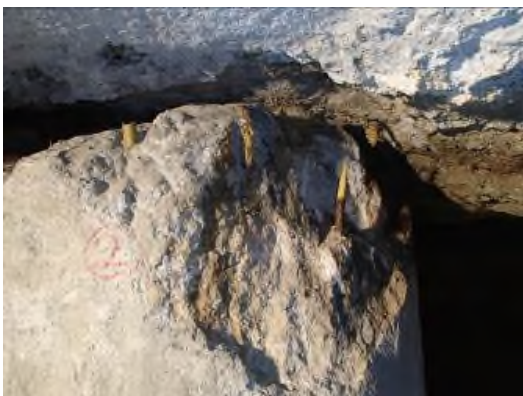
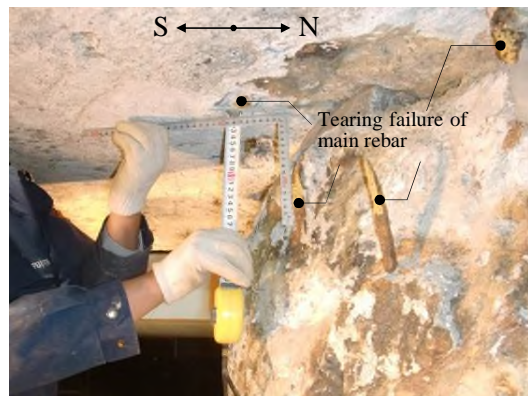
Slip failure at the pile head joint was observed in 4 of 8 piles with relatively small axial load. Photo 6 shows an example of Slip failure. The horizontal gap between pile and pile cap caused by the slip was about 70 mm along N-S direction as shown in Photo 6 (b); the direction of slip of the pile was north relative to the upper structure. Local bucklings of main rebars caused by the slip were found. Some tearing failures of the main rebars were also found at the pile head joint. The range of damaged concrete was about 20 to 40 cm from the top of the pile.

Photo 6 – Type D); Slip failure at the connection

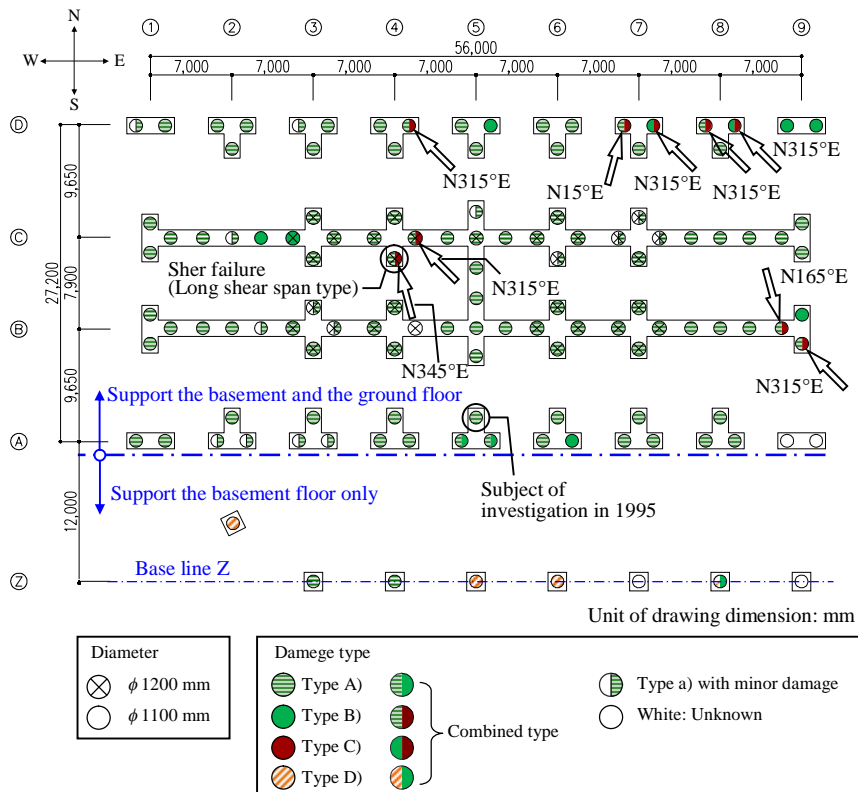
Fig. 5 – Distribution map of damaged piles

The distribution of damaged piles is summarized in Fig. 5. Table 3 shows the summary of the ratio of the numbers and notes of damaged piles. The most common type of damage was bending failure at pile head joint with far fewer instances of other types of damage. This type was seen all over the site. Slip failures at pile head joint were found at area of small axial load (supported the basement floor only).

The direction of horizontal force estimated by the shear cracks are shown in Fig. 5 as arrow symbols. The dominant direction of horizontal force was north-west. It is assumed that the most common direction of shear force estimated by shear crack was N315°E although a few shear cracks of pile with different angles were also observed.

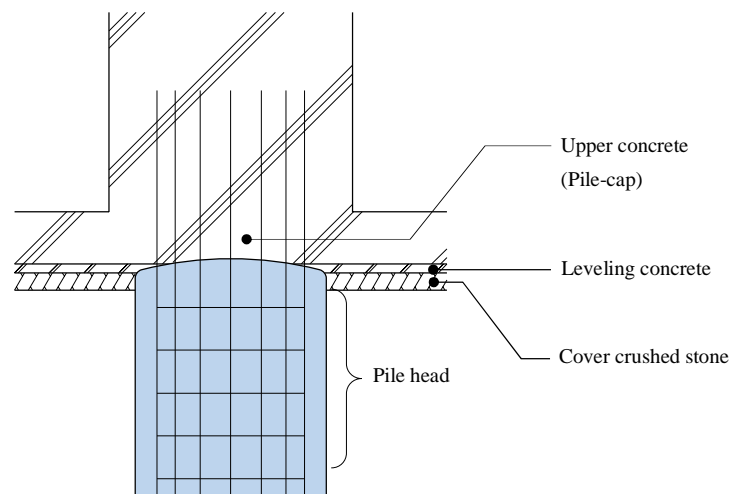
The factors causing the bending failure and slip failure at pile head joint were considered. At the time this building was constructed (1973), pile foundations were only designed for vertical loads based on the Common Specifications of Construction Work in Japan (1969 edition) [3]. Therefore, the pile head parts seem not to have been embedded in the upper concrete. Fig.9 shows the assumed detail of pile head at the time. Because of this detail of pile head, it can be considered that the bending failures at pile head joint were observed on many piles and the slip failures were observed in the case of small axial loads. In the case of the detail as Fig. 9, the leveling concrete between pile and upper concrete was weak against bending compressive force, so that the main rebars at the pile head joint received large tensile stress.

Fig. 9 – Assumed detail of pile head
based on the Common Specifications of Construction Work (1969 edition)
