Damage analysis of a compound retaining wall collapsed during the 2014 earthquake in Northern Nagano

K. Kuribayashi⁽¹⁾, T. Hara⁽²⁾, H. Hazarika⁽³⁾, K. Takezawa⁽⁴⁾, D. Shinagawa⁽⁵⁾

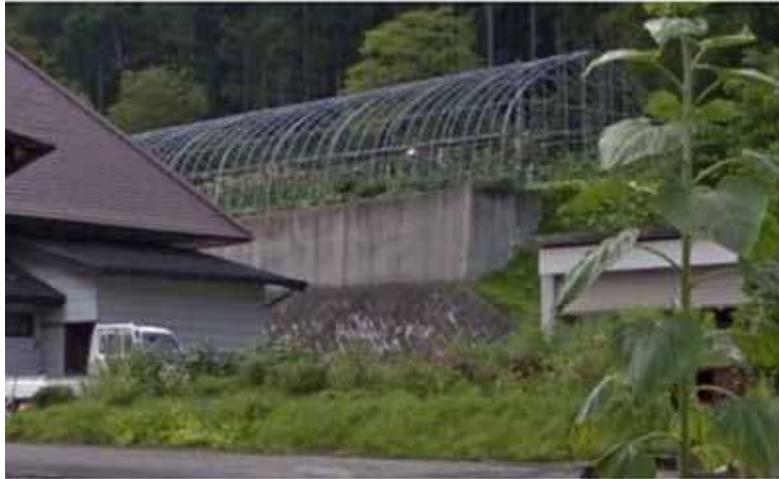
Fig. 2 – Compound retaining wall before earthquake (from Google Map ^[4])

Figure 2 and 3 show the retaining wall before and after the earthquake. The retaining wall, as described above, is a compound retaining wall consisting of a 4-meter-high block wall at the base and a 2-m gravity retaining wall on it. The upper gravity retaining wall collapsed after the earthquake, causing the backfill soil behind it to partially collapse.

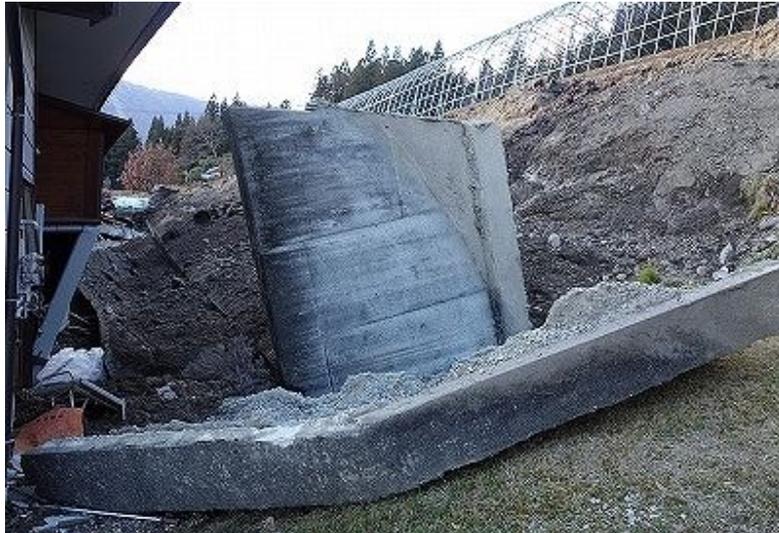
Fig. 3 – Compound retaining wall after earthquake

A simple measurement conducted on the site showed that the collapsed part of the retaining wall totaled about 42 m in length. While there is a vinyl greenhouse above the retaining wall, which measures 37 m in length and runs parallel to the retaining wall, no problems were found with the greenhouse. After the earthquake, the distance between the greenhouse and the top of the backfill soil behind the retaining wall measured about 50 centimeters. Meanwhile, before the retaining wall collapsed, the greenhouse is estimated to have been situated about 2 m from the top part of the wall based on the location of the remaining part of the retaining wall. It is therefore estimated that a 1.5 m-long area on the backfill soil slid down from the top part of the wall.

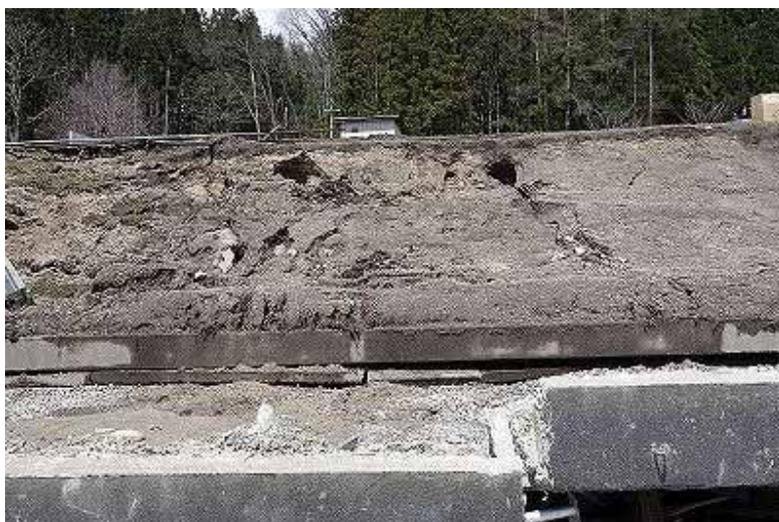
Fig. 4 – Piping traces of background

We also found some piping traces at the background of the wall. Figure 4 shows the piping traces. The trace size was about from 1m to 3m in width.

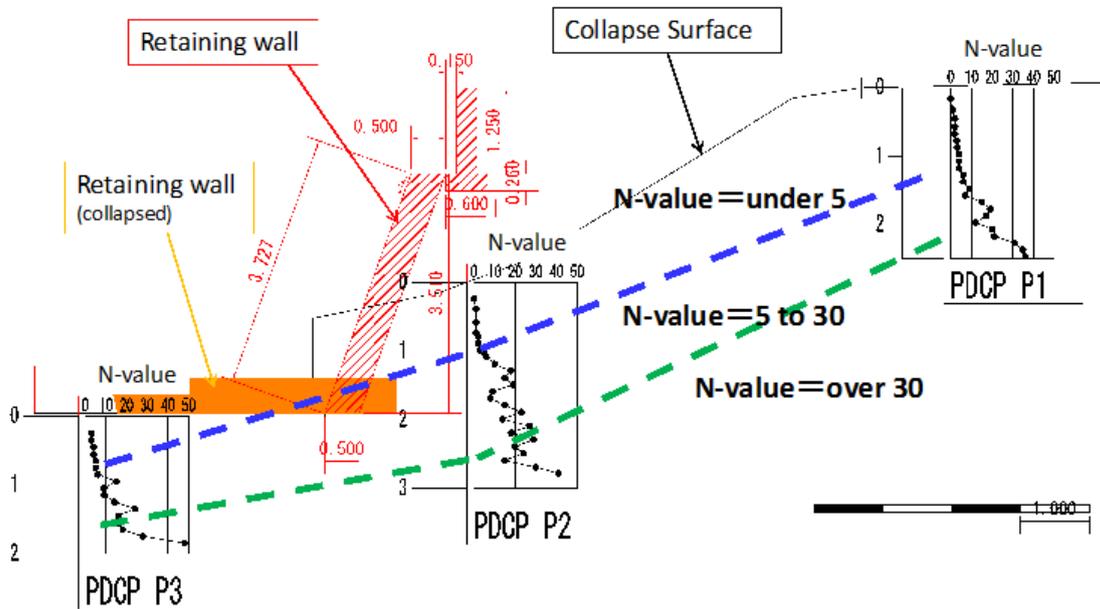
Fig. 6 – Results of PDCP tests (cross section of the wall and background)

According to the results of the PDCP test for P1 and the surface wave test for the A-A' measuring line, the area between the top of the retaining wall and the base of the gravity retaining wall is made up of soft soil (N -value of less than 10, $V_s = 80$ to 150 m/s), while the ground deeper than the base of the gravity retaining wall is made up of harder soil (N -value of 40 or higher, $V_s = 150$ to 200 m/s).

And according to the results of the PDCP test for P3, the N -value for the foundation ground at the base of the retaining wall is around 10 at a depth of up to 1.5 m or so below the ground surface, while hard soil with an N -value of about 30 appears at a depth of more than 2.0 m. The surface wave test for the B-B' measuring line, which is slightly distant from the base of the retaining wall, showed the underground soil is soft at a depth of up to 5.0 m or so with V_s being 80 to 150 m/s.

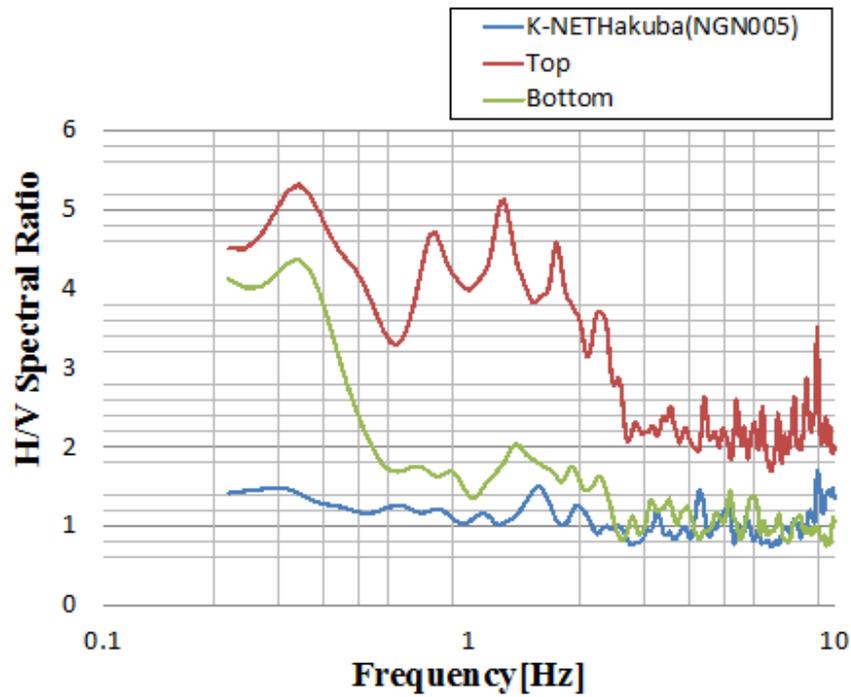
Fig. 8– Results of microtremor measurements (H/V spectral ratio and H/H spectral ratio)

Figure 8 show the results of microtremor measurements. When the H/V spectrum (H represents the geometric mean of orthogonal horizontal components and V represents the vertical component) was calculated based on the results of microtremor measurements, low-frequency waves were predominant for the grounds around the retaining wall. Significant amplification was also reported between the upper and lower parts at around 1 Hz - a level at which the retaining wall structure becomes vulnerable to vibrations. For example, the H/V spectrum was nearly 1.0 for the ground near the K-NET Hakuba (NGN005) measurement point.

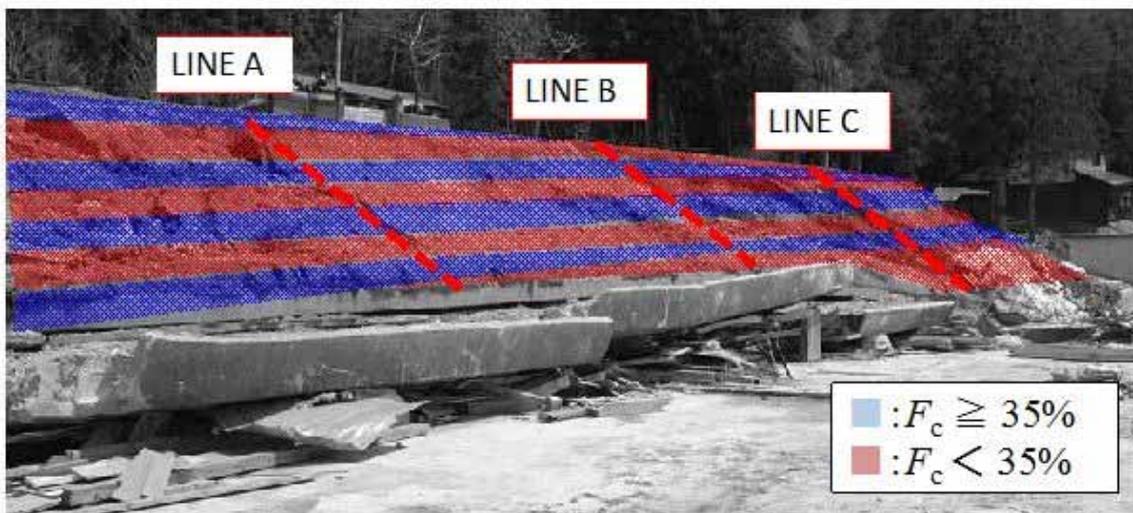
Fig. 9–Stratum structure of background

Figure 9 shows stratum structure of background, and Figure 10 shows the particle size distribution curve for the studied specimens which sampled with core cutter. According to the results, we found out that the background soil has a wide variety of soils, such as sandy soil, silty soil, and clay. Furthermore, these soils has formed alternating layer, as shown in Figure 9. The thickness is about 1m if divided with a point where fine fraction contents(F_c) equal 35%.

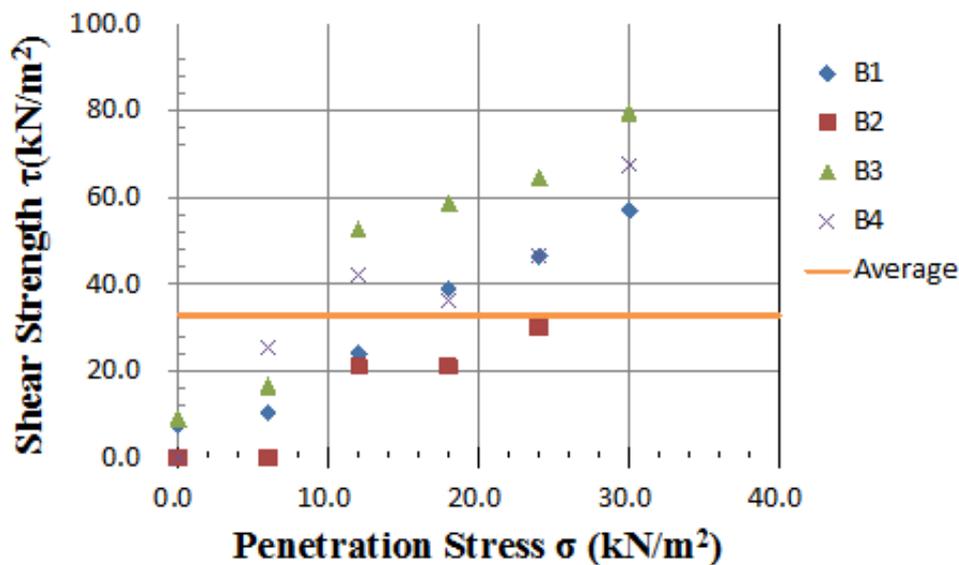
Fig. 12– Shear strength, τ , estimated with soil strength test rod

Figure 12 shows the shear strength of the background using soil strength test rod. The shear strength, τ , estimated using a soil strength test rod, correlates with the penetration stress, σ , in some cases, while in other cases they do not, depending on the survey location. Thus it is estimated that the particle size composition of the backfill soil varies. The average of the shear strength, τ , was 32.8 kN/m².

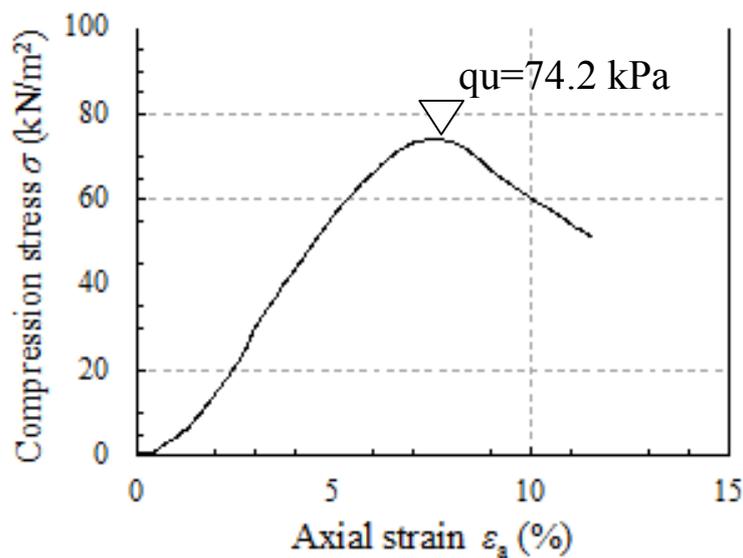
Fig. 13– Relationship between compression stress and axial strain (Sample D)

Figure 13 shows the relationship between stress and strain found through the unconfined compression test. While the unconfined compression strength, q_u , was 74.2 kN/m^2 , the deformation modulus, E_{50} , was 1.06 MPa . Based on the premise that $q_u/2$ is equal to the shear strength, τ , the value is estimated to be approximately equal to the average of τ , 32.8 kN/m^2 , which was calculated with a soil strength test rod.

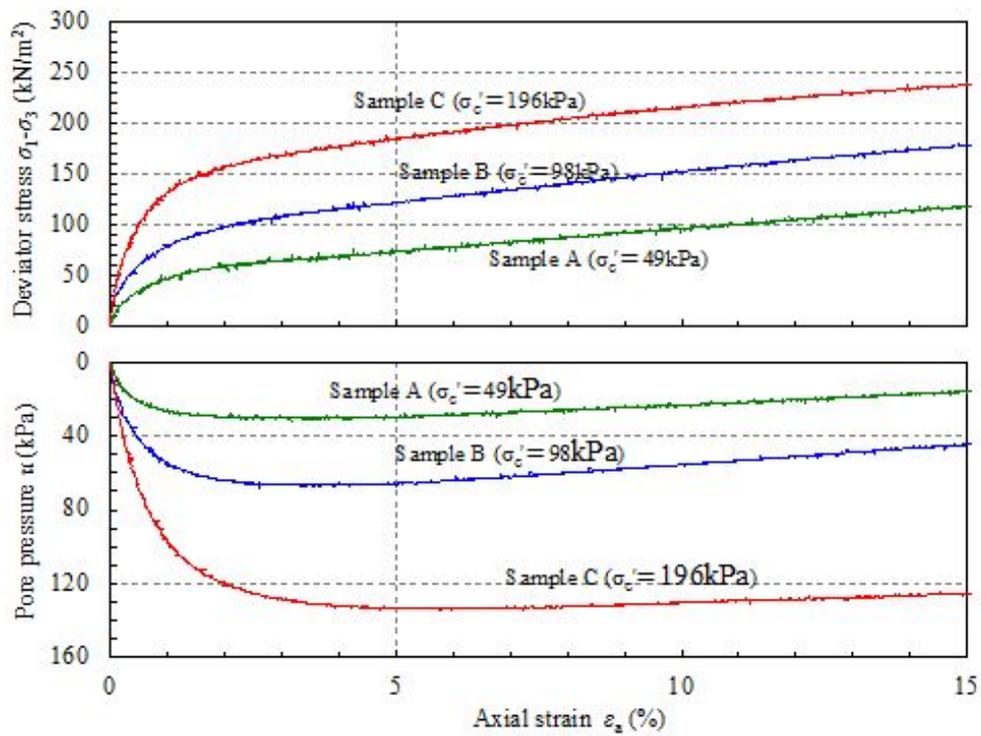
Fig. 14– Relationships between deviator stress, pore water pressure and axial strain (Sample A,B,C)

Figure 14 shows the results of the triaxial test for each sample, referring to the relationships between the deviator stress, pore water pressure and axial strain. As for the relationship between deviator stress and axial strain, the deviator stress for Samples A, B and C rises, as the axial strain increases. The major principal stress for them does not reach its obvious peak until ϵ_a rises to 15%. The higher the peak strength becomes, the more the effective confining pressure, σ_c' , rises, providing clear evidence of confining pressure dependency. As for the relation between the pore water pressure and axial strain, a positive pore water pressure is generated immediately after the start of loading, which indicates negative dilatancy characteristics. The pore water pressure reaches its peak at around 5% of ϵ_a and then begins to decline gradually, showing positive dilatancy.

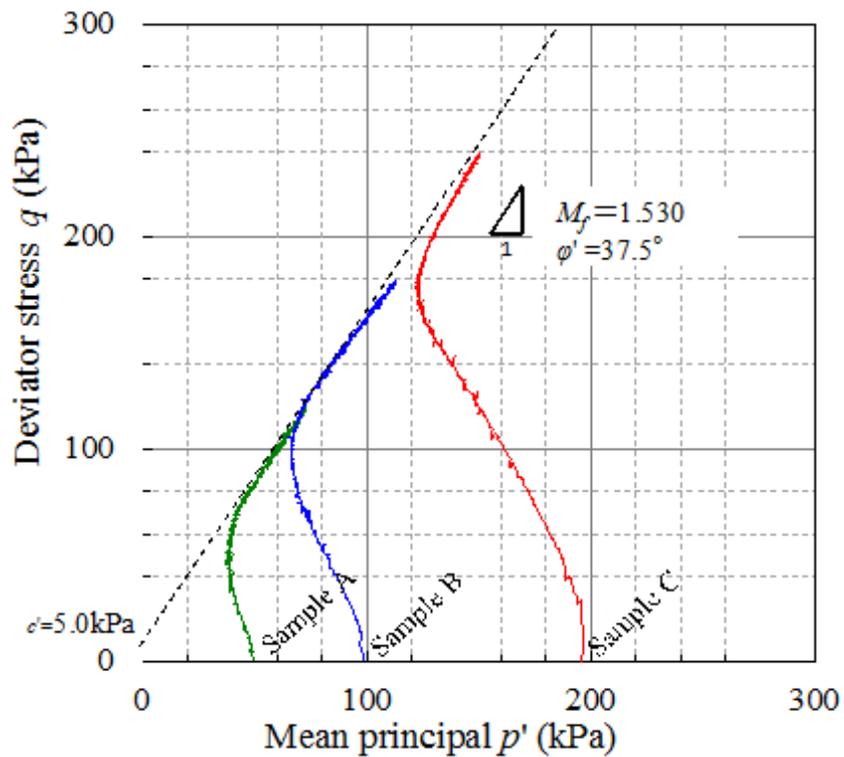
Fig. 15– Effective stress path (Sample A,B,C)

Figure 15 shows the effective stress path based on the results of the triaxial test. Considering the relationship between the mean effective principal stress, denoted by p' , and the deviator stress, q , the mechanical characteristics are consistent with those found in middle-density sandy soil, unlike the sample described in Figure 2, in which viscous material was predominant. The internal friction angle, ϕ' , was 37.5° , while the viscosity, c' , was estimated at 5.0 kN/m^2 . Meanwhile, ϕ is estimated to be 35° with a method of *Meyerhof* [7] based on the N -value of 10 obtained through the portable dynamic cone penetration (PDCP) test conducted at a depth of 1.0 m in our earlier survey. The N -value obtained by the laboratory triaxial test and the value obtained by the PDCP test are almost consistent with each other.

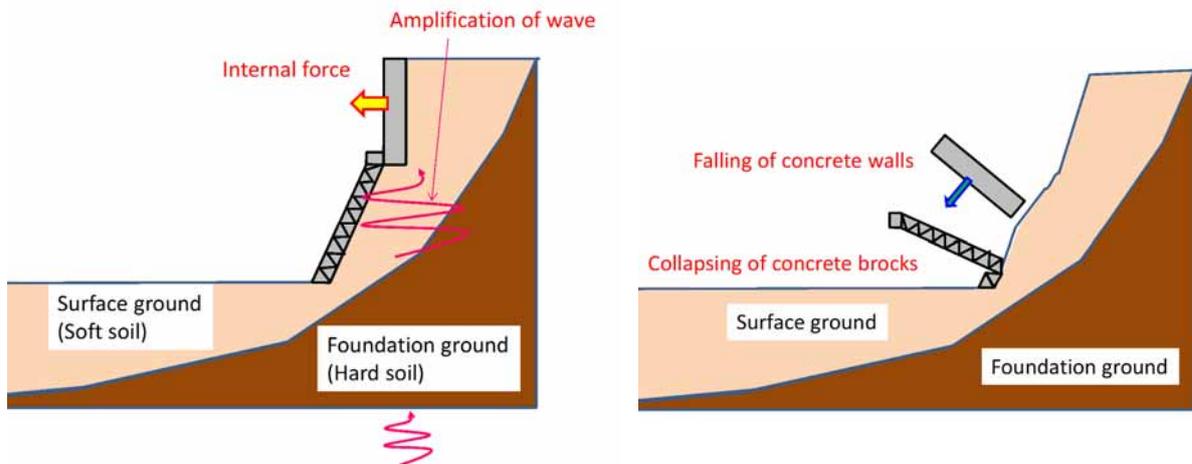
Fig. 16– A mechanism of collapsing of the wall

We showed a mechanism of collapsing of the wall at Figure 15. We surmise the mechanism as follows,

- 1) A seismic wave amplified due to the influence of the slope of the foundation ground(hard soil), a large internal force acted the top of the retaining wall.
- 2) Because the retaining wall is a top heavy structure, a horizontally force due to earthquake concentrated on the base of the concrete block retaining wall.
- 3) As a result, the concrete blocks were collapsed at first, and then the upper concrete wall fell on the blocks.
