Investigation and Analysis of Building Structures Damaged in Nepal M_s8.1 Earthquake on April 25th, 2015

YU. Shizhou⁽¹⁾

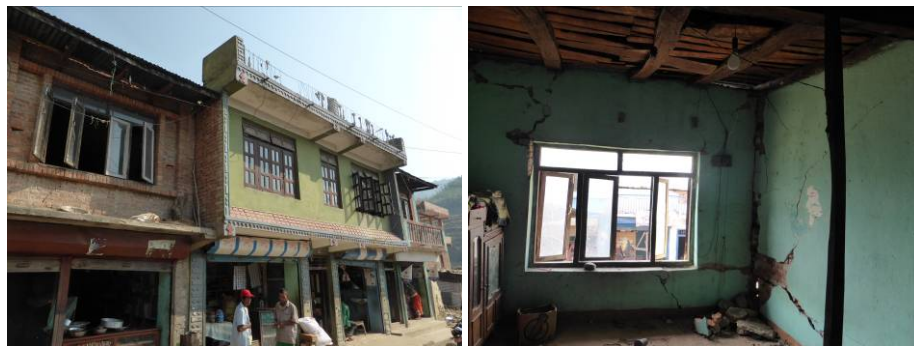
In Fig.3 the brick-wood house is damaged seriously and walls of second floor are complete failure. There are two collapsed rubble houses in Fig.4. The reinforced concrete frame house shown in Fig.5 is serious damaged. For the business, this building has a larger space, but the columns constructed in small size. Most columns of it are failure in ground floor.

Fig. 3 – Serious damaged brick-wood house in Deupur

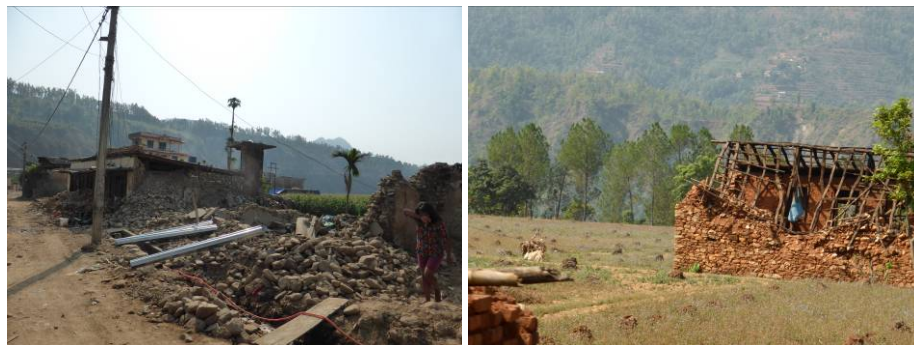
Fig. 4 – Collapsed rubble houses in Deupur (left) and Necpane (right)

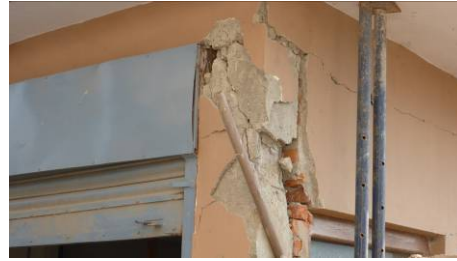
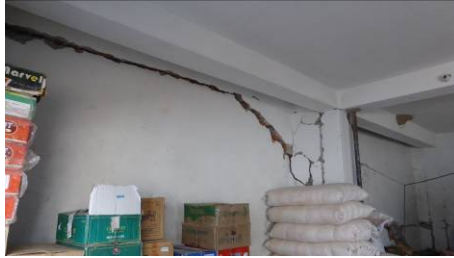
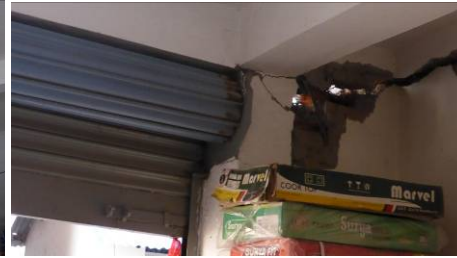
Fig. 5 –Serious damaged RC houses in Deupur

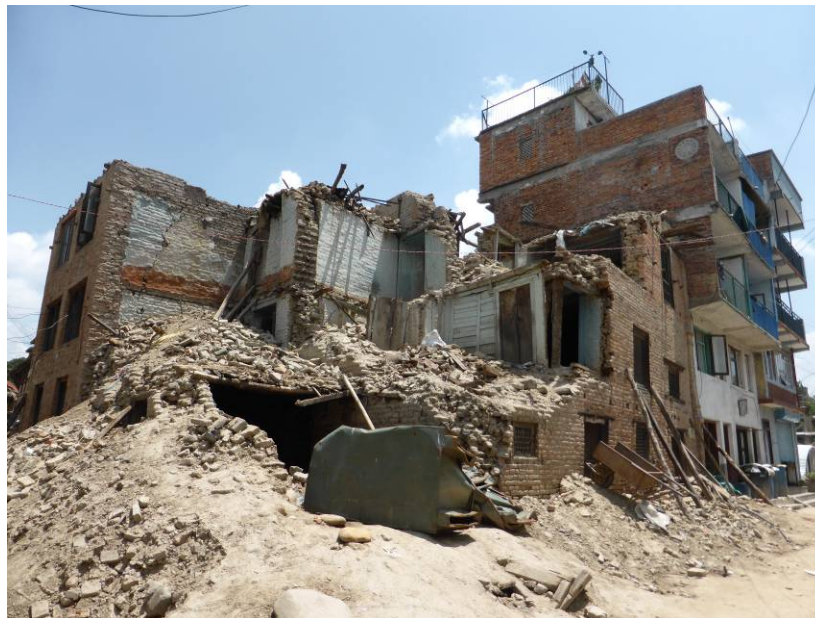
There are many old houses existing in the city, includes some historical buildings. Due to the poor seismic capacity, most of them damaged seriously. In Fig.6, some brick-wood houses collapsed, which locate in Kathmandu. The damage can be found easily in some old blocks and the peri-urban areas. In this earthquake, a large number of historical buildings had been damaged. In Fig.7, some historical buildings in Kathmandu and Gorkha are shown.

Fig. 6 – Collapsed brick-wood houses in Kathmandu

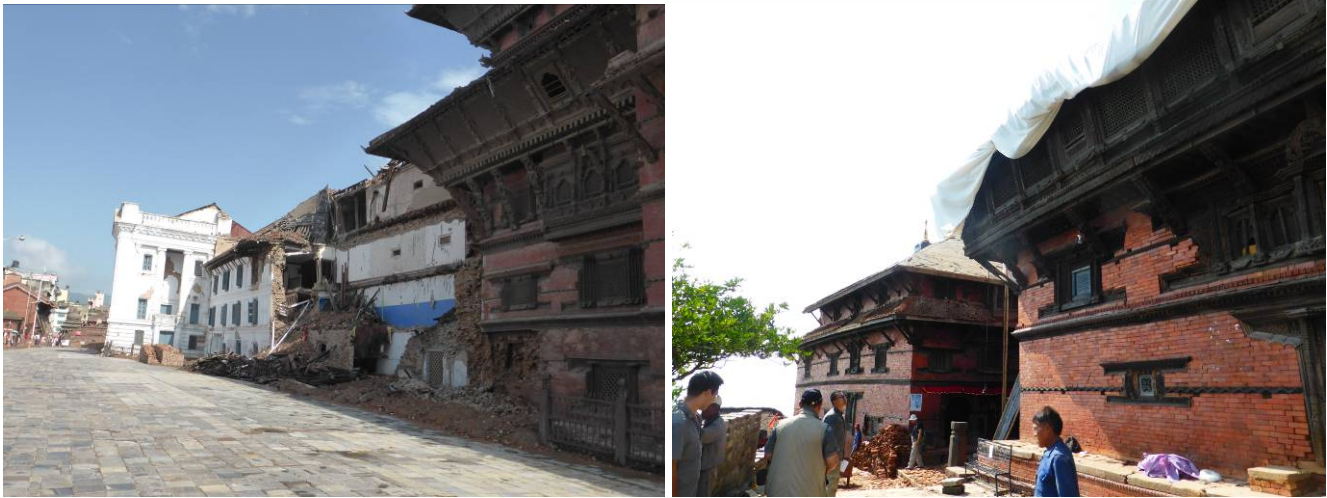
Fig. 7 –Serious damaged historical buildings in Kathmandu and Gorkha

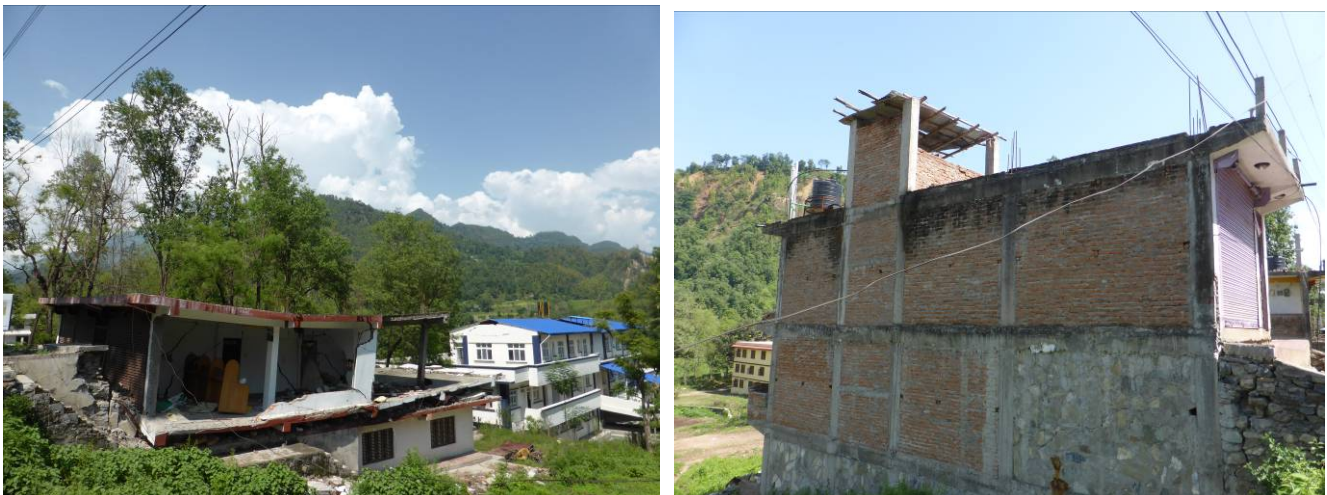
In Fig.8, two building locates slope in Talakhu (N 85.44856°, E 27.82579°) , which connect with roads by platform, the left one collapsed, and the second floor disappeared. Compared with this building, the right one with filled room near the road, it is basic intact. And in Fig.9, several RC buildings locate on the top of a hill, after earthquake, most of them collapsed due to the ground instability.

Fig. 8 – Two buildings damaged by platform in Talakhu

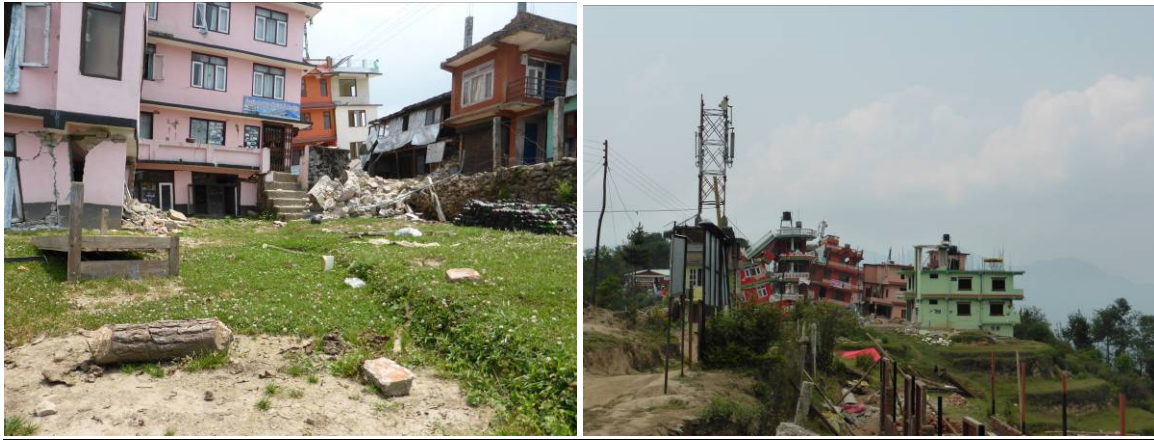
Fig. 9 – Several RC buildings collapsed due to the ground instability

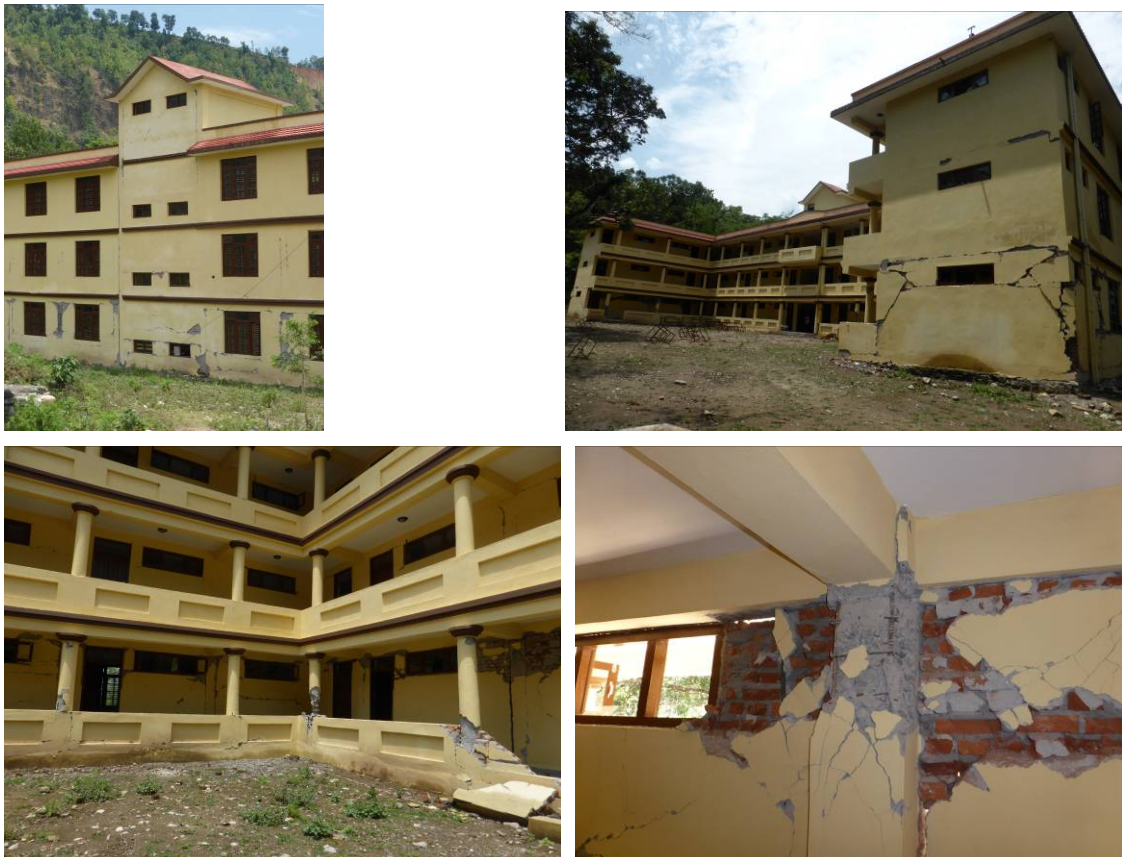
In Fig.10, a teaching building is a RC structure and constructed in valley terrace. Lacking of structural columns, the external walls of first floor are damaged seriously. the columns of aisle are almost failure at the connection with low wall. The stirrups set in the top of columns are not enough. In Fig.11, the columns of a RC building are broken, because the stiffness of the stone wall is larger than the columns'.

Fig.10 – Serious damaged teaching building in Gorkha

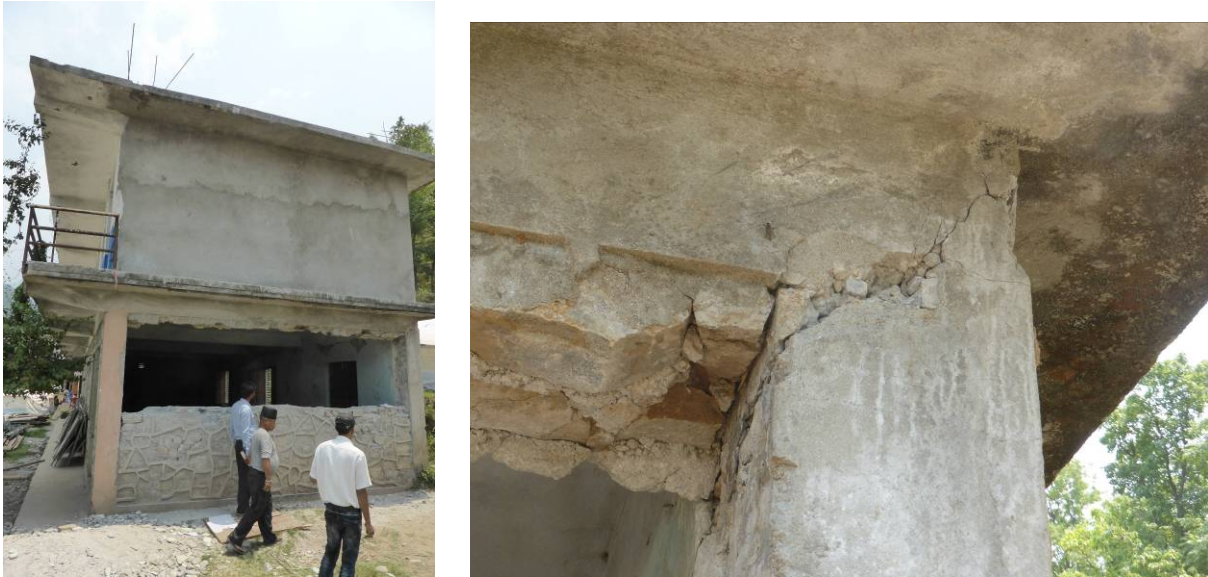
Fig.11 – RC building of higher secondary school in Sindhupalchok

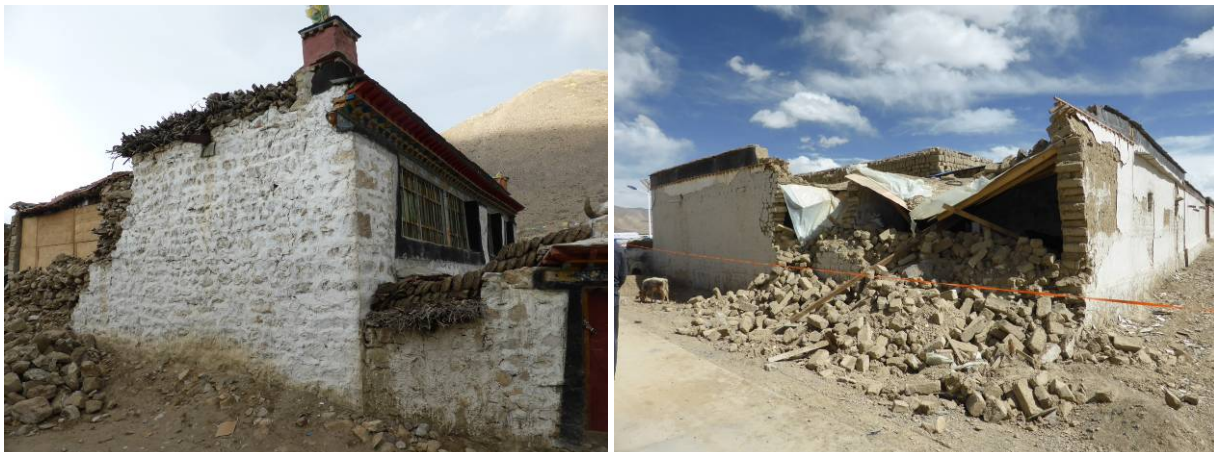
In Fig.12, there are two common type structures in Tibet, the left structure is rubble house and another one is raw soil house. And in Fig.13, slightly damaged RC buildings are shown, the filling wall of the building in right photo has crack, and two buildings are damaged by the collision of each other in left photo.

Fig.12 – Collapsed rubble building (left) and soil building (right) in Tibet

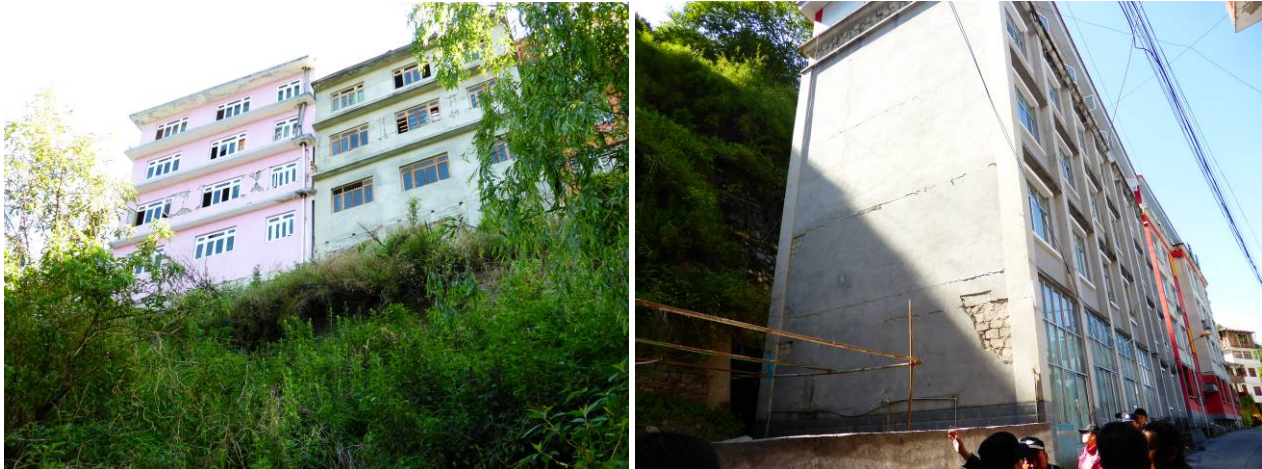
Fig.13 – RC buildings damaged in Tibet
