## STRONG MOTION OBSERVATION AND DAMAGE ASSESSMENT IN KATHMANDU, NEPAL AFTER APRIL 25, 2015 GORKHA EARTHQUAKE

### Abstract

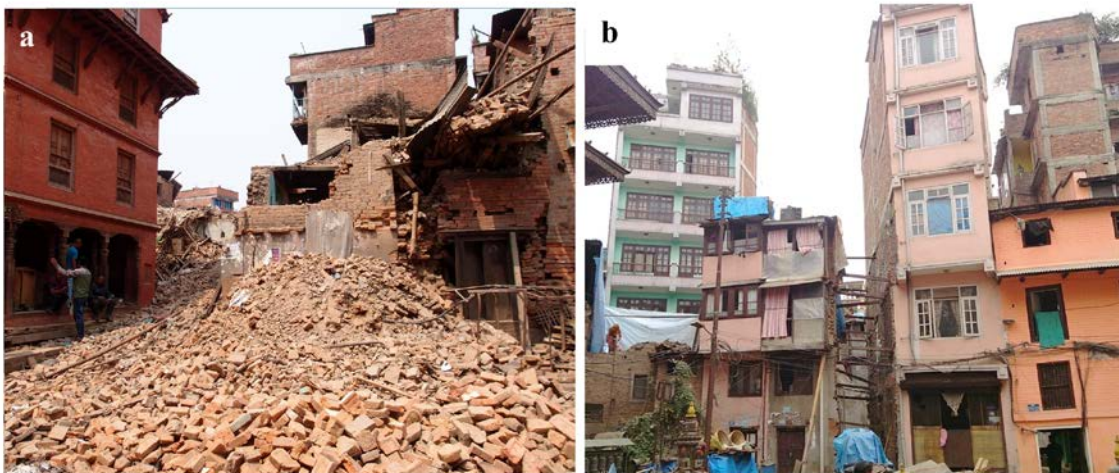
The low strength and lack of adequate structural members to resist lateral forces in these masonry buildings is the cause of damage during earthquake. Although, some buildings with wooden frames have withstood strong earthquakes, many load bearing structures get damaged by out-of-plane as well as in-plane failure. As time passes, the walls also get weakened by dampness and loss of mortar [19]. The mud-mortar can't hold the bricks in place and thus increase their vulnerability as was seen in city of Bhaktapur in east Kathmandu (Fig.4a).

The rapid rate of urbanization in Kathmandu has given rise to unplanned constructions without proper engineering consultation. This has given rise to many RC buildings with questionable qualities despite the fact that RC frame structures have better resilience to earthquakes compared to traditional load-bearing structures. The RC buildings built with current construction practices were found to be highly vulnerable to strong motion [20]. One can see buildings with highly asymmetrical designs of high vertical to horizontal ratios (Fig.4b) and RC frame structures on higher floors above mud-mortar masonry floors. In other cases, as owners wait for a suitable time to add additional floors, the RC columns and reinforcements on top of buildings are left exposed for a long time resulting in rust of rebar.

Figure 4 – a) Loss of mud-mortar from the fired-bricks in Bhaktapur, b) Asymmetrical designs of RC building in Kathmandu taken before the earthquake.

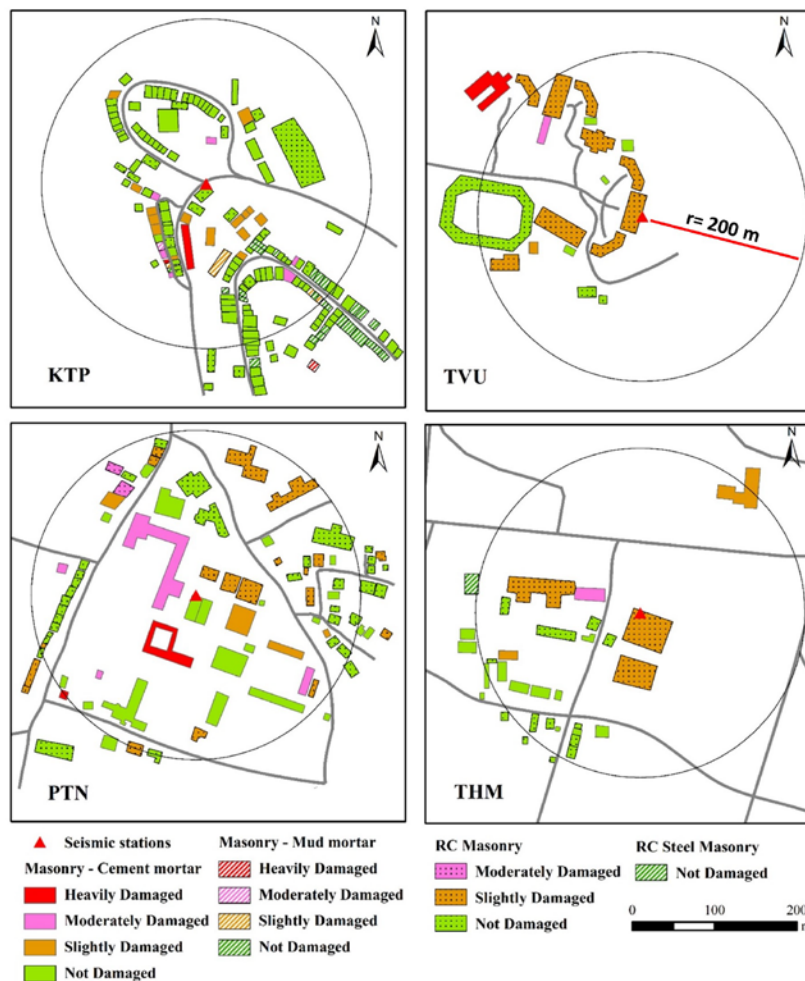
Figure 5 – Damage situation of buildings around the four stations.

Site	I* (1-2s)	PGA (cm/s <sup>2</sup> )	Damage situation	Number of buildings	Damage Ratio (%)
KTP	4.28	241	Majority of buildings unharmed with less than 2% buildings heavily damaged	174	5.74
TVU	5.54	238	Cracks in RC building foundations, one masonry building completely collapsed	19	10.52
PTN	5.04	151	Few masonry and RC structures developed cracks	85	9.41
THM	5.03	147	Very few damage except in an old school masonry building	32	3.13

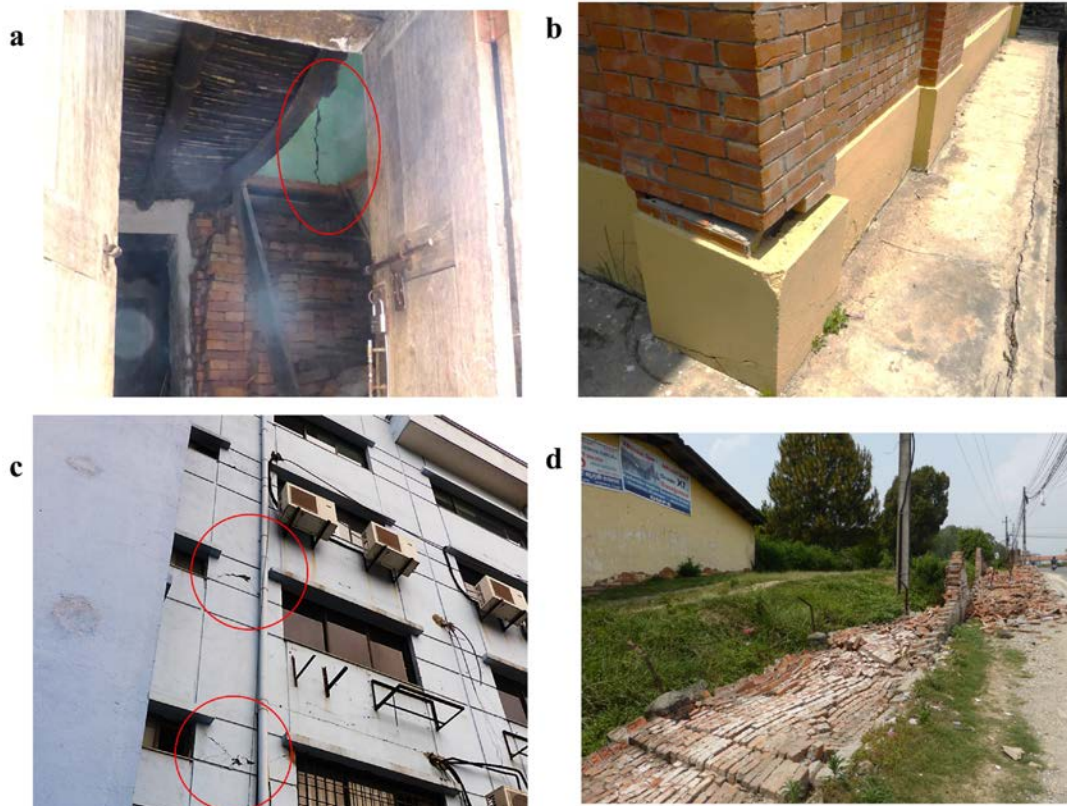
Few masonry buildings (mud-mortar) showed instances of cracks (Fig.6a) in inner wall and we encountered few fallen roof tiles in some. A three storied building suffered complete collapse (Fig.7a) of a façade facing steep-topography baring the structural members. Overall, we found less than 6% of buildings suffered moderate to heavy damage during the earthquake.

Figure 6 – a) Cracks developed in masonry buildings of KTP, b) Damaged columns in ground floor of a RC buildings at TVU, c) Shear-cracks seen in a RC building in PTN, and d) Collapsed compound wall in THM.

Damages in form of broken window panes and slight cracks on the ground floor were observed. There were damages to foundation and columns (Fig.6b) in some of the RC structures and a compound wall around one of the departments was completely collapsed. A single storied masonry cement mortar building constructed in late 60's suffered collapse of the walls and ceiling (Fig.7b) making it unusable. Statistically speaking, this site suffered the most damages (~10%).

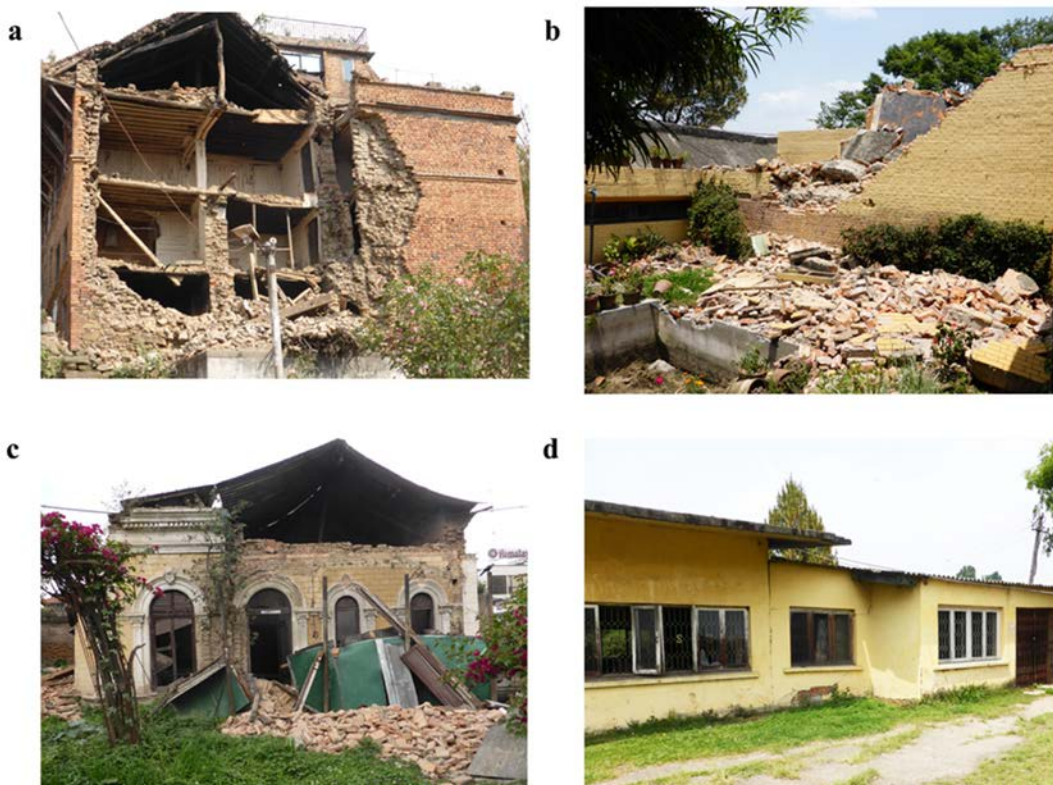
The area under consideration in Sano-Thimi is the new settlement where most of the private buildings are RC frame structures but some public buildings of institutes, schools, and government offices are masonry structures. There is also a RC buildings with steel columns and we put it under the RC- steel masonry class. The strong motion accelerometer THM is installed on the ground floor of the four storied RC building of University Grants Commission. This building in this site suffered the least damage compared to others (Fig.5). The compound walls of the school and other office premises fell down (Fig.6d). A masonry building of high school developed wall cracks and tiles fell from roof of another masonry building (Fig.7d).

Figure 7 – a) Collapsed facade in KTP, b) Damaged masonry building in TVU, c) Damage to masonry building with '*bajra*' mortar, and d) Damaged school building in THM.
