## Lessons learned from damage of the owner-built RC frames in the 2015 Nepal earthquakes

The 2015  $M_w$ -7.8 Nepal Earthquake and its aftershocks caused great loss of lives and severe damage to buildings. A team of 22 professors from China Earthquake Administration was sent for an extensive field investigation on the damage of buildings and lifelines. As part of the research efforts, the study presents the observation results and quantitative analyses on damage of the own-built reinforced concrete (RC) frame structures, which are widely adopted in the urban or sub-urban areas throughout Nepal. The frames are constructed of slender RC columns, RC beams and masonry infill walls, and exhibited much better seismic performance than most of other types of buildings, such as the stone, soil, masonry or wooden buildings. However, a lot of owner-built RC frames were still severely damaged or even collapsed. Lessons must be learned from the damaged buildings for facing the future earthquakes. First, beside RC frames, traditional structural systems with a good integrity was examined and introduced. Second, Typical structural features of the Nepal owner-built RC frames are demonstrated. Thi

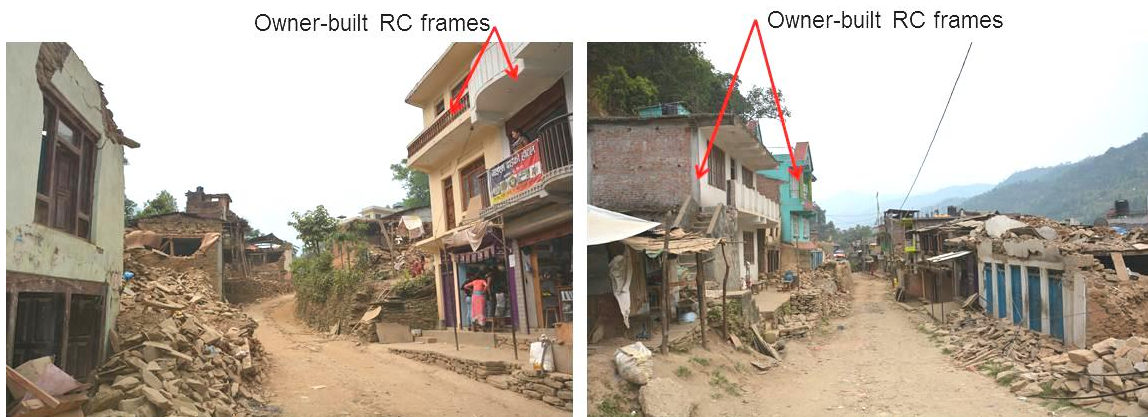
Before the 2015 Nepal earthquakes, researchers [3, 4] had investigated the seismic performance of the RC frames in Nepal, and stated that the owner-built RC frames were deemed to have insufficient strength, limited duration, lack of ductile detailing and poor construction. It is observed from the field investigation that the owner-built RC frames usually presented significantly better seismic performance than other types of structures. As an illustration, Fig. 2 shows an overview of the buildings along the main street in Jalbire, which is a village in Sindhupalchok. The RC frames in the photos are indicated by arrows. The RC frames survived and presented minor damage, while other buildings, which are constructed of brick, stone, adobe or wood, were all severely damaged or collapsed. These severe damaged buildings are not engineered, generally lack of integrity and connection detailing against seismic loads, and are widely used in the rural area. It might be most effective way of mitigating the earthquake disaster to improve the performance of the RC frame by learning lessons from the damaged RC frames, and to promote the structural system by keeping its traditional simple form.

Fig. 2 – Difference of damage degree between various types of structures (at Jalbire, a village in Sindhupalchok)

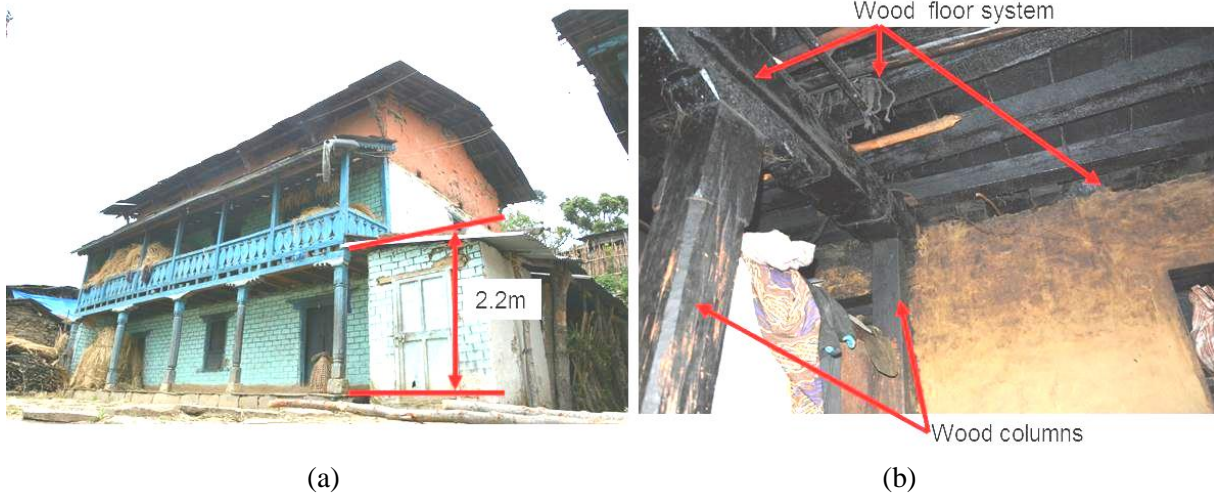
In the field investigation, the authors tried to give more attentions to the well survived non-engineered buildings in the vicinity of many collapsed buildings. Besides the RC frames, another type of structure that was not engineered at all was also found relatively effective for collapse prevention. Fig. 3(a) shows the global view of the entire building and Fig. 3(b) shows the local details inside this building. This is also one of the traditional type of buildings with a few special features: (1) wood is used extensively to form the frame the buildings, including roof system, floor system and columns; (2) The walls are constructed of stone and soil, and strengthened by wood members; (3) According to the quantitative investigation, the story height of the building is about 2.0 meters, and the span of wood beam is also about 2.0 meters or less, which are quite small. Note that the masonry pattern shown on the wall is not real masonry but painted decoration lines on the surface. Compared with the collapsed random rubble masonry buildings and adobe buildings, this structural system present a better integrity, and might be of some value for further study to build economic earthquake-resistant rural resident buildings.

Fig. 3 – Wood strengthened stone-soil structure (at Pangdang, a village in Sindhupalchok District)

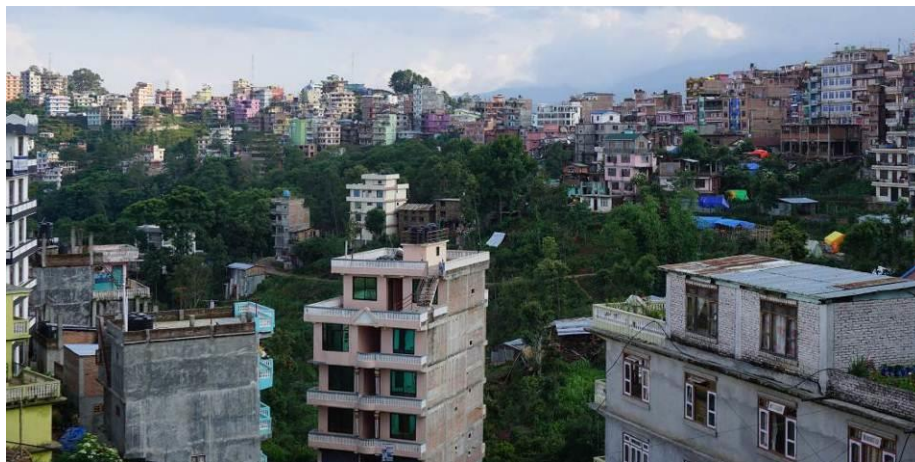
Fig. 4 – Full of owner-built RC frame in the Charikot Municipality

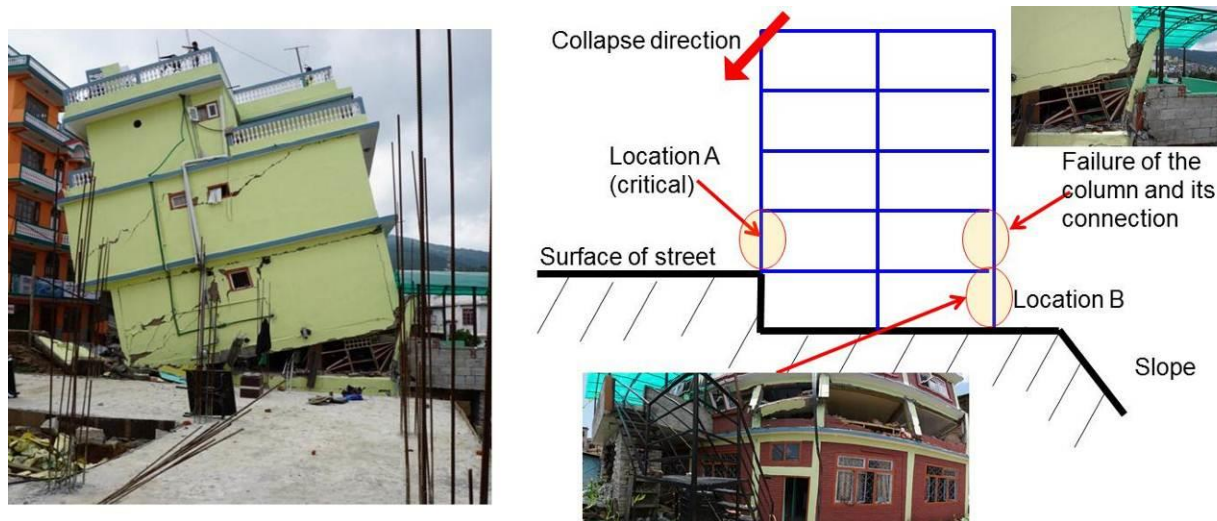
A lot of RC frames are built on a sloping site in Charikot and Chautara. The slope effects would induce more collapse risk of the buildings. According to the investigation, RC frame buildings are more likely to have two potential weak stories. Taking the building in Fig. 5 as an example, the two weak stories are indicated by Location A and Location B. The bottom story where B is located is likely to become a weak story, because the lateral stiffness has a sharp change from the foundation to the bottom floor. Location A is also a critical location to collapse due to the significant stiffness change due to the enhancement of the street ground to the bottom story. For the case in Fig. 5, Collapse initiated from location A because of lack of infill walls at the story facing to the street. The collapse was finally caused by the failure of columns at the weak stories, which indicate the slab composite effects are very strong, and the design to realize “strong column, weak beam” seems quite difficult to achieve.

Fig. 5 – Building collapse due to slope effects (in Charikot)

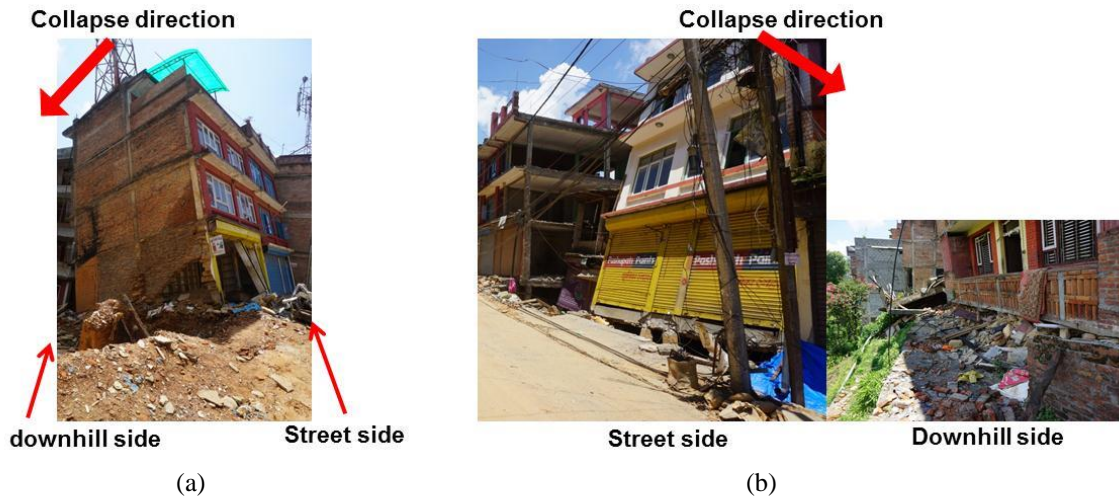
Fig. 6 shows another two collapsed buildings. Failure initiated from the ground floor or foundation (similar to Location B in Fig. 5) rather than from the upper story that faces to the street. Hence, either of the buildings inclined to the downhill direction. The sloping site effects sometimes are combined with the failure of foundation. The building in Fig. 6(a) had no basement, and was inclined due to the failure of downhill side column bases and their foundations. The building in Fig. 6(b) collapsed due to the weakness of downhill side columns, as the location B in Fig. 5. As the street-side columns at the bottom story were restrained by the retaining walls, the bottom story is not likely to vibrate into the street side.

Fig.6 – Building collapse to the downhill direction (in Chautara): (a) collapse with the failure of foundation; (b) failure of the ground column on the downhill site.

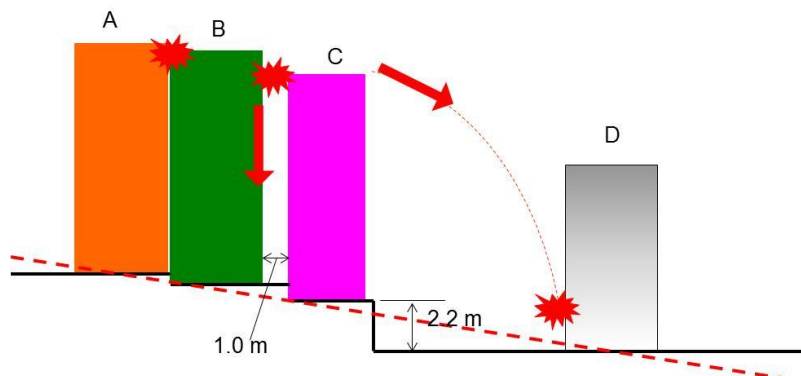
Poundings of different types between adjacent buildings were widely observed in the field investigation. Fig. 7 shows three types of poundings between four buildings, which triggered a different failure mode for each of the buildings. Buildings A and B originally touched each other before the earthquakes. After the earthquakes on May 12, Building A exhibited minor damage at the infill walls of the first story, while Building B collapsed due to a complete failure at the first story, as shown in Fig. 8(a). Building B was originally 1.0 m away from its neighbor Building C. The lateral deformation of Building B and C was too large to avoid the pounding between them. In the end, they crashed each other at the top stories, which triggered a global collapse of building C, as shown in Fig. 8(b).

It is pointed that building C was at very high risk to suffer a global failure. As shown in Fig. 7, building C had five stories with a total height of 14 m, but only had total width of 4.0 m, which was quite narrow. Unfortunately, the building was also located at the edge of a 2.0-meter-high platform. Furthermore, as building C fell down from the platform, the column at the top of building C crashed into the second floor of the building D, and penetrated its infill walls, as shown in Fig. 9.

Fig.7 – Collisions between four buildings

It can be concluded from the systematic collisions between the neighboring buildings that the distance between the adjacent buildings is one of the key parameters related with the failure mode. Seen from the case in Fig. 7, the interval between two buildings should be either small enough to work together or large enough to avoid collision. Also seen from Fig. 7, slope sites or weak neighboring buildings can also increase the pounding risk. Flexible connections or materials (like wood or rubber) can be used between the buildings with a high risk of severe collision, like the case between Buildings B and C.

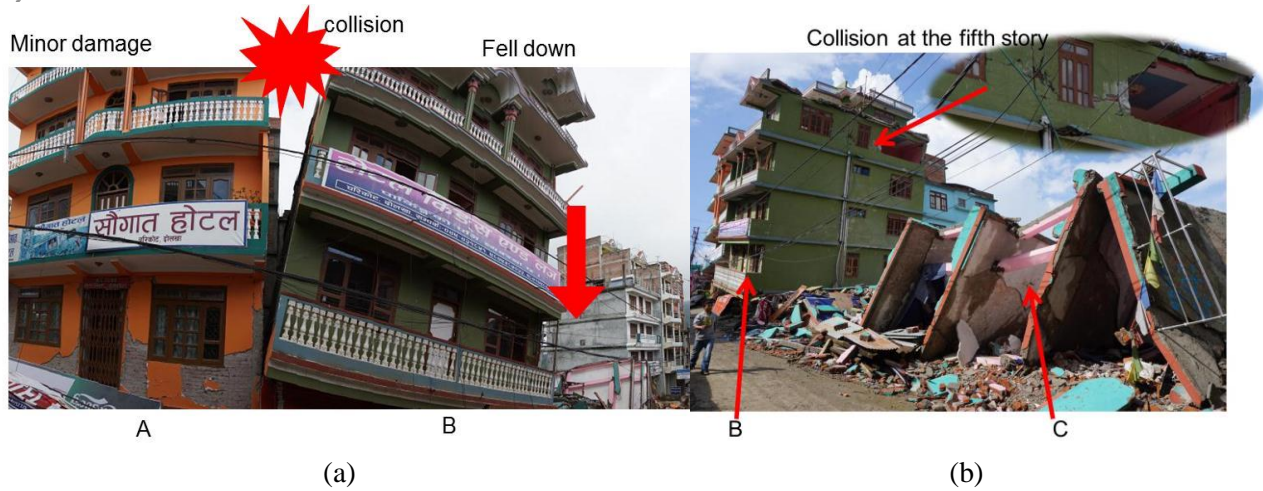
Fig.8 – Interaction between the buildings: (a) Buildings A and B; (b) Buildings B and C

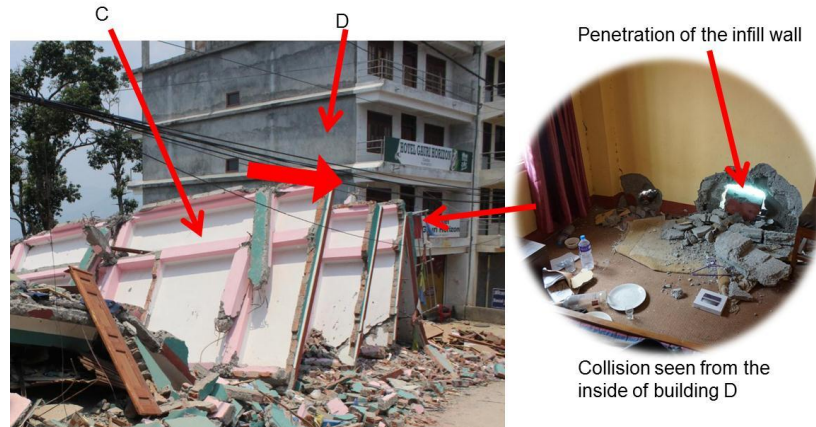
Fig.9 –Interaction between Buildings C and D

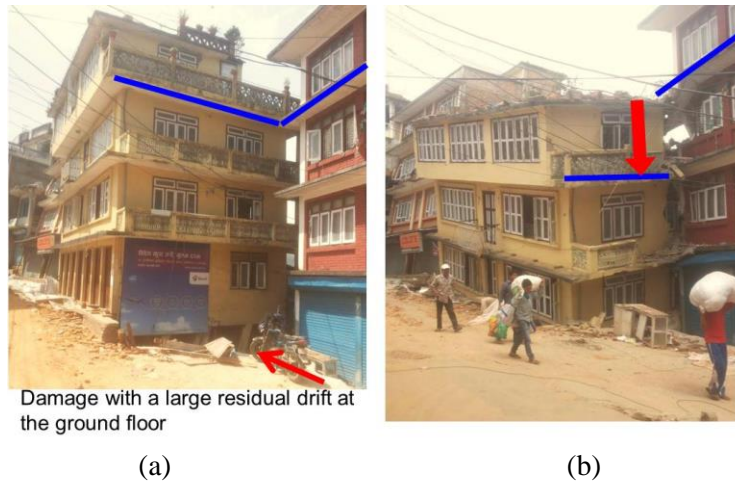
A few very strong aftershocks occurred after the main shock, and most of the structural collapses of RC frames occurred in the May-12 aftershocks, so it is evident that the collapse of buildings would be related to some extent with the damage accumulation under the earthquake sequence. One of the examples is the five-story RC frame in Chautara, as shown in Fig. 10. The building was severely damaged with a large residual drift at the first story after the main shock, but did not collapse at all. When the strong aftershock on May 12 occurred, the first story of the building was destroyed completely, and collapsed to the ground with a vertical displacement of about -2.0 m. It is quite difficult to quantify which was more fatal, the effects of damage accumulation or the strong motion on May 12. In either Chautara or Charikot, most collapsed RC frames were observed in the aftershocks. Although most of the owner-built RC frames were not designed by the code, a lesson is learned from the phenomena that more considerations are required for the seismic design on how to face the damageable strong aftershocks.

Fig. 10 – Collapse related with the cumulative damage of the earthquake sequence: (a) states after April 25 earthquakes (photo from the building owner); (b) states after May 12 earthquakes (in Chautara)
