BUILDING DAMAGE PATTERNS OF NON-ENGINEERED MASONRY AND REINFORCED CONCRETE BUILDINGS DURING APRIL 25, 2015 GORKHA EARTHQUAKE IN NEPAL

R. Guragain⁽¹⁾, S.N. Shrestha⁽²⁾, D. K. Maharjan⁽³⁾, S. Pradhan⁽⁴⁾

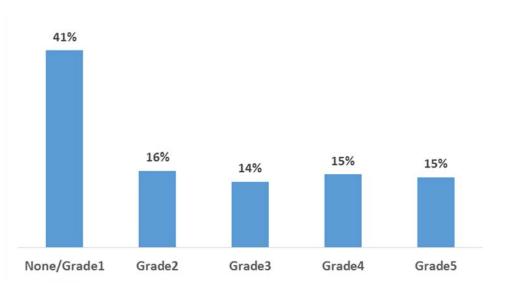
Figure 8: Overall Damage Grade Distribution vs Building Typology

Figure 8 shows the overall damage grade distribution of the buildings assessed. While as the Figure 9 shows the damage grades versus the building typology distribution. From the Grade 5 damage, which is 15% of the total building stock, 11% is stone in mud buildings which is about 75% of the total collapsed buildings. Other major damaged categories are brick in mud and adobe.

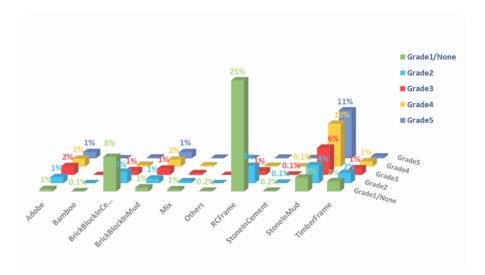
Figure 9: Overall Damage Grade Distribution vs Building Typology

Very little damage to reinforced concrete buildings is clearly seen. Stone in cement and brick in cement masonry buildings are also found less suffered in comparison to mud based construction

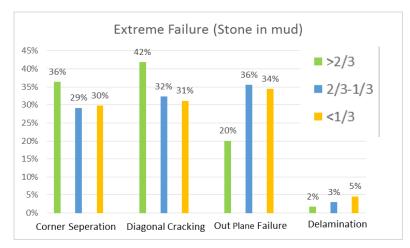
Figure 10: Different type of Damages in Stone in Mud Buildings

Figure 10 and Figure 11 shows the comparison of different type of damage to stone in mud and brick in cement buildings. In stone in mud buildings, diagonal cracking and corner separation are found the major type of damage. Though, the delamination is generally considered one of the major problem in stone masonry buildings, standing buildings with delamination was relatively small. This might be due to the reason that the delaminated buildings either got partial to complete collapse or had out of plane failure.

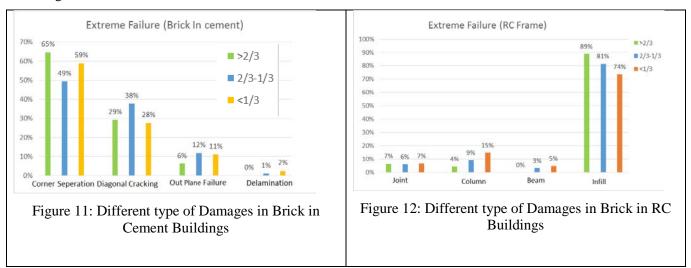
In the brick in cement buildings, corner separation and diagonal cracking are the major damages in the standing damaged buildings. Out of plane failure is relatively small and delamination is negligible for this category of the building.

Figure 12 shows different type of damages to reinforced concrete buildings. Damage to infill walls is the highest, however, this damage can be categorized as the non-structural damage. In the remaining damages, damages to column and joints is found the major damage. While, damage to beams is relatively small.
