DYNAMIC BEHAVIOR OF A PILE-FOUNDATION BUILDING WITH THE EFFECT OF IRREGULAR PILE-SUPPORTING STRATUM

Abstract

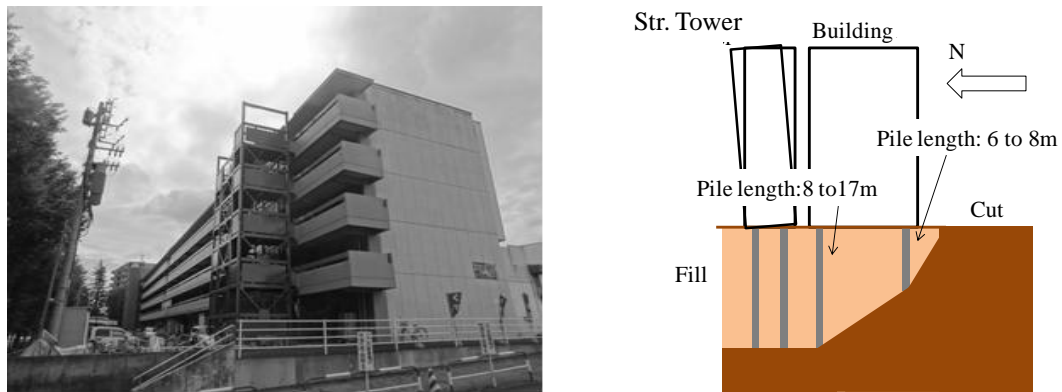
Fig. 2 – Damaged building ^[2]

The building was constructed in 1971 in the man-made residential area, approximately 5 km north-east of the center of Sendai. The building site and neighboring fill area distribution are shown in Fig. 1(b). The building is a five-storey RC frame structure that also suffered from the 1978 Miyagi Earthquake. The photo in Fig. 2(a) shows a panoramic view of the building. The vicinity of the site is a man-made reclaimed area, and the building exits around the edge of the fill area. The blue-colored area in Fig. 1(b) indicates the fill area reclaimed by the development of the residential site ^[3]. According to the design documents, the piles in the north frames are longer than those in the south frames. The difference in pile length between the north and the south is approximately 10 m at most. A schematic figure of the building sections, including the pile foundations and the ground, is shown in Fig. 2(b). The seismic behavior of the building is considered to have been affected by the surface layer of the fill area owing to the irregularity of the pile-supporting stratum.

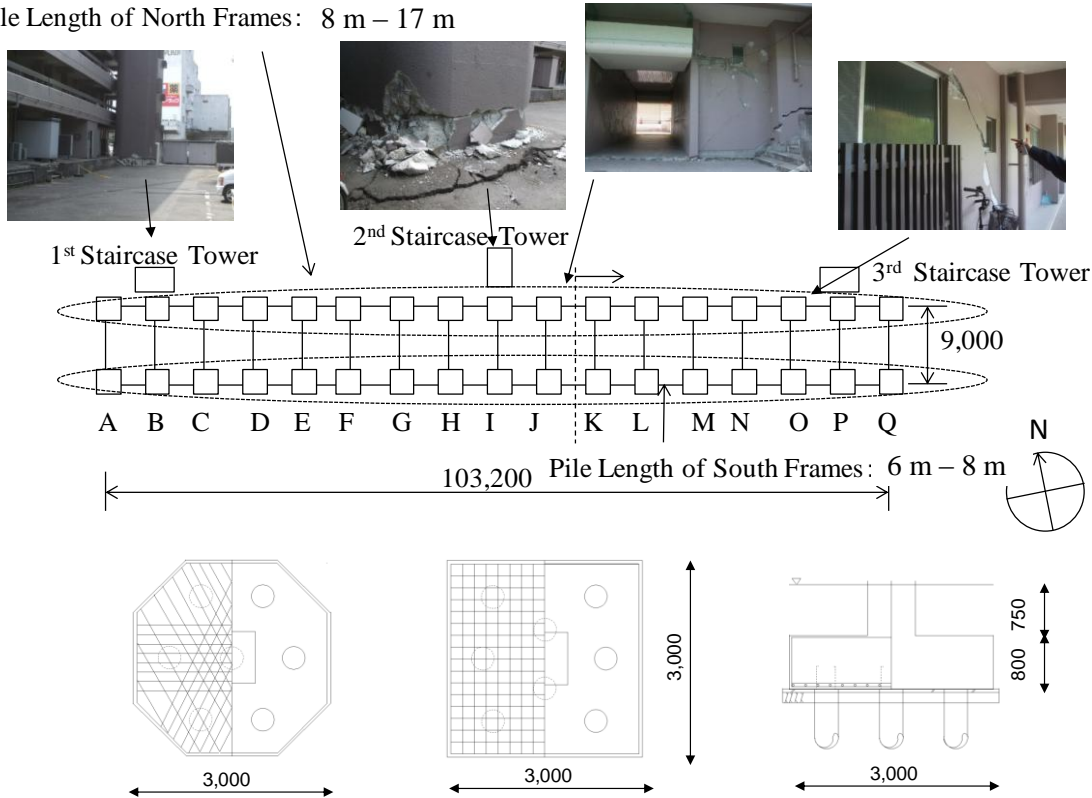
Fig. 3 – Schematic plan of building with damage and figures of the foundations

An outline of the damage and a plan of the building are shown in Fig. 3. The plan of the building consists of a long rectangular shape of 103 m in the longitudinal direction and 9 m in the transverse direction. The building has the three sets of staircase towers adjacent to the north side. The building consists of 17 structural frames, named as Frames A to Q. The structural frames are mainly supported by the foundations, as shown in Fig. 3. The octagon-plan foundation has seven piles in a group, and the rectangular-plan foundation has eight piles in a group. The pile lengths of each foundation are listed in Table 1. All piles turned out to be PC piles with a diameter of 350 mm. The difference in the pile lengths of the north and the south foundations are clearly

shown. The piles supporting the staircase towers are much longer than those of the building. The inclination of the pile-supporting stratum from south to north is estimated based on the differences in the pile lengths of the staircase tower, and the north and south foundations of the structural frames of the building.

The authors conducted a damage survey of the building after the 2011 Tohoku Earthquake. One of the most specific characteristics of the damage is a leaning staircase tower resulting from the damage to the foot and pile head of the tower. All three towers indicated a lean to the north. A bending failure at the foot of the tower was observed in the first and second towers. Severe damage at the pile head may have occurred in the third tower, because minor and intermediate cracks were observed. However, no significant failures were found at the foot of the third tower. The tower has an inclination over an angle of 1/30. On the other hand, the superstructure of the building showed no significant structural damage. However, the large shear cracks on the non-structural walls of many housing units and large bending cracks at the center of the girder at the east edge of the building were observed.

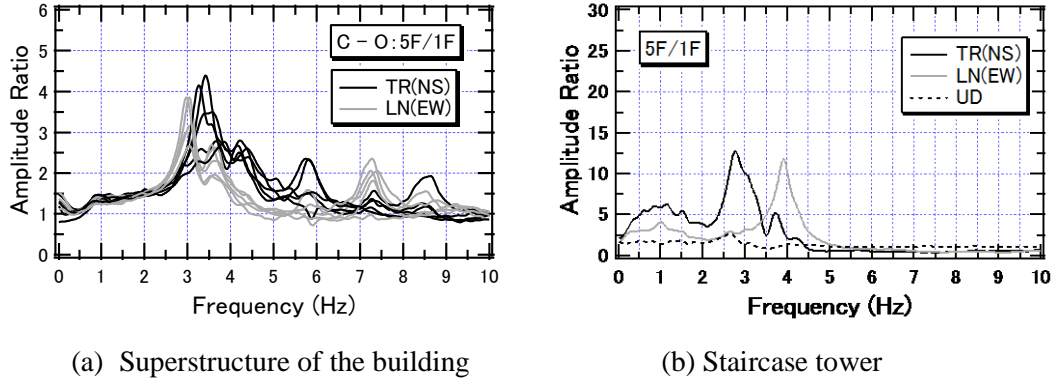
Fig. 4 – Amplitude ratios between 5F and 1F ^[2]

Microtremor measurements were carried out after the earthquake to estimate the dynamic characteristics of the building. The results were reported, including a discussion of the dynamic characteristics of the building and the staircase tower [2]. Amplitude ratios between 5F and 1F of the superstructure of the building derived from the microtremor measurement data of the structural frames C, G, I, K, and O are shown in Fig. 4(a). The natural frequencies fluctuate depending on the frames. They are estimated at approximately 3.5 Hz for a fixed-base system (5F/1F) in the TR (NS) direction. The amplitude ratios between 5F and 1F of the third staircase tower are also shown in Fig. 4(b). The natural frequencies are estimated at 2.8 Hz in the TR (NS) direction, and 3.9 Hz in the LN (EW) direction, for the fixed-base system (5F/1F). While the amplitude ratio curves of the superstructure have multiple peaks, indicating torsional motion and higher modes, the amplitude ratio curve of the staircase tower has a single distinctive peak, indicating a bending-type first mode. The natural frequency in the TR (NS) direction is lower than that in the LN (EW) direction. This is the effect of the rectangle plan with a strong axis in the NS direction and a weak axis in the EW direction. A small peak is observed, indicating torsional motion in

the TR (NS) direction immediately after the first mode and close to the natural frequency in the LN (EW) direction. It is also interesting that the UD direction has a spectral peak at almost the same range as the TR (NS) direction. This is because the tower inclined owing to the damage from the earthquake. Therefore, the spectral peak in the UD direction indicates a coupling effect of the TR (NS) direction from the inclination.

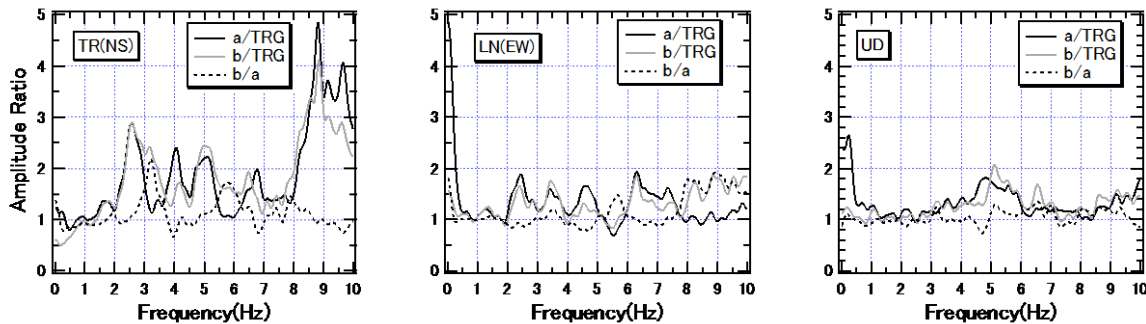
Fig. 6 – Average amplitude ratios between observation sites ^[2]

Attempts to estimate the one-dimensional wave propagation characteristics of the reclaimed soft soil layers at the site of the building were conducted based on an analysis of the earthquake observation records. From the results of Fig. 6, the predominant frequency of the soft soil layer is assumed to be 2.5 Hz. According to the design documents for the building, the pile lengths of the north frames range from 8 to 17m. Two cases are prepared for the estimation, where the depth of the surface layer is assumed to be 15 m (Case 1) and 20 m (Case 2). Using the information for the predominant frequency and the depth of the surface layer, the shear wave velocity of the subsurface layer is estimated to be 180m/s for Case 1 and 240 m/s for Case 2 by Eq. (1). In the damage survey after the 2011 Tohoku Earthquake, the shear wave velocity of the damaged man-made reclaimed residential area of the hill side of Sendai is estimated to be 160 to 180 m/s by the surface wave method ^[5]. The results estimated from the observed earthquake records are in good agreement with the damage survey of the man-made reclaimed residential area.

The relative relations between the observation sites are discussed using the results of Fig. 6, where the average amplitude ratios between the center (a) and the east (b) of the building and TRG are compared in three directions. The amplitude ratios of a/TRG and b/TRG indicate clear peaks at approximately 2.5 Hz in both the TR (NS) and LN (EW) directions. This result leads to the assumption that the one-dimensional dynamic characteristics of the reclaimed soft soil layer at the site of building can be considered to be 2.5 Hz in the horizontal directions. Some small peaks appeared at 4 Hz, 5 Hz, and at higher frequencies that considered the effect of the irregularity of the pile-supporting stratum. The effect is more remarkable in the TR (NS) direction.

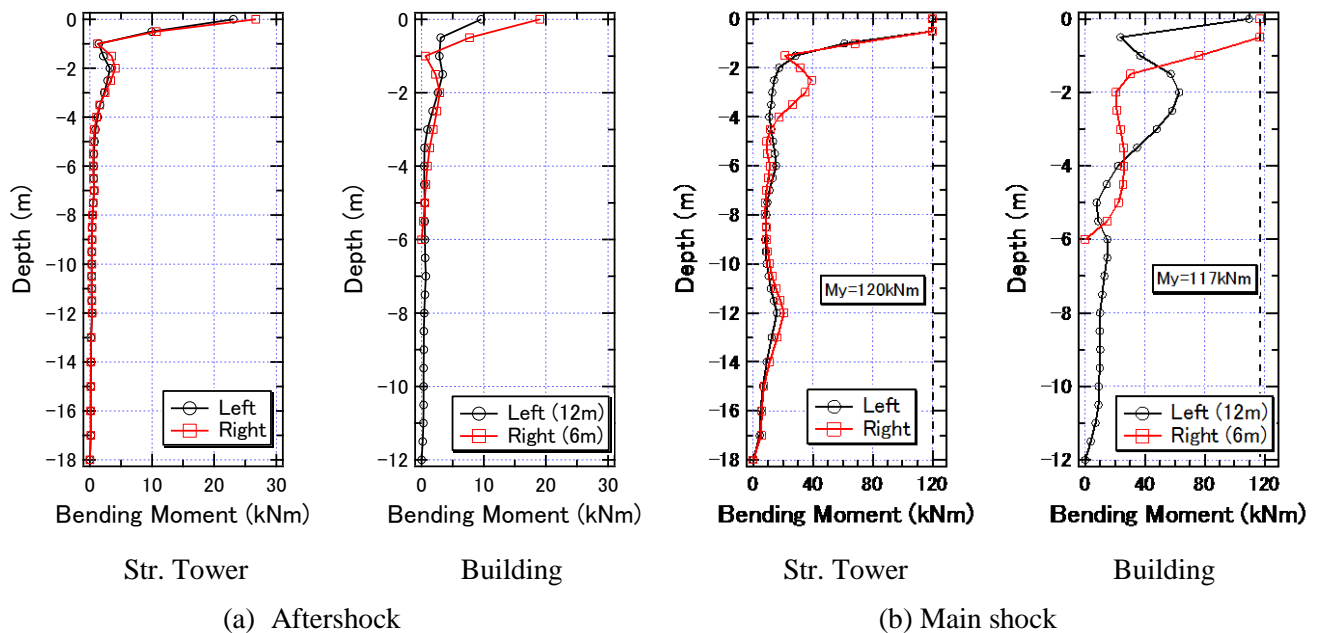
Fig. 11 – Maximum bending moment distribution in depth

The results for the main shock are illustrated in Fig. 11 to 13 in order to discuss the dynamic response of the piles and examine the differences in the pile lengths and the effects of the irregular pile stratum. The distributions of the maximum bending moments of the piles of both the building and the staircase tower in depth are shown in Fig. 11 for (a) the linear analysis of the aftershock and (b) the nonlinear analysis of the main shock. It should be noted that Young’s modulus of the pile is assumed to be 4.0×10^7 kN/m² for the linear analysis, which is different from that listed in Table 4. The figures of Fig. 11 (a) shows that in the linear analysis, the bending moments at the pile heads of the right piles are larger compared to those of the left piles for both the staircase tower and the building. In particular, in the results for the building, the bending moment at the right pile is much larger than that of the left pile at the pile head. The left pile is 9.6 kNm and the right pile is 19.0 kNm. In the results for the nonlinear analysis of the main shock [see Fig. 11 (b)], the bending moments at the pile heads exceed the yield bending moments for both the staircase tower and the building, except for the left pile of the building. The yield bending moments are also described in the results for the main shock ($M_y = 120.0$ kNm for the staircase tower and $M_y = 117.0$ kNm for the building). The bending moments at the pile heads of the staircase tower are larger than the yield bending moment for both the left and the right piles. For the building, the bending moment at the pile head of the right pile is larger than that of the left pile. The length of the right pile of the building is shorter than the left pile owing to the inclination of the pile-supporting stratum. The results reflect the difference in the pile lengths of the building. The bending moment of the left pile of the building tends to increase in the middle of the ground at approximately GL-2 m. This is considered to be an effect of the nonlinear responses of the soil layers. The same trend can be found in the results for the right pile of the staircase tower (approximately GL-3 m). The bending moments of the pile heads are in good agreement with the extent of the damage. However, the results for the right pile of the building seem too large compared with the damage to the building. The nonlinear responses of the soil layers are susceptible to the assumptions of the parameters of the dynamic characteristics. Therefore, the results are dependent on the assumptions of the nonlinear model of the soil. The process of determining the parameters should have more attention paid to it, and will be discussed in a future study.

- 1) It is confirmed that the effect of the irregular pile-supporting stratum appears in the dynamic responses of the piles. In the response of the building, the bending moment of the right pile (6 m) becomes larger than that of the left pile (12 m). This can be considered an effect of the difference in the stiffness of the pile owing to the pile length, and the nonlinear response of the soil layers. The nonlinear response of the soil is also dependent on the irregular pile-supporting stratum. The bending moment of the left pile in the middle of the ground (GL-2 m) tends to increase. This could be a result of the nonlinear response of the surface soil layers.

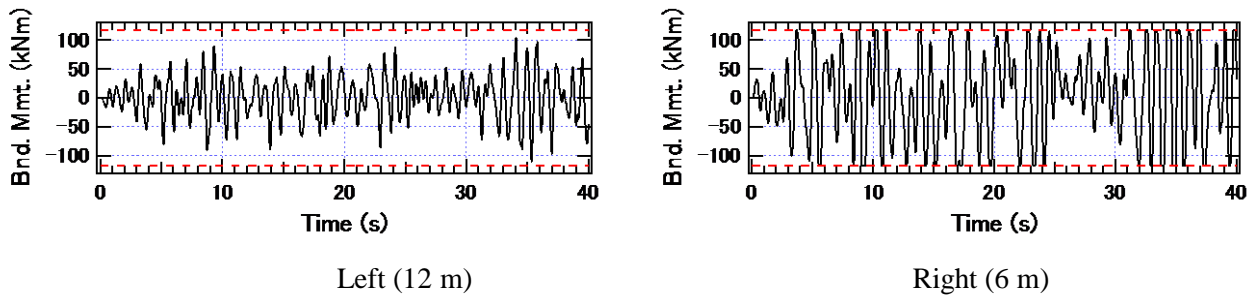
Fig. 12 – Time histories of bending moment at pile heads of the building
(Dashed lines indicate yield bending moment of 117.0 kNm)

Fig. 12 shows the time histories of the bending moments at the pile heads. Fluctuations in the dynamic responses of the bending moments at the pile heads are clearly shown in the time histories. For the left pile, the response of the bending moment is less than the yield bending moment of 120.0 kNm. On the other hand, the response of the right pile of the building indicates a strong nonlinearity for almost all durations corresponding to

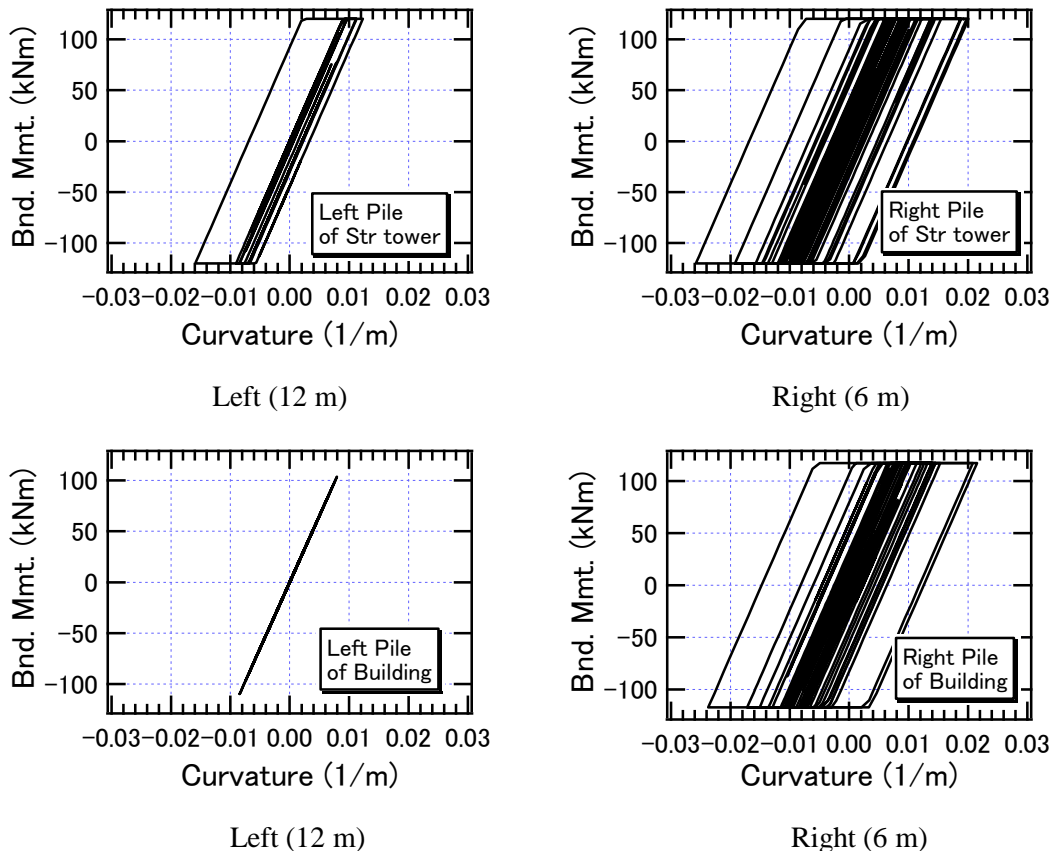
Fig. 13 – Bending moment and curvature relations at pile heads

the results observed in the maximum bending moment distribution of Fig. 11. Fig. 13 shows the relations of the bending moment and the curvature at the pile heads of the staircase tower and the building. As shown in Fig. 11 and 12, a nonlinear response strongly appears for the right pile. The ductility factors representing the extent of the structural damage are 1.8 for the left pile and 2.8 for the right pile in the staircase tower, and 2.6 for the right pile in the building. The relation of the left pile of the building does not show the nonlinearity. The results indicates that the nonlinear response of the pile head of the staircase tower is larger than that of the building. If the capacity of the ductility factor is assumed to be 3.0, the pile head of the staircase tower is considered to have been severely damaged, and the pile head of the right pile of the building is also close to severe damage. The results of the staircase tower are in good agreement with the extent of the observed damage in the previous section. However, the response of the building tends to be larger than the observed damage. It may be considered that there is still some more room for improving the model with regard to the response of the right pile of the building.

- 2) The ductility factor of the right pile of the staircase tower is 2.8. If the capacity of the ductility is assumed to be 3.0, the result is in good agreement with the extent of the damage to the staircase tower by the main shock. By contrast, the ductility factor of the right pile of the building is 2.6, which is close to 3.0. The response of the building in this simulation can be considered too severe compared with the extent of the damage. The reason for this difference is mainly attributed to the estimation of the soil property, especially the nonlinear characteristics of the surface soil layers.
