# THE CHURCH OF SAN FRANCISCO IN SANTIAGO, CHILE. ANALYSIS OF 400 YEARS OF EARTHQUAKE-RESISTANCE BEHAVIOUR

N. Jorquera<sup>(1)</sup>, N. Palazzi<sup>(2)</sup>, L. Rovero<sup>(3)</sup>, U. Tonietti<sup>(4)</sup>

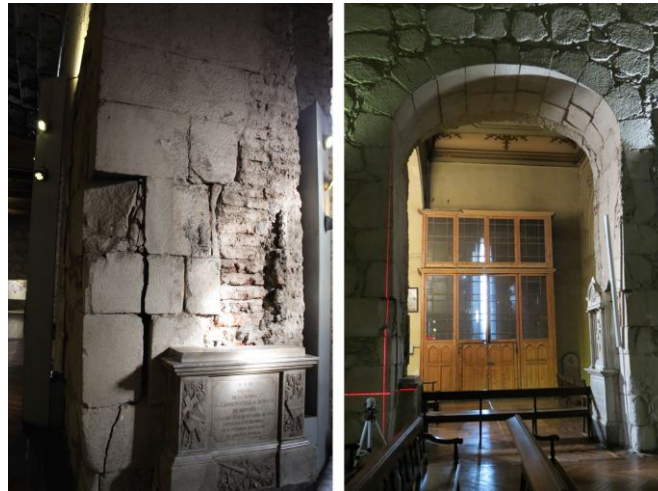
The stone-masonry central walls were bored to create arches and, therefore, they are not able to face dynamic actions well, showing dangerous cracks and deformation of some arches (Fig.3).

Fig. 3- Deformation of an arch and dangerous cracks in its base.

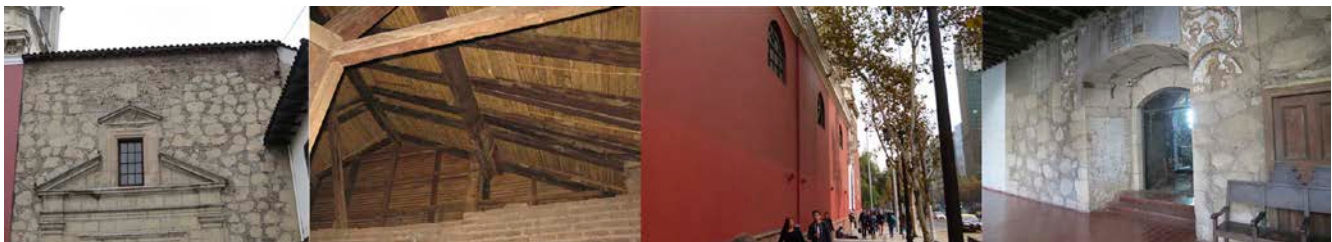
During its 400 years of life, the Church of San Francisco has suffered some local damage due to the combination of two factors: the Chilean earthquake’s severe action and the constructive defects of the building due to the numerous transformations in its history, which has given rise to deficiencies both in the in-plane capacity of the walls and in the “box-behavior” determined by disconnections between the walls. Openings in masonry walls, absence of transverse bond and additions with different materials have represented the preferential ways for the damage due to the action of the earthquake. Nonetheless, the stiffness in-plane horizontal of the diaphragm constituted by the timber roof was able to effectively distribute the seismic action between structural elements.

Reconstruction of rear presbytery façade using wooden elements and bricks shows collapse occurred on the top wall. These failure mechanisms have occurred for the following reasons: the high conventional slenderness ( $\lambda_c = 14.6$ ) of wall, the significant distance between the transversal walls, the ratio between length and height  $L/H=0,88$  [7], the lack of a connection with the roof covering, and the presence of a wide opening. Similarly, the main façade presents a summit reconstruction of brick and discontinuities with the orthogonal walls with a ratio  $L/H=0,605$  [7]. Moreover, this façade shows an additional vulnerability associated with the eccentricity of the bell tower inducing different inertia than the main block. The longitudinal outside walls have important discontinuities in the proximity of the transept intersection, which belongs to the original nucleus of a Latin cross. This discontinuity represents a weakness to overturn. In the north and south transepts, the reconstruction of the walls with bricks puts in evidence the already activated out-of-plane mechanism.

Fig. 6- Damage to Main Facade (a), Presbytery Façade (b), North Transept (c), South Transept (d).

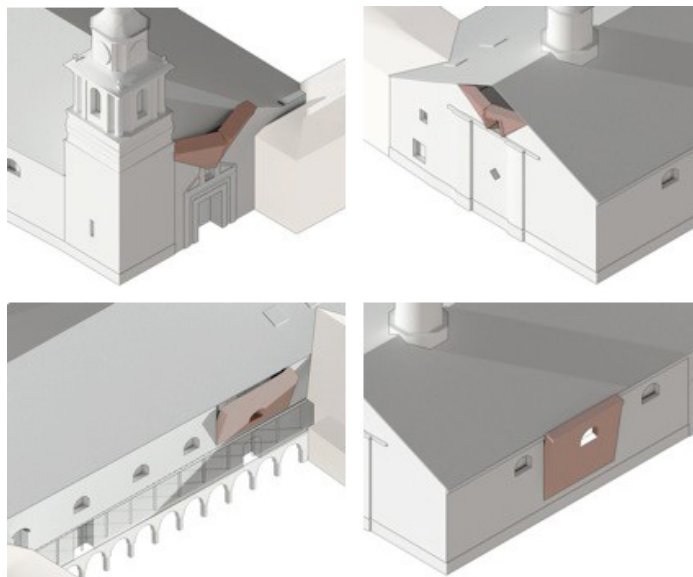
The first step of analysis is the identification of the damage mechanisms that will most likely be activated. The analyses were performed for the current state and the original previous state (Latin-cross plan). In the current state the mechanisms identified are: the gable overturning of the main façade and the rear façade of presbytery, consisting of cuneiform blocks, the overturning out-of-plane around the two oblique cylindrical hinges, and the simple overturning of the north and south transept walls around the cylindrical hinges of the base of building (Fig.7). In the original previous state the mechanisms evaluated are the same but with different materials, with the exception of the mechanism characterizing the main façade. In fact, since the gable was confined both to the contiguous walls and the shear walls, the mechanism considered is the horizontal arch mechanisms (horizontal bending) of confined wall. The horizontal arch inside the wall reached the limit state due to the crushing of the masonry at key stone for the compressive stress at the limit of the material's capacity (considering  $f_{m,min}=2,6\text{MPa}$ , according with M.Q.I. method) (fig. 8).

Fig. 7- Damage mechanisms of the Main Facade (a), of the Presbytery Façade (b) and of the South Transept (c) and of the North Transept (d)

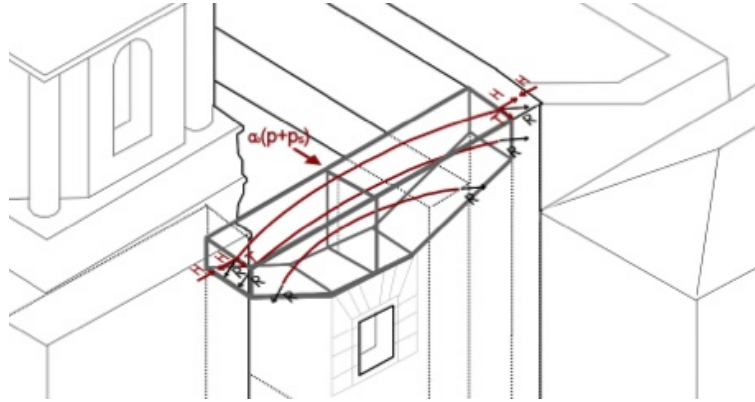
Fig. 8. The horizontal arch mechanisms (horizontal bending) of the Main Façade's confined wall

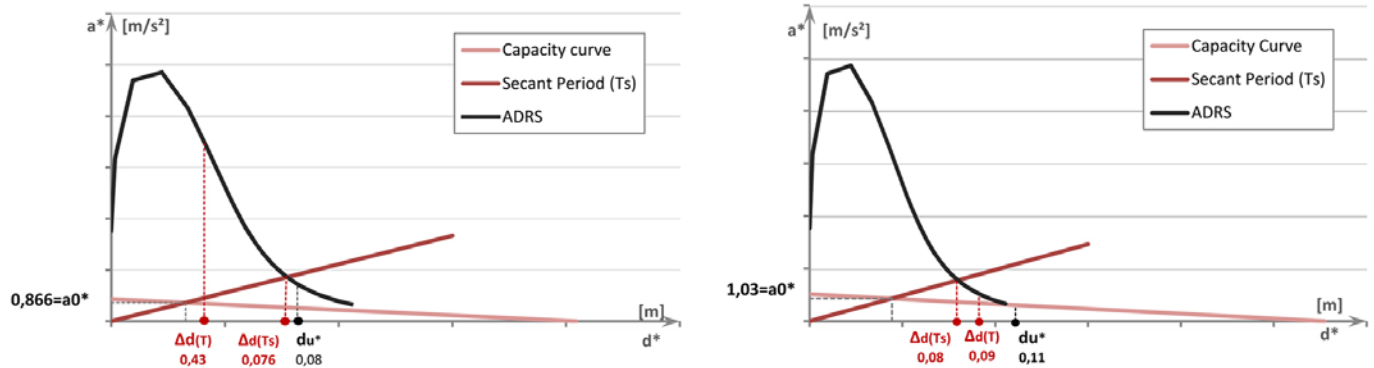
Fig. 10- Capacity and Demand Curves for Macro-blocks: North Transept (a), South Transept (b)

From the comparison between the Capacity and Demand displacement (8) of the transept walls the relations (8) are satisfied (fig.10) and justifies both the absence of the collapse and the activation of the mechanisms detected through linear kinematic analysis.

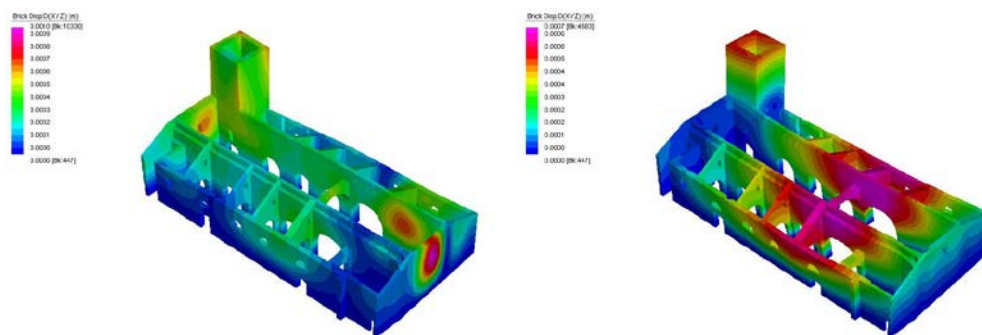
Despite the fact that the structural responses obtained through the global finite element analysis are characterized by significant limitations for masonry buildings, the vulnerabilities that have been detected in the kinematic analysis are coherent with the obtained results. In fact the first 9 modes show the intrinsic vulnerability highlights both the crack patterns that kinematic analyzes (Fig. 11). Beyond that it is possible to observe that the distribution of the masses is not prevalent in a single mode but is distributed in numerous modes. This circumstance shows that the structure does not exhibit a well-defined global behavior and that the evaluations based on local analysis are more significant. In fact (from table 4), the structure shows the prevalent local behavior.

Fig. 11- FEM output: displacement, mode3 and mode7
