DAMAGE ASSESSMENT AND SEISMIC RETROFIT OF TRADITIONAL AND MODERN MIDRISE BUILDINGS IN THE AFTERMATH OF 2015 NEPAL EARTHQUAKE

H. Kit Miyamoto (1) and Amir SJ Gilani (2)

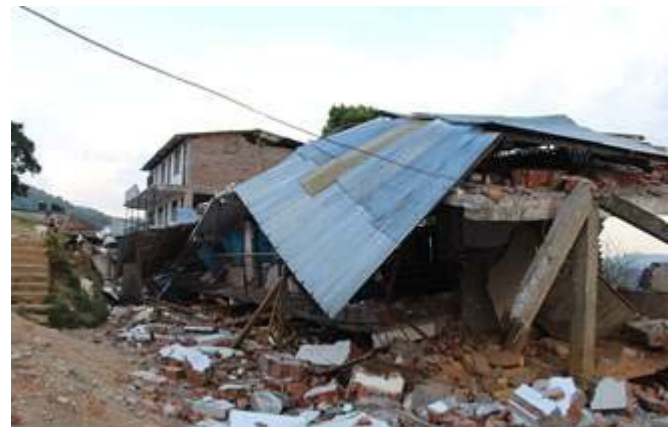
In the past earthquakes in developing countries, school buildings have been especially vulnerable to damage from earthquakes [2]. The same was the case in Nepal; see Fig. 5. In the aftermath of the 2015 main event, data from the Department of Education [3] was analyzed by the authors. Preliminary findings are shown in Table 1 -. It is noted that damage to school buildings was extensive ad widespread. The number of school casualties was, fortunately, limited because the earthquake occurred on Saturday when schools were not in session.

Fig. 5 Collapsed school building

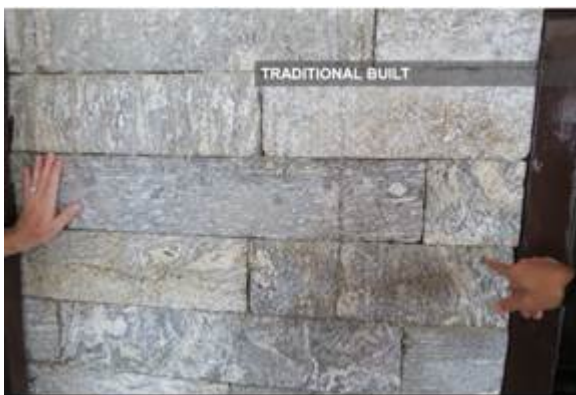
Fig. 7 Traditional bearing wall building

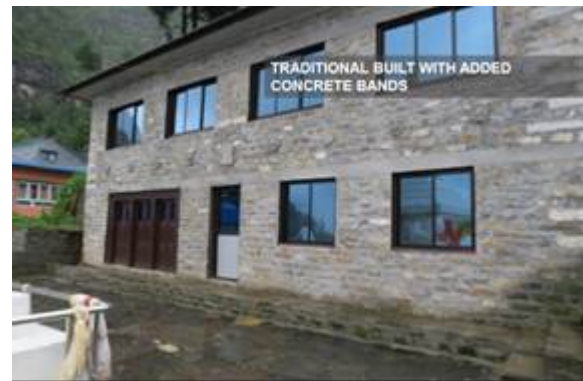
Fig. 8 Building with concrete band

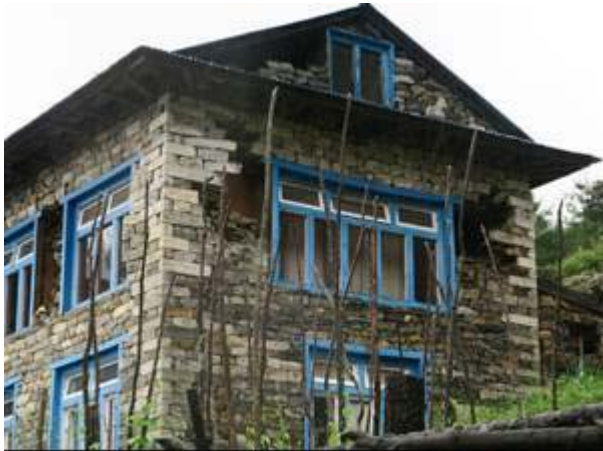
The level of damage in traditional construction was highly depended on the construction practice. The buildings with stone and mortar generally performed well. Although cracks were noticed in many of these buildings, these cracks did not pose a safety hazard. By contrast, in older buildings where either no mortar was used or when mud was used as mortar, there was significant damage. For these buildings, as shown in Fig. 8, the out-of-plane failure of walls was the most common mode of failure, where stonewalls fell over or stones fell out, generally at the top of the walls. Since these bearing walls carry both seismic and gravity loading, their out-of-plane failure can compromise the gravity load path and can result in collapse of roofs and floors. For the surveyed buildings, a secondary wood beam supporting the roof was observed in many of the buildings. This member supported the roof after the failure of walls and prevented collapse of the roof. Visual observations also

Fig. 9 Out-of-plane failure of bearing wall building

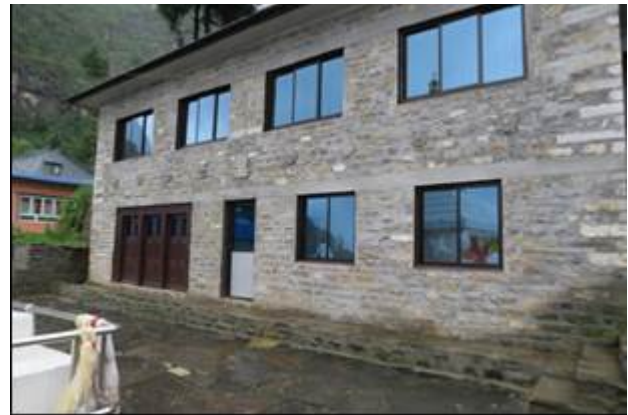
showed that, of the traditional buildings that experienced damage, the mud mortar appeared to be more brittle than the mud in other buildings. Accommodation structure built with cut rock, cement, and ring beams that performed well; see Fig. 9.

Fig. 10 Undamaged accommodation building

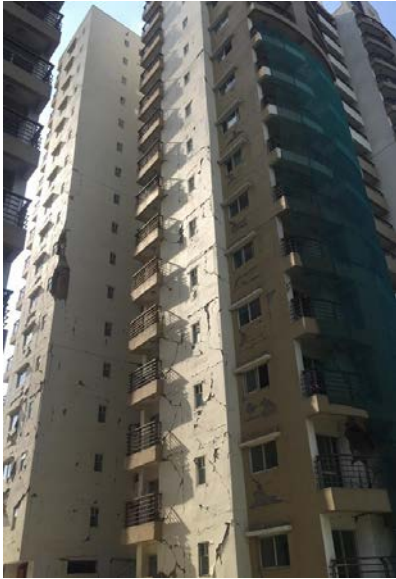
As mentioned previously, the soft soil underlying the Katmandu region produced large spectral accelerations in the 1-4 sec period range and excited mid-rise buildings. Many of these buildings are of newer construction vintage, had ductile detailing, and as such did not experience collapse. However, damage to these tower buildings was widespread; see Fig. 11. Most of the mid-rise buildings used reinforced concrete moment framing as the lateral force resisting system. In addition, unreinforced infill walls were used for these buildings. The damage to the infill walls was extensive; see Fig. 12, which caused the tenants to move temporarily out of these units. It is noted that these are high-end condominium units.

Fig. 11 Exterior cracking, residential tower

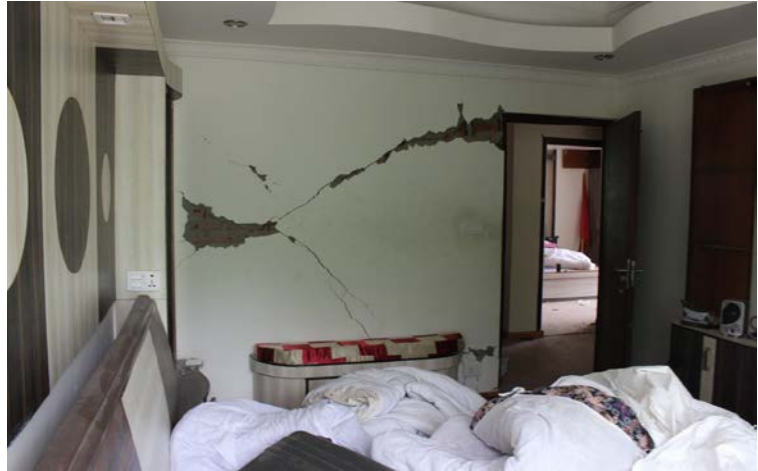
Fig. 12 Interior diagonal cracking of infill walls

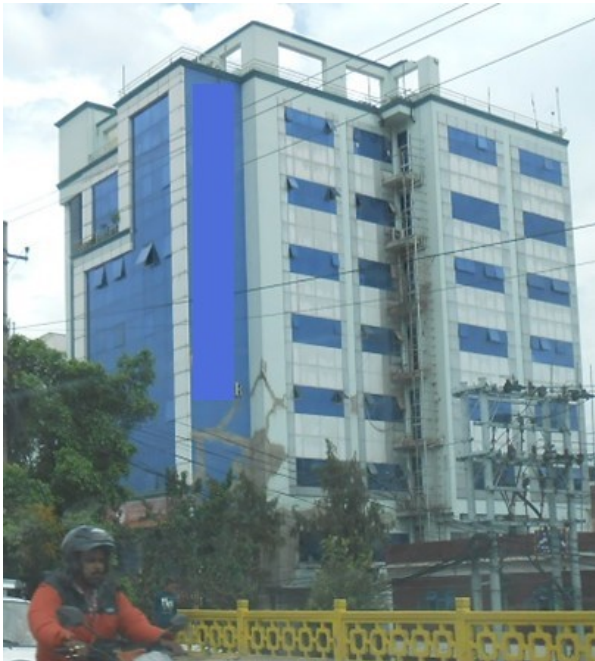
Fig. 13 Photograph of residential tower

The application of seismic dampers to an existing building was demonstrated after damage assessment of a residential tower was completed. The 10-story 32-m tall tower is approximately square in plan measuring 18 m on side; see Fig. 13. This tower was constructed using reinforced concrete moment frame system with masonry infill. Typical columns were 600x600 mm to 800x800 mm square and rectangular beams measured 300x600 mm. The mathematical model of the building is presented in Fig. 14. In this model, the diagonal viscous dampers are also shown. The building seismic weight is approximately 47 MN.
