## FULL SCALE SHAKING TABLE TEST ON A URM CAVITY WALL TERRACED HOUSE BUILDING

F. Graziotti<sup>(1)</sup>, U. Tomassetti<sup>(2)</sup>, A. Rossi<sup>(3)</sup>, S. Kallioras<sup>(4)</sup>, M. Mandirola<sup>(5)</sup>, A. Penna<sup>(6)</sup>, G. Magenes<sup>(7)</sup>

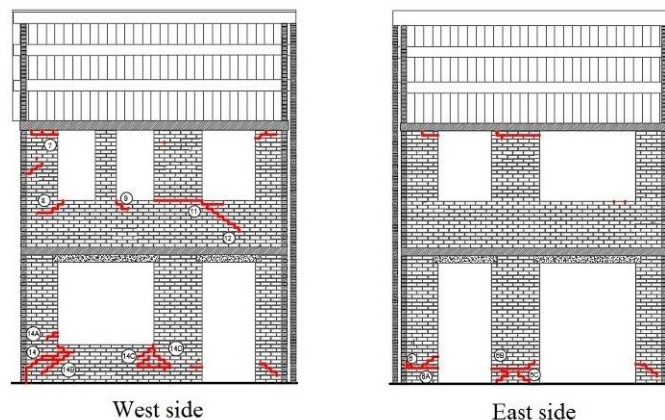
The first cracks being observed in the CS masonry of the second storey were recorded after the test at PGA of 0.241g (150% of EQ2). They are mainly horizontal cracks observed just below the interface between masonry piers and the second floor level slab, as mapped in Fig. 8 (corresponding to a 1<sup>st</sup> inter-storey drift of 0.34% and a 2<sup>nd</sup> floor displacement of 9 mm). A horizontal crack was also developed along the base of the squat pier of the second storey, on the West side, indicative of the pier's rocking response. This crack was further extended with a stair-stepped diagonal pattern to the centre of the adjacent spandrel.

Fig. 8 – Crack pattern in the inner longitudinal walls after the test at nominal PGA of 0.243g (150% of EQ2)

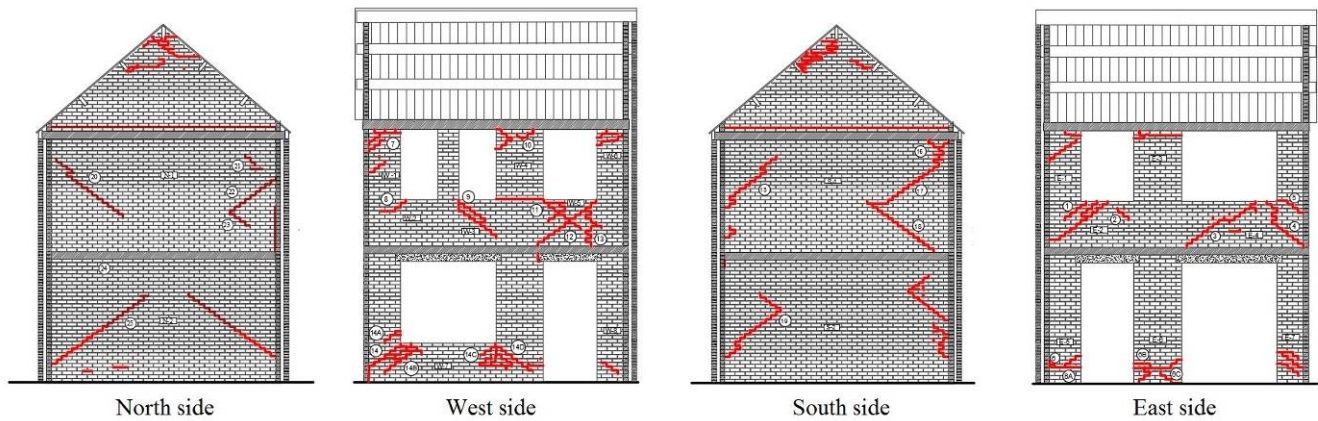
As far as the damage reported in the transversal walls is concerned, the formation of diagonal cracks with an angle of 45° with respect to the horizontal plane, was clearly observed. A stair-stepped cracking pattern through the mortar joints, with opening no greater than 1.2 mm (Fig. 10c). Focusing on the gables, horizontal cracks along their base were apparent (one or two layers above the second floor level), indicative of an out-of-plane overturning mechanism occurring at the gable level. Other cracks are also identified at the locations where the timber beams of the roof are connected with the gable walls. Cracks around these beams are due to interactions of the beams with the supporting masonry gable walls (Fig. 9).

Fig. 9 – Crack pattern in the inner CS walls after the test at nominal PGA of 0.324g (200% of EQ2)

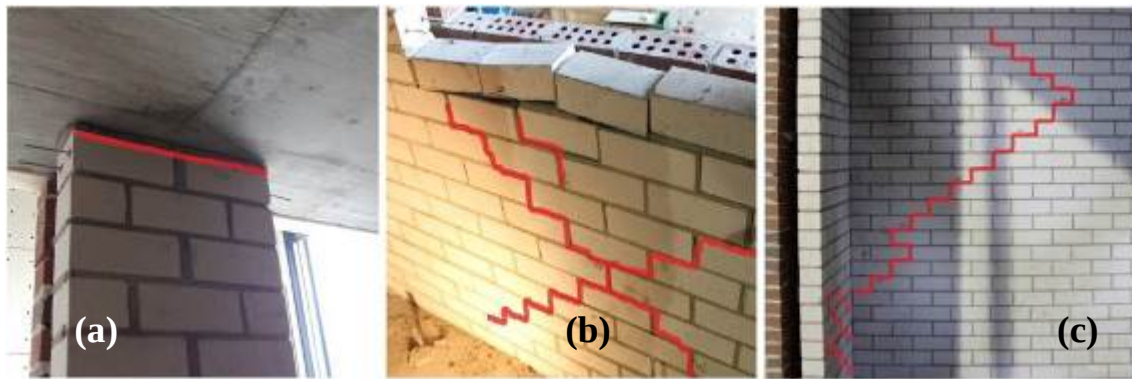
The building experienced a substantial level of damage (compared to that observed under lower intensity shaking) after the test performed at PGA of 0.305g (200% of EQ2). At this shaking level a global response of the structure was triggered, as evidenced by the formation of new cracks or the elongation of pre-existing ones, identified on every specimen's walls, as shown in Fig. 9. Detailed survey of the building was conducted revealing extensive damage in the spandrels of the calcium silicate masonry. In particular, the formation of wide diagonal cracks (starting from the corners of the openings), with sliding of the mortar joints and de-cohesion of blocks were observed (Fig. 10b). In addition, the horizontal cracks located at the top of the second storey piers were extended, reaching a maximum residual sliding of 15 mm (Fig. 10a).

Fig. 10 – Damage observed in the load-bearing masonry: (a) sliding on the top of the second storey longitudinal piers; (b) de-cohesion of masonry blocks and diagonal shear cracks through the joints; (c) stair-stepped cracking pattern through the mortar joints of out-of-plane walls (the cracks are highlighted)

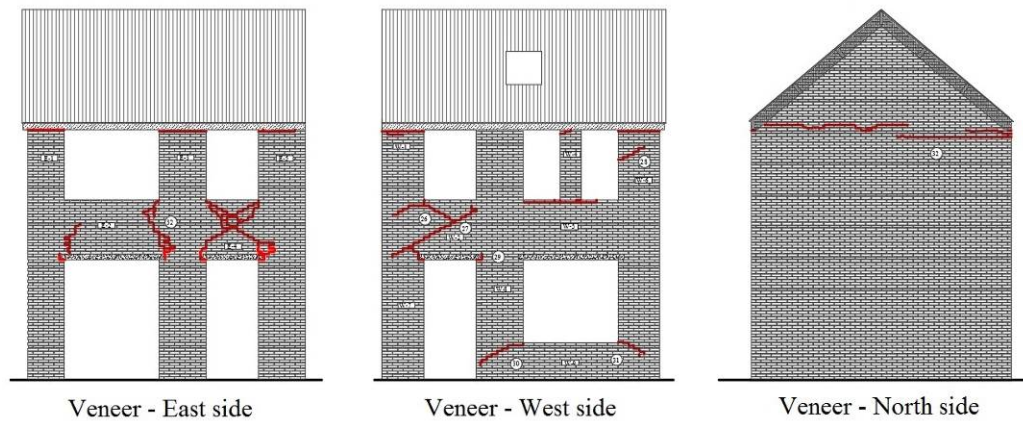
Fig. 11 – Crack pattern in the veneer walls after the test at nominal PGA of 0.324g (200% of EQ2)

To a great extent, most of the deformations were absorbed by sliding of the concrete lintels with respect to the masonry supports, as well as sliding at the interface of the roof wall plate timber beams and the second storey masonry piers (Fig. 12c). In the northern veneer, the only cracks observed are located at the second floor level; being extended along the entire length they are associated to the tendency of the gable wall to develop an out-of-plane overturning mechanism (Fig. 11).

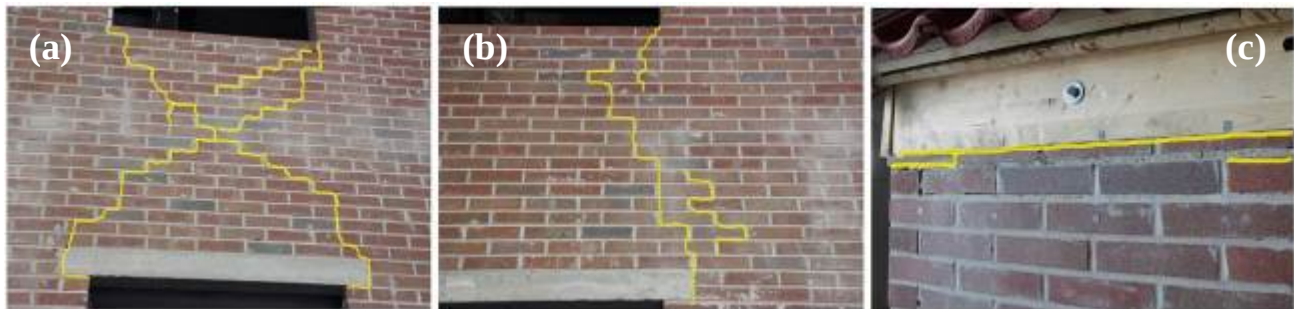
Regarding the damage noticed in the veneer walls, perceptible cracks were developed only during the last tests. More specifically, the long spandrel of the eastern façade, developed a flexural mechanism with vertical cracks at both ends originating from the concrete lintels (Fig. 12b), whereas the shorter spandrel presented

failure in shear, forming the characteristic X-shape crack pattern (Fig. 12a). On the western side, large stair-stepped shear cracks were observed, such as those crossing the entire short spandrel with an angle of 45°, manifest of a shear failure mechanism.

Fig. 12 – Damage observed in the veneer: (a) spandrels failed in shear with the formation of X-shaped crack pattern; (b) development of flexural mechanism evidenced by vertical cracks; (c) sliding at the interface with timber beam
