APPLICATIONS OF MODERN TECHNOLOGIES FOR THE SEISMIC ASSESSMENT OF HERITAGE CONSTRUCTIONS IN PERU

R. Aguilar⁽¹⁾

Abstract

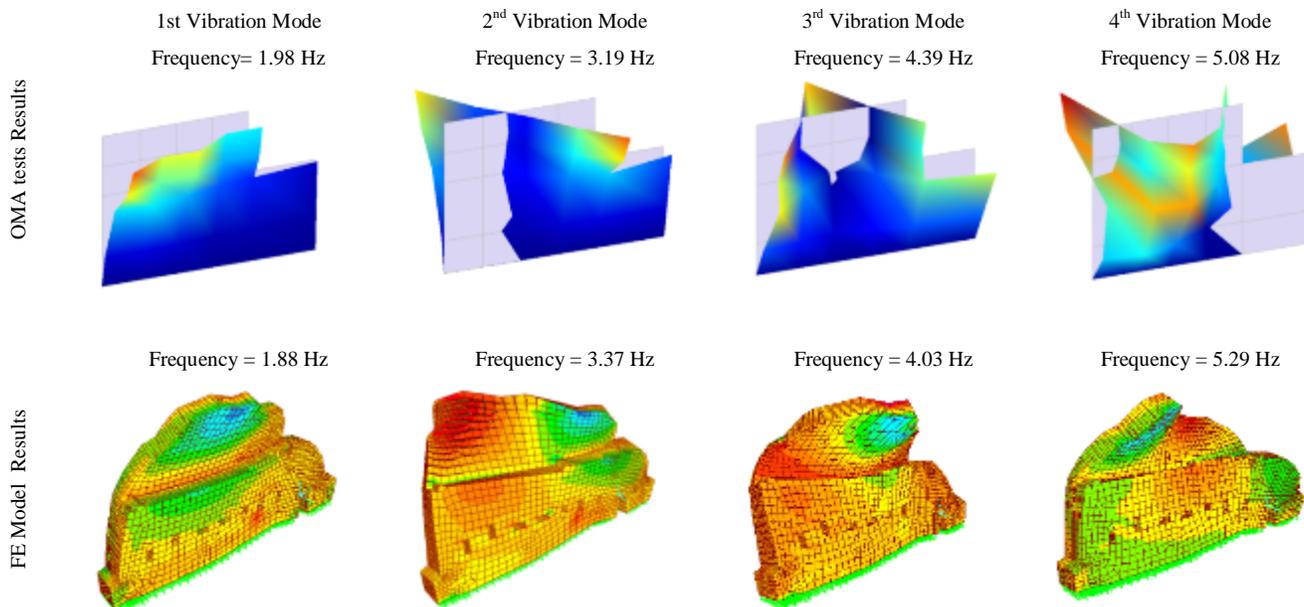
A Finite Element (FE) model was next implemented using solid elements with homogeneous properties considering two different materials, one for the lower part and one for the upper part of the wall (coinciding with the change of section). An optimization and calibration process was then carried out using the Douglas Reid method [11] aiming at matching the numerical and experimental results of the first four natural frequencies and modal shapes. The selection of appropriate calibration variables was made through a sensibility analysis which showed that the most important parameters to consider were the elasticity modulus (affected the results of the natural frequencies), and the geometry and specific weight of the material (affected the modal shapes). As shown on Fig. 5, the calibration process allowed obtaining a model that adequately represented what was registered on the field. As shown on Table 2, the final values obtained for the mechanical properties of the material show a clear difference on the quality on the lower and upper masonry of the wall (verifying what was observed on the field).

Fig. 5—Final Results of the calibration process of the numeric model (adapted from [10])

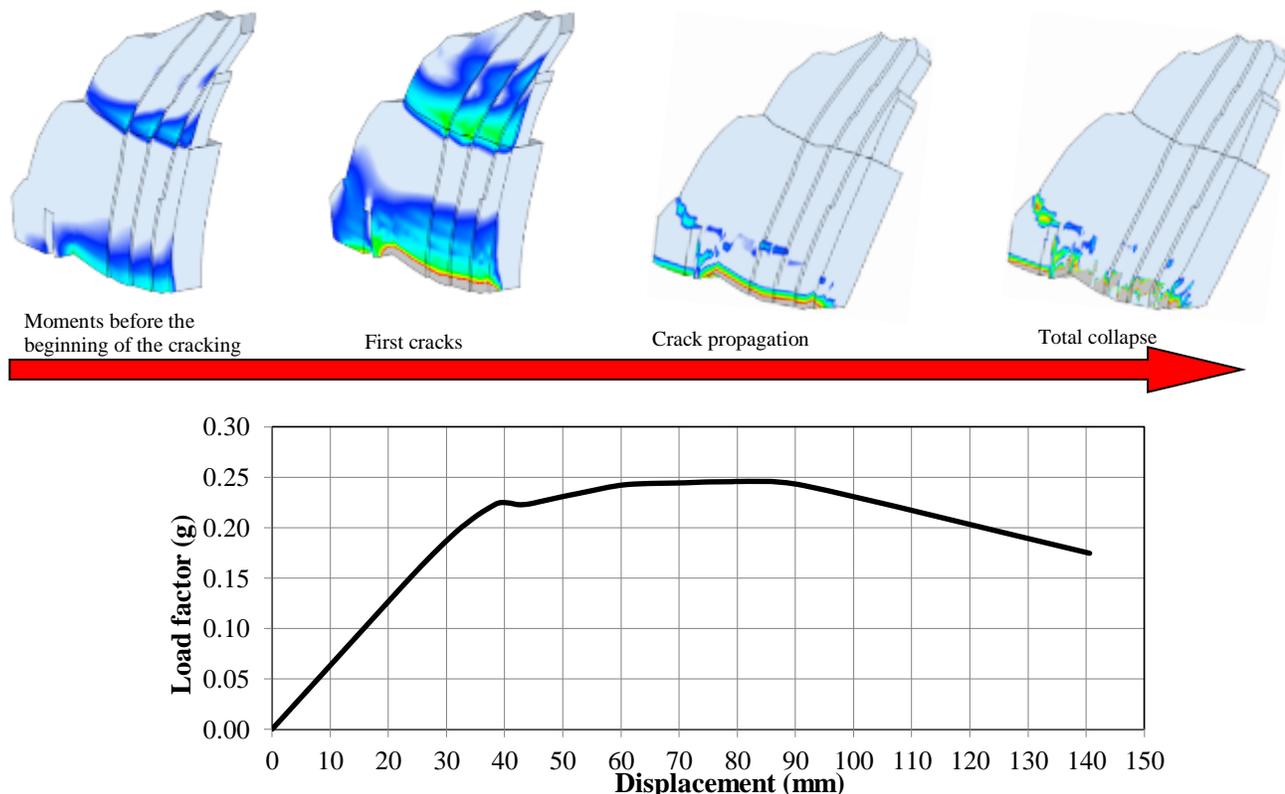
Static non-linear analysis is a simplified method to evaluate the seismic response of buildings through the simulation of a unidirectional lateral static increasing load that acts on the structure [12]. In this work, this analysis was performed to identify the critical sections and possible collapse mechanisms of the studied wall. As shown in [10], the non-linear behavior of the stone masonry was determined from empiric relations with the elastic properties determined through the calibration process of FE model and OMA tests. The analysis considered a constant gravity load and a lateral load pattern proportional to the mass. Fig. 6 presents the evolution of the mechanism of the wall when it is submitted to a lateral load. As shown, the cracking associated to tensile stresses in bending develops simultaneously at the base of the wall and the upper section (where the thickness transition exists). On the next phase, the crack propagates on altitude but a concentration of fissures propagates to the interior of the section at the base. On the next phase it is observed that liberation of stresses take place on the upper section and that the development of a global balancing mechanism initiates. Finally, the mechanism evolves with the total damage that corresponds to a complete overturning with the propagation of the cracking pattern inside the wall at the base.

Fig. 6–Evolution of the collapse mechanism and capacity curve of the studied wall at Chokepukio (adapted from [10])

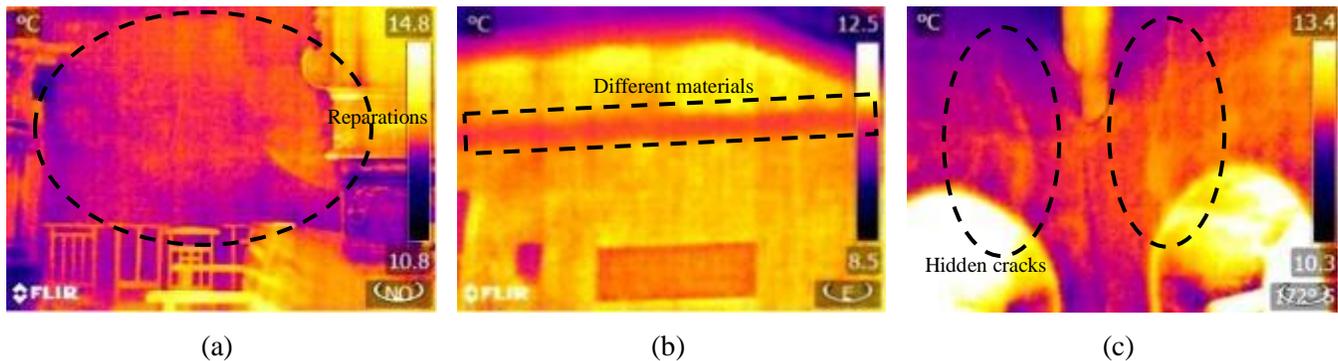
To complement the initial visual survey, Infrared (IR) Thermal Imaging was carried out aiming at identifying hidden reparations, change of materials, hidden cracks, and presence of humidity. The technique of IR thermography allows the identification of differences in surface temperature caused by changes in heat flow [15], which could indicate anomalies in the structure. Passive IR thermography approach was considered for the experimental program carried out in July, 2015. All the tests were carried out while the exterior temperature was around 8°C higher than the interior temperature of the church. For the tests, a FLIR Infrared Thermal Imaging Camera model T440 [16] was used. IR thermography allowed the identification of reparations, insertions of different elements, changes in materials, and cracks that were hidden with recently renewed plaster. Embedded timber beams were detected in the transitions of walls and tympani in the lateral chapels. Cracks were identified on the walls near the connections of timber beams and roofing system. Several cracks with a scattered distribution were also identified on the back façade wall. Diagonal cracks near openings (windows and doors) were also found. Fig. 8 shows three types of the more common structural anomalies found in the field survey.

Fig. 8– Results of the experimental program with IR thermography (adapted from [17]): (a) evidences of reparations in walls; (b) evidences of different materials in the walls of the chapels; and (c) evidences of cracks in the bell tower

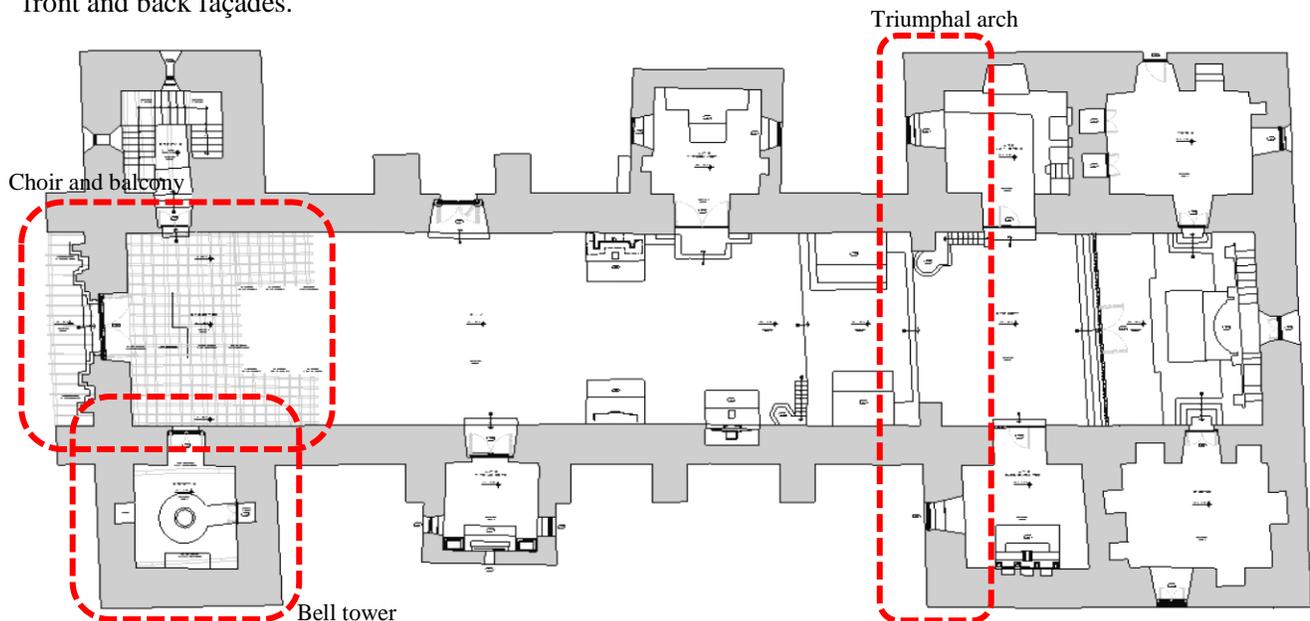
The church had undergone repetitive interventions, especially in the last 50 years. Unfortunately, most of them were aesthetic and their effect was only to hide the structural damage of the church [14]. In a detailed visual inspection on 2012, some major anomalies were found: large cracks in the triumphal arch, severe cracking patterns in some walls of the presbytery, cracks in the Baptistery’s lintel and on the main façade, deflection and deterioration in some structural timber elements (especially in the tie rods that connect the lateral walls in the nave and the supporting system of the choir and exterior balcony).

The visual inspection and experimental program with IR thermography allowed the identification of the most damaged areas in the church. Fig. 9 summarizes these results showing that the damaged areas are located in the bell tower, triumphal arch, front façade, choir, and connections of timber tie rods and adobe walls in the main nave. Vulnerable mechanisms were also identified as possible out-of-plane failure of the tympani of the front and back façades.

Fig. 9–Results of most damaged areas in the church after visual inspection and IR thermography

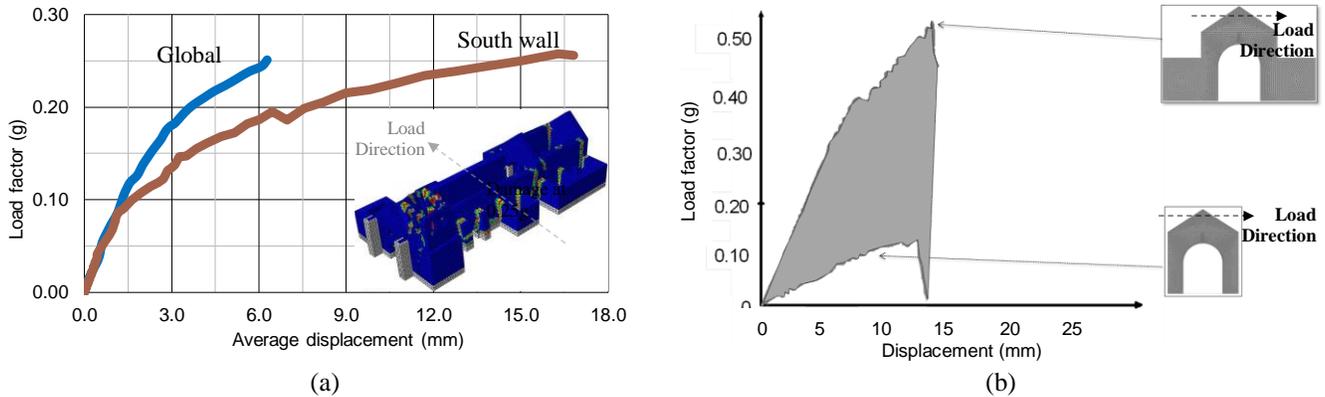
chapel), lateral windows, and the tympanum. As shown in Fig. 11b, the result of this analysis is an envelope of a capacity curve defined by the extreme conditions. This analysis show that the lateral capacity can have large variation and that the maximum resistance can be from around 0.15 g to 0.50 g depending on the structure configuration.

Fig. 11–Lateral force capacity curves for: (a) entire church; and (b) triumphal arch
