PERFORMANCE OF MASONRY WALL RETROFITTED USING CFRP SHEETS AND ANCHORS

G. Huaco Cardenas Ph.D.⁽¹⁾, J. Jirsa Ph.D.⁽²⁾

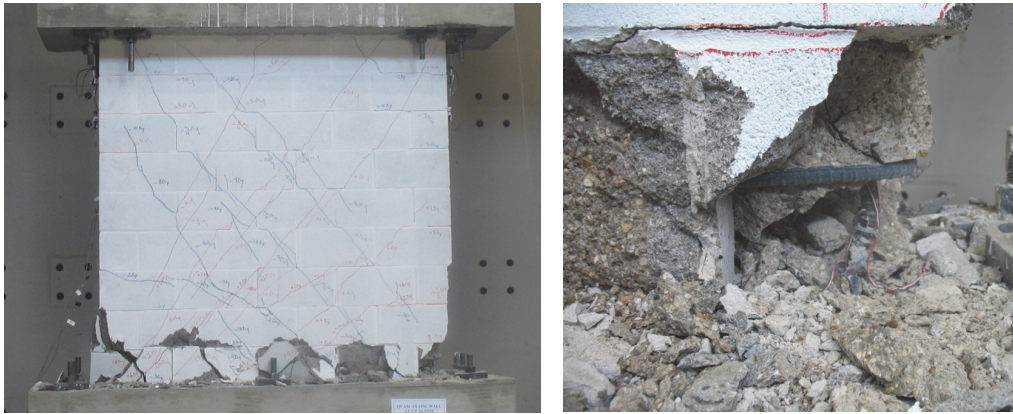
The constant axial load applied was 140kips before begin to push and pull the specimen. After yielding of the vertical bars and later the shear capacity specimen, diagonal cracks formed in the wall and large sliding deformations were noted at the bottom of wall. The crushing occurred in the bottom in two courses of the wall.

The vertical bars in the wall were bent due the high shear deformation. After the wall began to crush, the specimen was not able to support the 140kips axial load producing a collapse at 1.4 in. lateral deformation (2% drift ratio). The shear capacity degraded from maximum presented 175kips to 80kips loading north and from 171kips to 61kips loading south, less than half the peak capacity. Sliding at the base was the predominant feature of behavior at large deformations, and represented more than 70% of the total deformation of the specimen. Sliding at the top was less than 1% of the total deformation of the specimen. The maximum displacement to north without the sliding is 0.39 in. (0.54% drift ratio) and 0.43 in. (0.6% drift ratio) to south direction. Fig.2 shows the damaged wall and failure patterns such as the diagonal cracks and the crushing on inferior corner toes.

Fig. 2 – Final condition of the masonry wall, diagonal cracks crossing the field of the wall and sliding at the base (left) and toe crushing of the inferior right corner of the masonry wall (right) [3]

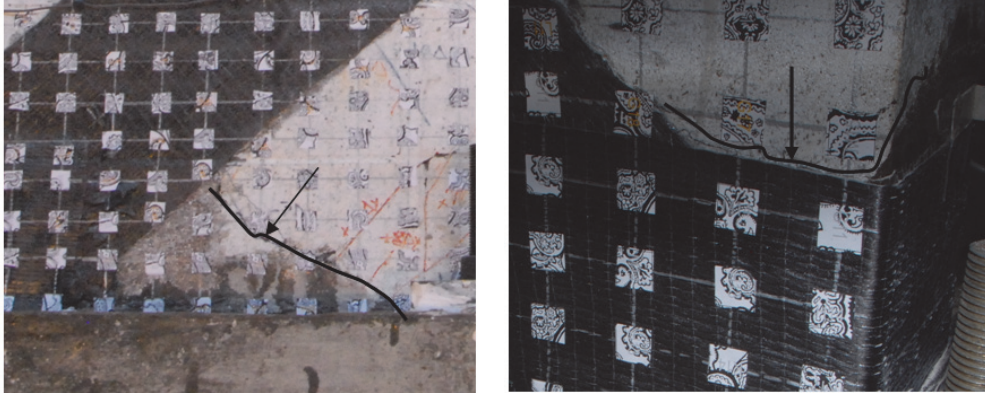
The existing crack in the bottom-left corner of the wall opened when the specimen was loaded to the south. This crack was located close to the end of the CFRP tension tie as it can be seen at Fig.8. Additionally, Fig.8-right shows the existing crack located on the bottom-right corner close to the edge of the U-wrap. The crack opened when the specimen failed loading to north.

Fig. 8 – Existing cracks opened after reach maximum south (left) and north (right) lateral displacement.

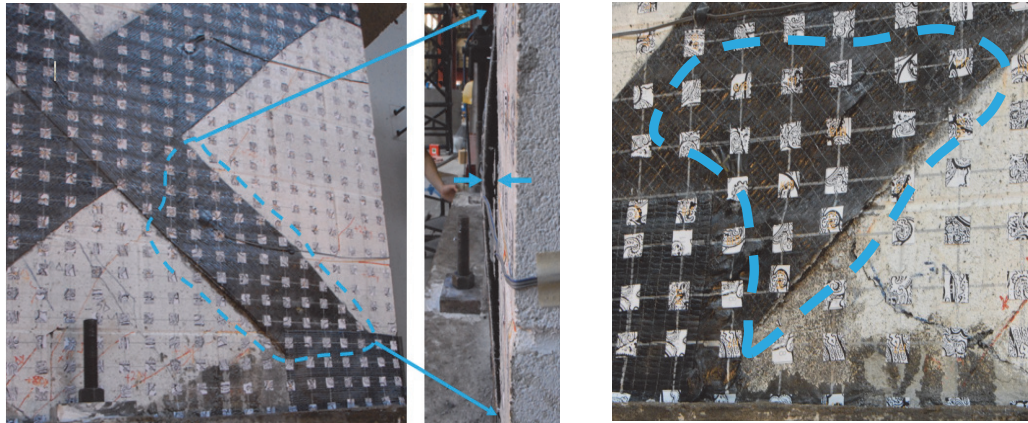
Fig. 11 – Buckling presented on 9in.wide CFRP sheets (left), and on 12 in.wide CFRP sheet (right)

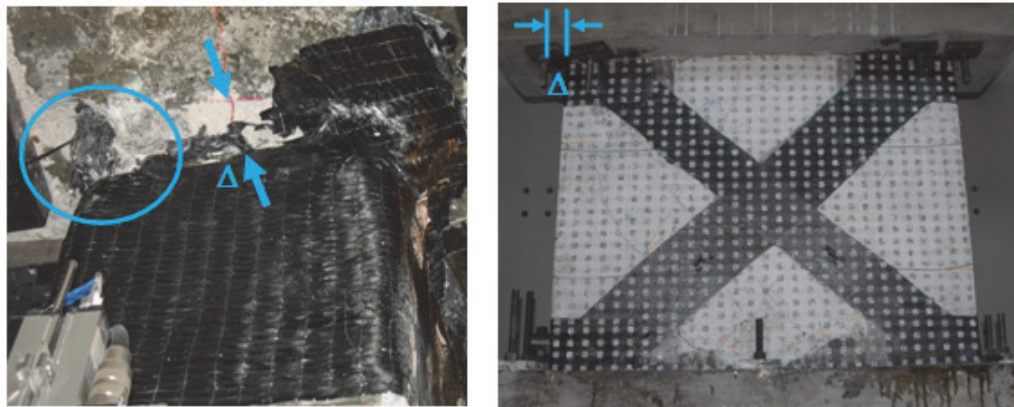
CFRP diagonal strips two 9" wide layers worked as axial tension punctual brace when the masonry wall was loaded to the north. After the CFRP 12" wide started to debond, some noise was heard indicating the beginning of the debonding for that CFRP two 9" tie. The CFRP anchors transferred tension from the CFRP diagonal strips to the top and bottom support of the wall. The maximum strain measured was 0.0052 on the front face of specimen which is slightly above 50% of the strain capacity of the CFRP according to the producer's specification. The maximum strain deformation measured on the CFRP strip on the back face was 0.0039. Compressive strains in the CFRP strips were measured under loading to the south. At the second last cycle of the test, the CFRP strip buckled. The maximum strain in compression prior to buckling was 0.0016. However, when the buckling occurred CFRP on front face of the wall, the compressive strain was 0.0027 and 0.0014 on the back face of the wall. It was observed also that the strain measured was longer on the bottom part of the diagonal ties, having concentration of compression stress on this region. Buckling of the CFRP tie was noticed as well (Fig.11). Failure was due to rupture of the CFRP anchors installed on the top north corner of the masonry wall (Fig.12). Those CFRP anchors provided restraint against the sliding between the wall line and the top concrete beam. The CFRP anchors carried the axial load from the debonded CFRP diagonal ties (2 x two 9in.CFRP

sheets), and a tension due to the correspondent diagonal component of the force produced during sliding. The sliding measured at failure was 1.24 in.

Fig. 12 – Amount of slip following rupture of CFRP anchors on 9in wide CFRP sheet ties. Same pattern presented on 12in wide CFRP sheet ties without rupture of corresponding CFRP anchors.
