## PERFORMANCE OF THREE DIFFERENT PILE FOUNDATIONS IN URAYASU CITY DURING 2011 TOHOKU EARTHQUAKE

K. Tokimatsu<sup>(1)</sup>, H. Suzuki<sup>(2)</sup>, A. Abe<sup>(3)</sup>

### Abstract

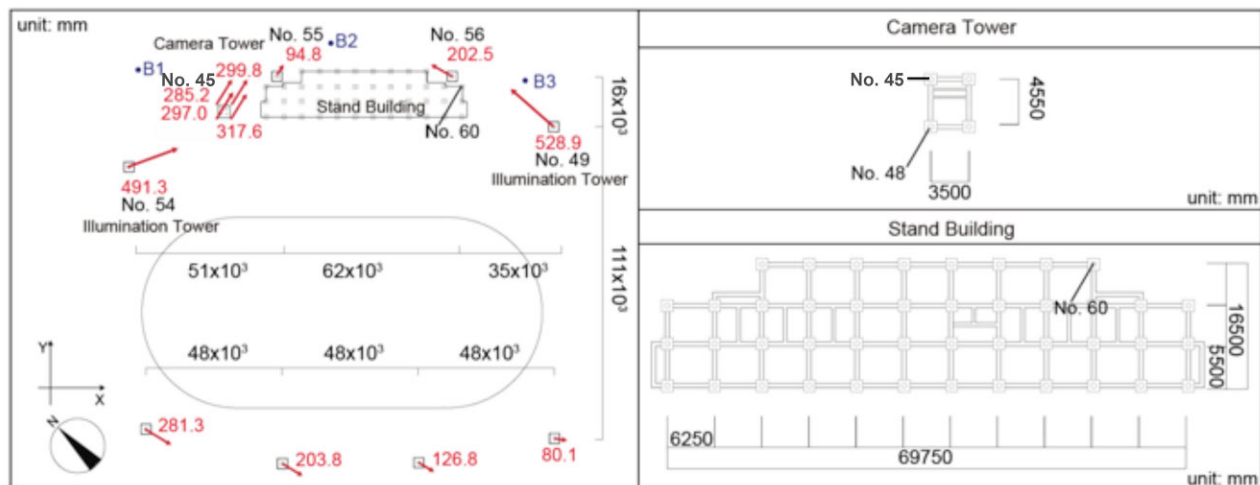
Fig. 2 - Layout and foundation plans of structures in Urayasu Sports Park and permanent horizontal displacement of piles [2, 4]

determine horizontal displacements of each structure, assuming that the undamaged Stand Building remained as was before the quake. The result of the field survey was shown in Fig. 2 with red arrows.

Camera Tower was displaced horizontally by about 30 cm, while Illumination Towers moved up to 52 cm. It is interesting to note that the displacement of Illumination towers tends to be larger with approaching to and to occur toward Stand Building. Pile integrity test made for three piles revealed that, while Pile No. 60 of Stand building had no damage, Pile Nos. 54 and 56 of Illumination towers experienced damage at some depth in the ground.

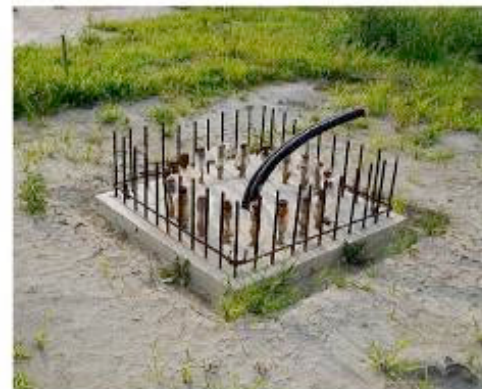
Photo 1 shows a pile cap of Illumination Tower founded on Pile No. 54 that appeared to tilt slightly rightward (southeastward), suggesting permanent horizontal movement of the pile. Thus, a field survey was made to

Fig. 4 - Moment-curvature relations for piles investigated Photo 1 - Damage to Illumination tower No. 54 [2]

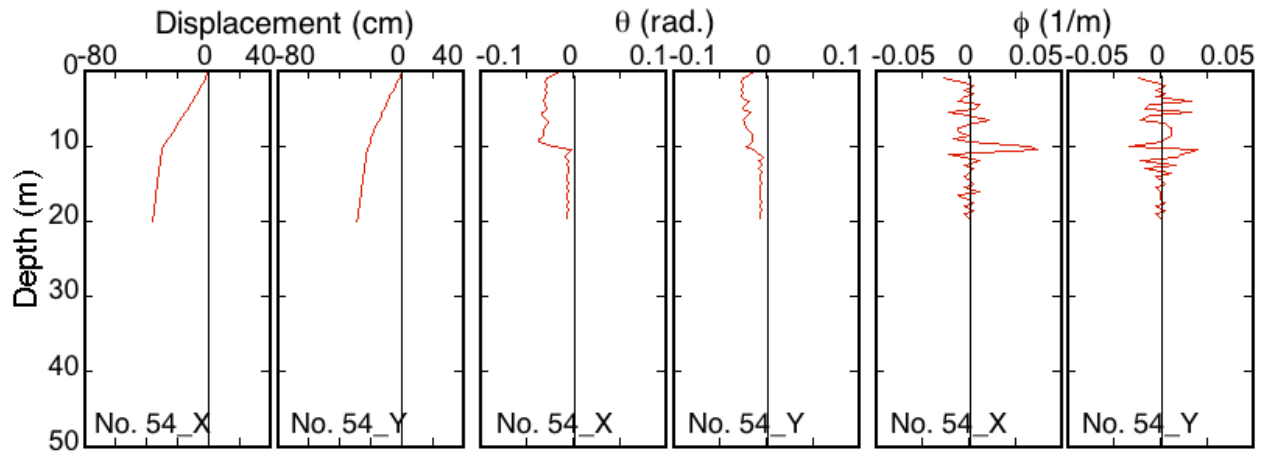
Fig. 5 - Distribution of slope angle, horizontal displacement and curvature with depth for Pile No. 54

Figures 5-7 show the distribution of slope angle, horizontal displacement, and curvature with depth for the three piles investigated. The X and Y directions in the figures correspond to those shown in Figure 2 and the depth was measured from the bottom of each pile cap. The horizontal pile displacement occurred shallower than 10 m at which some damage was detected with borehole camera observation. The detected pile curvature at the 10 m depth takes the peak value in all three piles, being consistent with the damage portion of the piles and claiming the effectiveness of inclinometer survey. The peak curvature in piles at Illumination Towers occurs immediately below the welded connection between the upper SC and lower PHC piles.

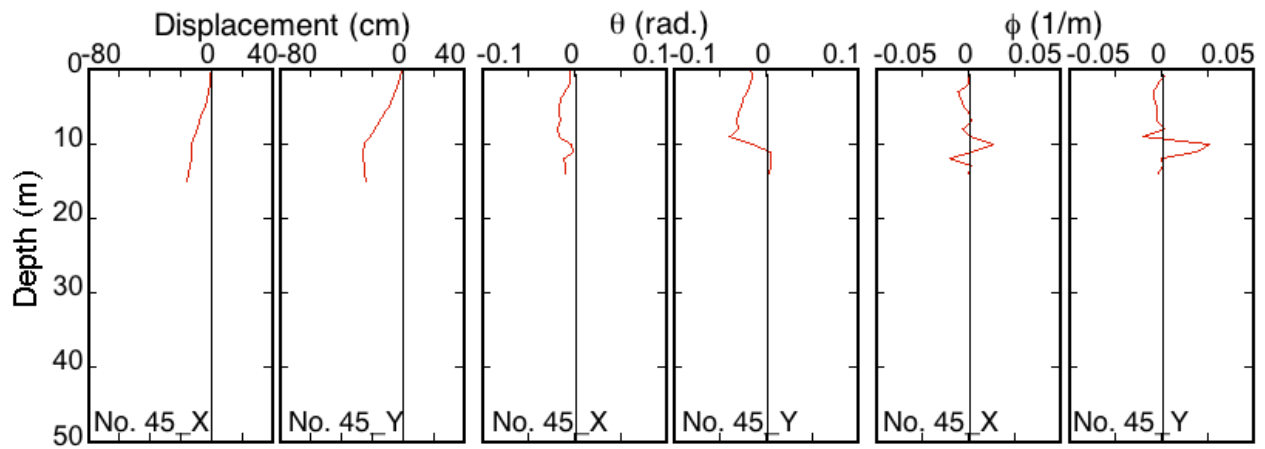
Fig. 6 - Distribution of slope angle, horizontal displacement and curvature with depth for Pile No. 45

The pile displacement at Camera Tower was less than about a half of those observed at the Illumination towers. This was probably attributed to the difference in rotational constraint at the pile head between the two structures; i.e., fixed at Camera Tower and free at Illumination Towers. This is evident by the fact that, unlike at Illumination Towers, the slope angle of pile at Camera Tower decreased with approaching to pile head as shown in Fig. 6.

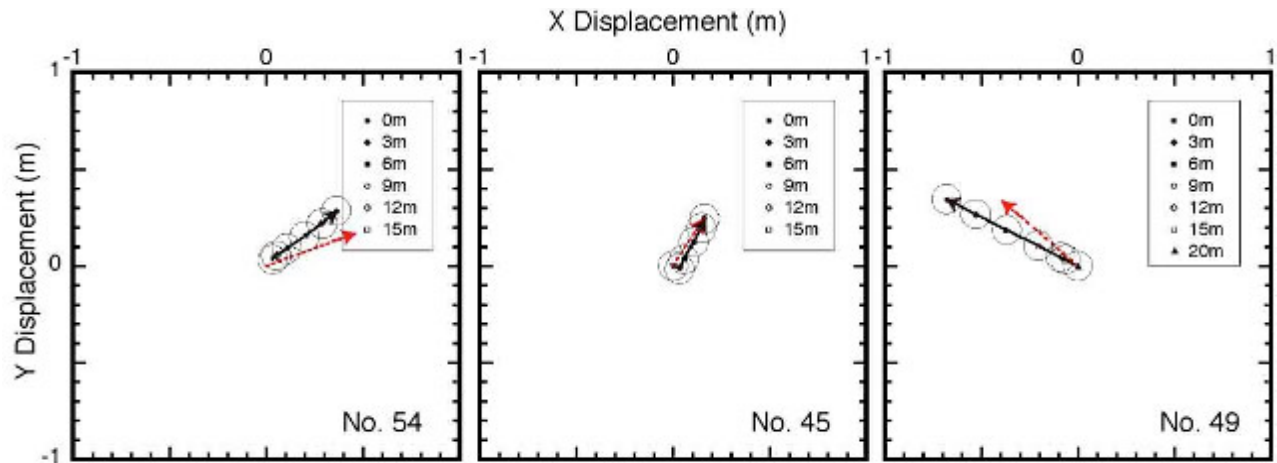
Fig. 8 - Horizontal permanent displacement vectors detected of three piles detected from inclinometer survey (black line) compared with conventional surveying (red line)

Black lines in Fig. 8 show the two-dimensional horizontal permanent displacement vectors with respect to those at a depth of either 15 or 20 m, which were detected for the three piles from the results of inclinometer survey shown in Figures 5-7. The horizontal displacement of the pile head relative to a depth of 15 to 20 m is 80-528 mm, with its direction varying from pile to pile. Also shown in the figure in broken red arrows are the vector displacements of pile head from the field survey as shown in Fig. 2, which are consistent with those obtained by inclinometer survey. The fairly good agreement in pile displacement between different tests appeared to warrant the reliability of the test results shown in Figs. 2 and 5-8.

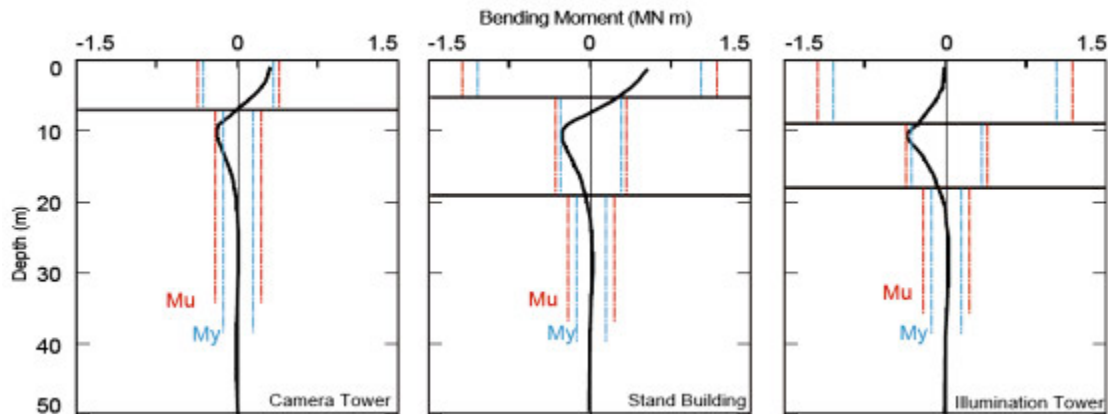
Fig. 11 - Distribution of computed bending moment with depth in unsafe direction for three pile foundations

Fig. 11 shows the distribution of bending moment with depth computed from the pushover analysis for the three foundations. Also shown in broken lines are  $M_c$  (the bending moment at concrete cracking at extreme tension fiber of PHC piles) or  $M_y$  (the bending moment at yielding of steel at extreme tension fiber of SC piles) and  $M_u$  (the bending moment at concrete crushing at extreme compression fiber of PHC and SC piles). The peak bending moments occur at both pile head and at depth of 10 m at Stand building and Camera tower with fixed rotational pile head, while it occurs only at depth of 10 m at Illumination tower with free rotational pile head. In addition, those at Camera tower and Illumination tower reach to  $M_u$  at depth of 10 m, suggesting extensive damage to piles. In contrast, it is less than  $M_c$  or  $M_y$  throughout the depth at Stand building, suggesting no damage. These estimates are fairly well consistent with the field observation including camera and inclinometer surveys. It is noteworthy that the design bending capacity of any pile was reduced significantly at the connection between the upper first and second sections, at a depth shallower than 10 m where the pile damage was detected, i.e., the bottom of the liquefied layer. This is likely because soil liquefaction, which was the major factor causing the pile damage, was not taken into consideration in the design of the pile foundations.

in pile capacity at the bottom of the liquefied layer and/or the pile group effects against liquefaction-induced ground displacement might have differentiated the damage level between the two. In addition, the difference in computed result between Stand building and Illumination tower suggests strong effects of rotational constraint conditions at the pile head, i.e., fixed for the former and free for the latter.
