## Performance of a seismically repaired masonry building

### Abstract

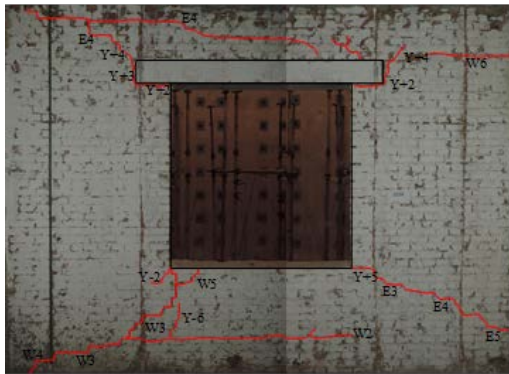
a. 104

Because of the length limitation, only the damages on the walls in the strong axis are discussed. Generally, the damages were concentrated in the first story. When the roof displacement reached 3.3mm, most walls in the first story cracked. At this moment, the story drift of the first story is 2.08 mm, and the drift ratio is 1/1587. The cracks initiated from the corners of window or door openings, along the bed joints or the head joints. The walls with similar opening ratios (opening area over the wall area) cracked almost simultaneously. With the increase of loading, the cracks developed along 45 degrees and became wider. When the roof displacement reached 13.2mm, X-type cracks were observed in most walls in the first story. Continuously to 22mm, almost all walls were damaged seriously accompanied with brick crush, out-of-plane deformation, and cracks wider than 20mm. Typical damages on the wall 104 and 204 as shadowed in Fig.1 are plotted in Fig.5. During the whole loading process, the damages on the constructional columns were very slight, with the maximum crack width less than 0.2mm.

Fig. 5 – Damages of typical walls

From the observation after the experiment, it is obtained according to the Code method that, the percentage of walls with obvious cracks is 26.5%, those with severe damages is 50%, and those near collapse is 23.5%. Therefore, the overall structure is judged as a severe damaged building, difficult to repair or economically inefficient if repaired.

Considering the cost and material availability, the meshed reinforcement mortar was selected to repair the building, combined with the grout to fill the cracks and the additional constructional columns at the intersections of any two or more pieces of walls. HPB-300 rebars with the diameter of 6mm were used to make the steel mesh with spaces of 300mm in both horizontal and vertical directions. Two pieces of meshes were placed on the both surfaces of a wall, and hooked together by steel rebars through the wall. The M10 mortar was selected for the retrofitting with the thickness of 35mm considering the covering clearance of steel meshes.

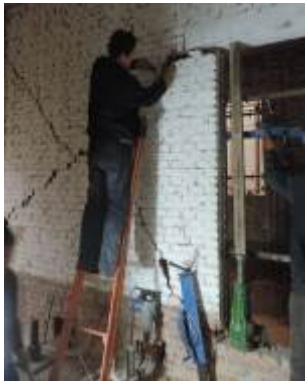
a. repositioning

Fig. 7 – Primary repairing processes

The repairing process includes repositioning of damaged walls with out-of-plane deformation, replacement of lintels falling during previous tests, filling the cracks wider than 1.0mm, clearing both surfaces to be covered by reinforced mortar, meshing and mortar plastering, and casting concrete to make additional constructional columns. Parts of the working procedures are shown in Fig.7, and the completely repaired building is shown in Fig.8. The repairing process has lasted for 23 days, while the build of the original building took 39 days. The cost of repairing is about 100,000RMB, while the construction of the original building spent 200,000RMB. If it

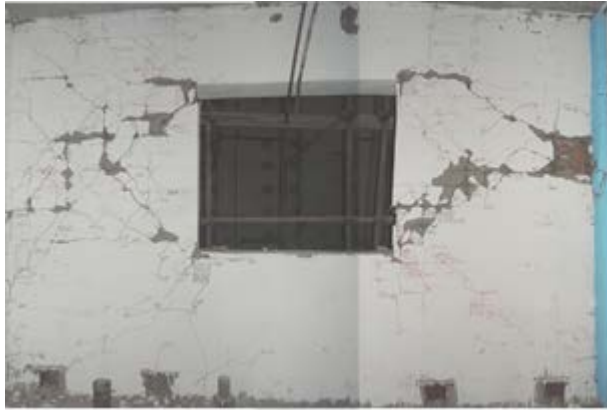
a. 104

The loading protocol of the repaired building is identical as the original building, but appended by two amplitudes of 33mm and 44 mm to achieve the expected failure mode. Similarly, the damages were concentrated in the first story, such as mortar spalling, rebar buckling in the constructional column, brick crush, and so on. However, the damage in the second story was relatively slight. No falling of mortar surface was observed. Cracks initiated from the opening corners. When being loaded to 11mm, the largest width of the crack was 3mm. The mortar started to spall when loaded to 16.5mm. The width expanded to 8mm at the amplitude of 33mm accompanied with brick crush. The deformation capacity of the repaired building is as twice as the original one. Damages of typical walls are shown in Fig.9 which can be compared with Fig.5 without repairing.

Fig. 9 – Damaged pattern of repaired masonry building
