Structural Damage Assessment of a Five Tiered Pagoda Style Temple in Nepal

Richard L. Wood⁽¹⁾, Mohammad Ebrahim Mohammadi⁽²⁾, Andre R. Barbosa⁽³⁾ Chandra Kiran Kawan⁽⁴⁾,
Manjip Shakya⁽⁵⁾, Michael J. Olsen⁽⁶⁾

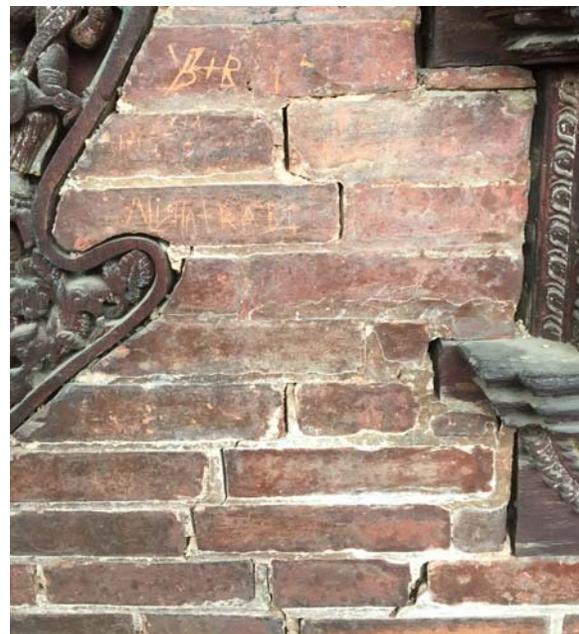
Fig. 2 – View of the Nyatapola Temple: (a) overview of the entrance from the south plaza and (b) view of the north wall with significant shear cracks.

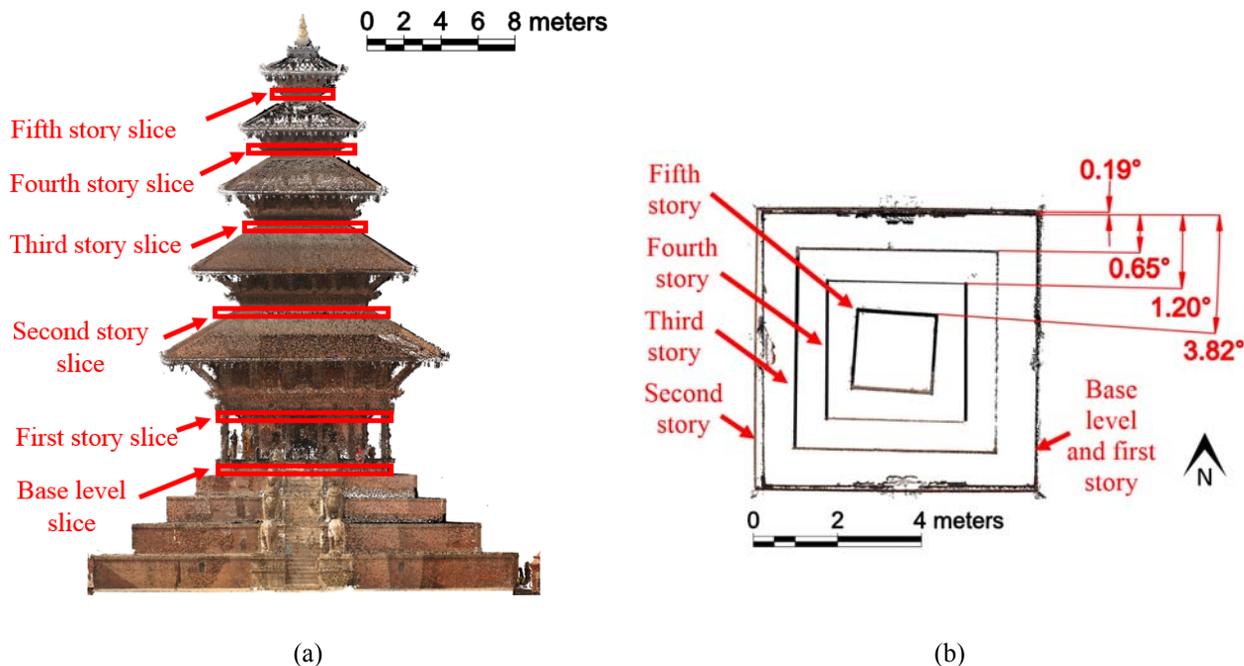
The five-story Nyatapola temple structure comprises of a timber frame with brick masonry infill walls, mud mortar, and timber floors; contributing to its classification of a structure with of its flexible diaphragms. After the 2015 Gorkha earthquake, severe cracking and grout loss was noted on all interior and exterior walls at the ground level of the structure. The residual deformation of the unified point clouds confirmed these damaged patterns observed in the structure. To accomplish this task, six slices of the complete point cloud starting at the base level to the top level are exported and compared to the ground level to identify any residual torsional drift (Fig. 7). Estimated residual torsional drifts for the first to fourth stories are 0.00°, 0.19°, 0.65°, and 1.20° anticlockwise, respectively; while a significantly larger clockwise rotation of 3.82° is noted at the fifth floor. These residual torsional drift values can be attributed to the earthquake response of the temple (for the second

and fifth floors) as verified by the ambient vibrations. However, this assumes that the building was constructed perfectly rectangular, which is unlikely to be the case.

Fig. 7 – Estimation of torsional permanent drift: (a) elevation view highlight location of the point cloud slices and (b) torsional drift as estimated from these slides by story.

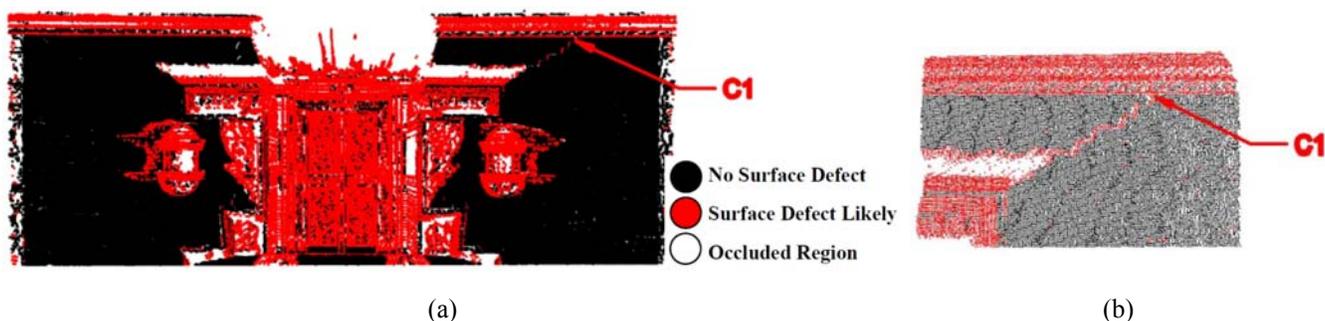
Fig. 8 – Crack locations identified at the ground level for the north exterior wall: (a) overview and (b) detailed view.

A detailed view of a significant shear crack (C1) is presented in Fig 8b. To quantify the defect, both length and the width of crack were measured as 1.27 m and 3.3 cm, respectively. Assuming that the crack consisted of a series of straight lines, the summation of the crack lengths can be directly computed. However, the width of the crack varies along its length; therefore, the average value of ten different width measurements is reported.

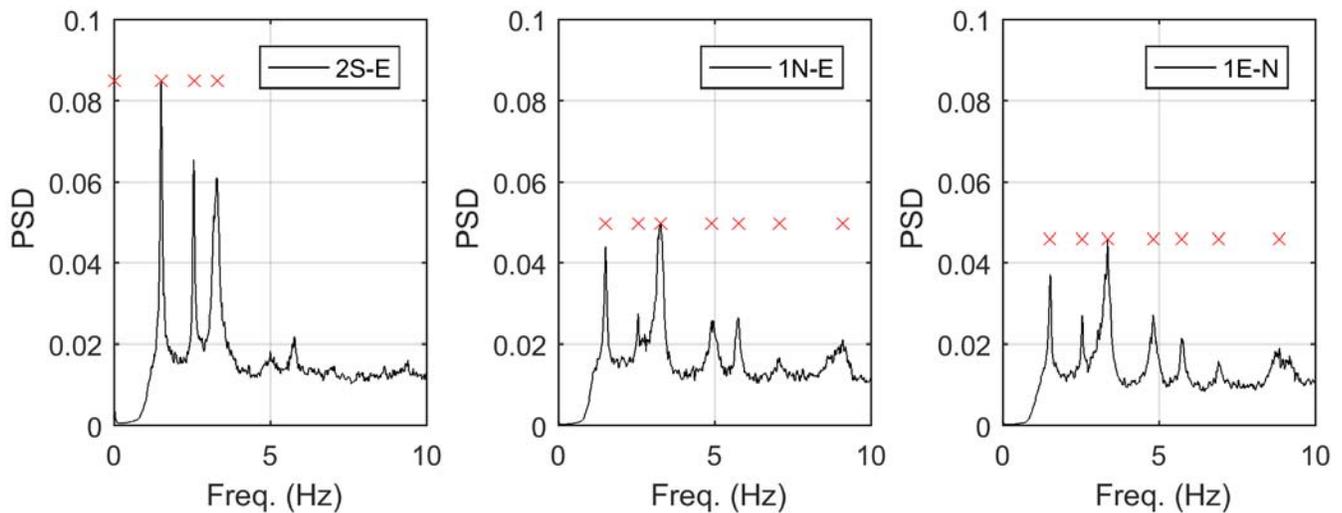
The acceleration time histories of each channel are filtered first for high voltage spikes using a Hampel identifier function of a neighborhood of five times the sampling rate (five seconds) and for values greater than five times the standard deviations from the neighborhood median. Then the channels are filtered in the frequency range of 1.1 Hz to 20 Hz using a Finite Impulse Response filter of order 8192. To estimate the natural frequencies, the 24-minute duration of acceleration data is divided into 30 divisions and the power spectral density computed. From the average power spectral density plots, the natural frequencies are extracted (as local maxima) as illustrated in Fig 9. Using the peak-peaking method, the first three excited modes are identified as 1.51 Hz, 2.55 Hz, and 3.31 Hz. Note all of these modes are identified as torsional (considering all three accelerometer setups), since modal coordinates have values in each direction of the structure at various levels. A frequency shift in the fundamental mode from 1.69 Hz to 1.51 Hz is observed when comparing the pre- and post-earthquake system

identification results. This shift represents a 16.8% period elongation in the structure, which is significant and demonstrated by the large shear cracking at the ground level (above the plinth). In the post-earthquake system identification, it is noted that the first four modes are torsional and may or may not be coupled with bending (currently inconclusive). The behavior is further confirmed in the temple assessment since the observed damage is not uniformly distributed and the greatest damage in terms of frequencies and crack widths is located at the north wall.

Fig. 9 – Identified modes by peak peaking following the 2015 Gorkha earthquake and its subsequent aftershocks.
