16th World Conference on Earthquake, 16WCEE 2017

Seismic performance of hydropower plant and highway system during the 2015 Gorkha Earthquake in Nepal

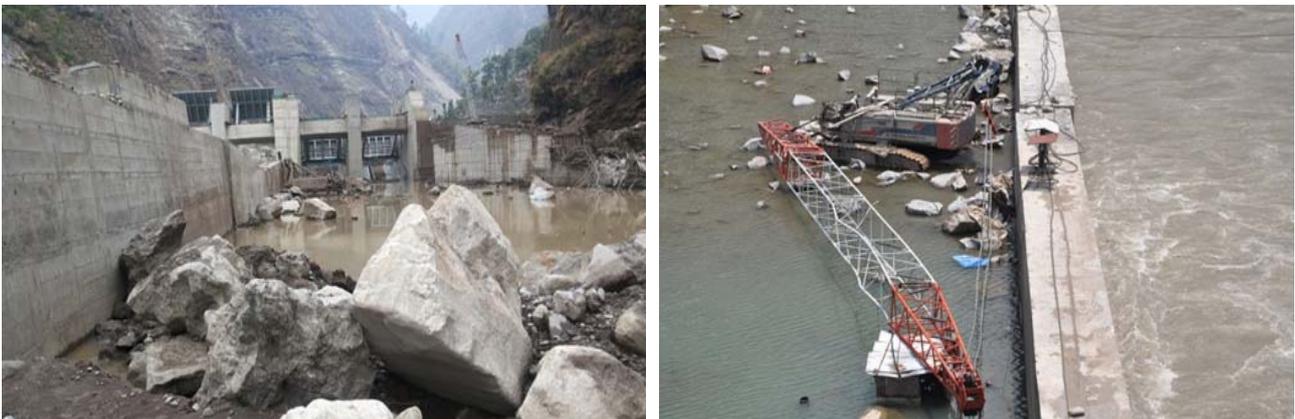
During these earthquakes, the damage of headworks is mainly caused by falling rocks, and shaking from the earthquake produced some crack in the wall of structures. For Upper Trishuli 3A, infrastructure in the headworks area sustained minimal damage, with the diversion dam, sand catcher and canal structures mostly unaffected. However, two radial gates of the gate dam were damaged which cannot be opened and might lead to additional damage to the site on monsoon (Fig.3). The upstream cofferdam, stone pitching and inlet slope were damaged by falling rocks. There were obvious cracks between dam and the water inlet. Power transformer lines in the headworks area were damaged severely (Fig4). Continuous falling rocks blocked the main access road to the headworks, and damaged a 100 m suspension bridge completely.

Fig. 3 – Gate dam of Upper Trishuli 3A was damaged by falling rocks.

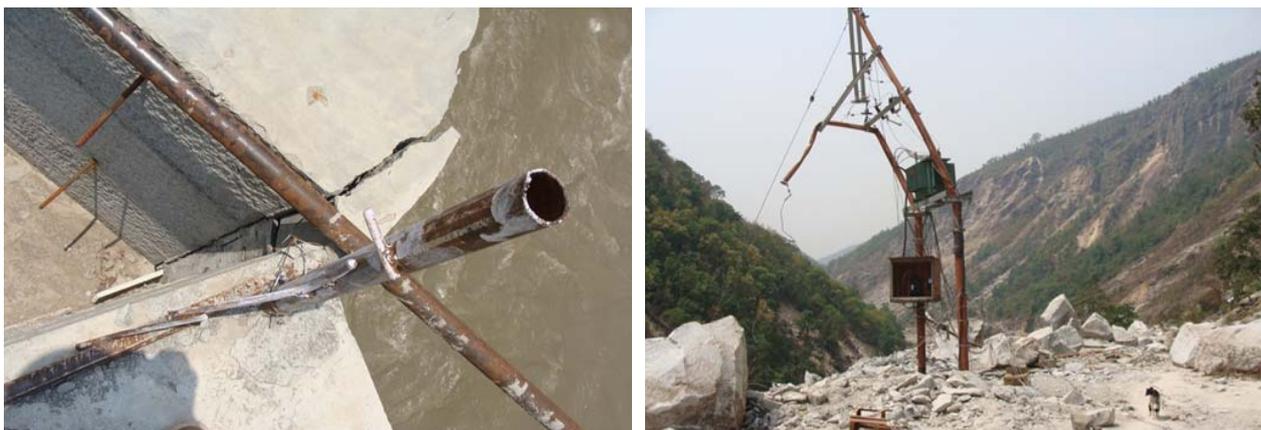
Fig. 4 – Cracks between dam and the water inlet, damaged power transformer lines in the headworks area.

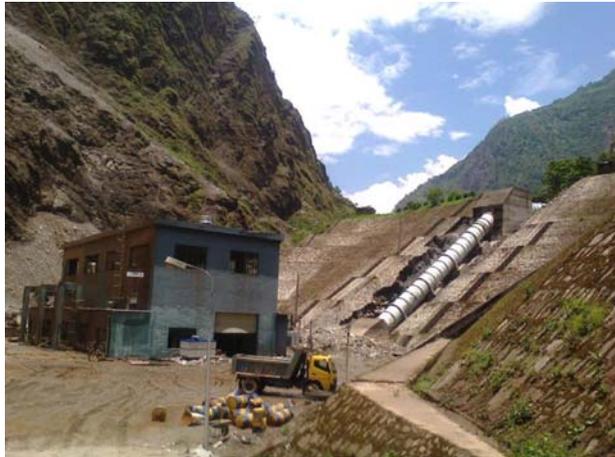
of falling rock debris by water from the burst penstock created a debris flow that inundated the workers colony, scoured the penstock liner and inundated buildings and electrical equipment on the upstream side of the powerhouse (Fig.5). For Sunkoshi, severe leakage in a stretch of 200 meter canal. For Sunkoshi Khola, the canal was dry at the inspection due to penstock burst by rock fall (Fig.6).

Fig. 5 – Penstock burst blowing out powerhouse.

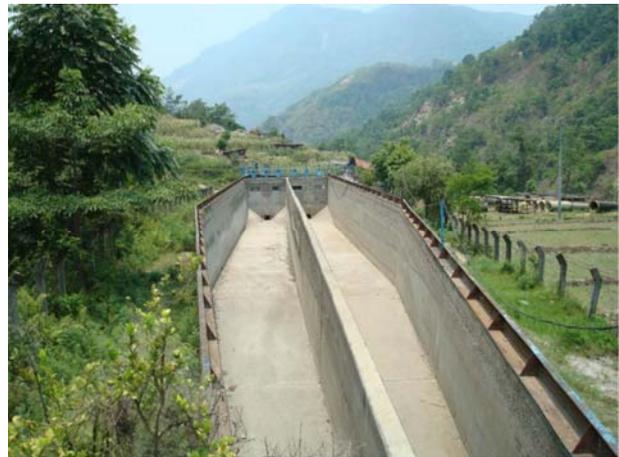
Fig. 6 – The canal of Sunkoshi Khola was dry.

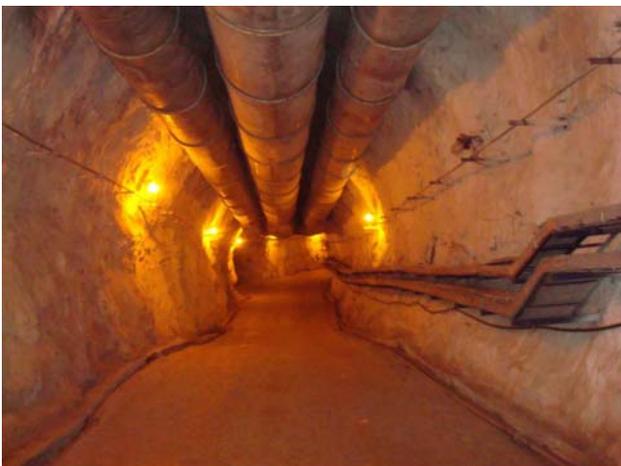
The underground powerhouse sustained minimal damage. For example, the powerhouse of Chilime, which is underground powerhouse, was operating during the earthquake (Fig.7). On the other hand, ground power house had to face the falling rocks and shaking. As mentioned before, the powerhouse of Upper Bhotekoshi was submerged due to penstock burst, and the powerhouse of Sunkoshi Khola was damaged by strong ground motion (Fig.8).

Fig. 7 – Underground powerhouse in Chilime.

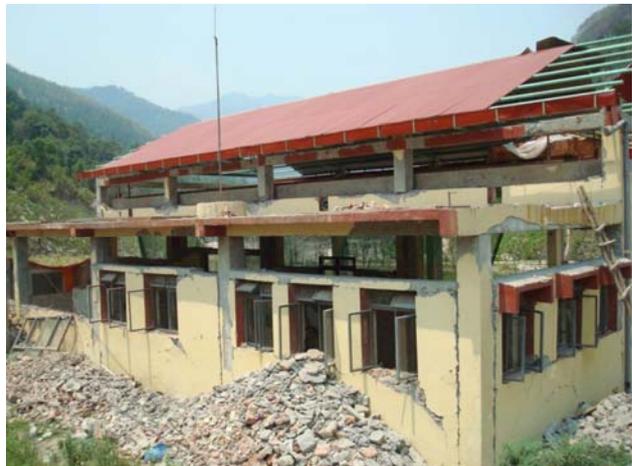
Fig. 8 – Ground powerhouse in Sunkoshi Khola.

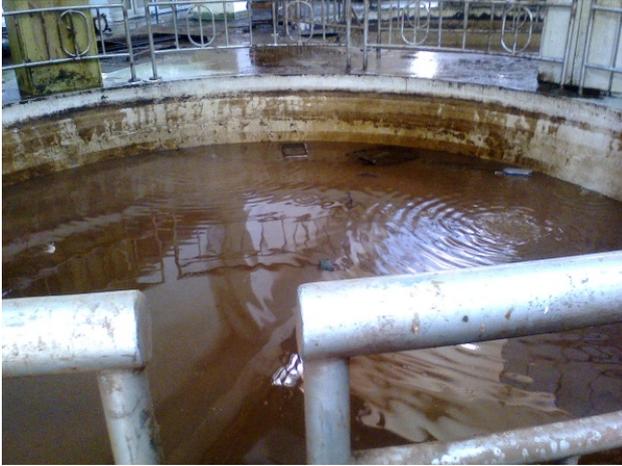
During the earthquakes, the generator in Upper Bhotekoshi lost its function because powerhouse was submerged (Fig.9). Meanwhile, falling rocks also damaged transformation equipment and transmission equipment at switching station (Fig.10). For Chilime, transmission line were damage by shaking. For Upper Trishuli 3A, power transformer lines were damaged duo to falling rocks.

Fig. 9 – Submerged generator in Upper Bhotekoshi.

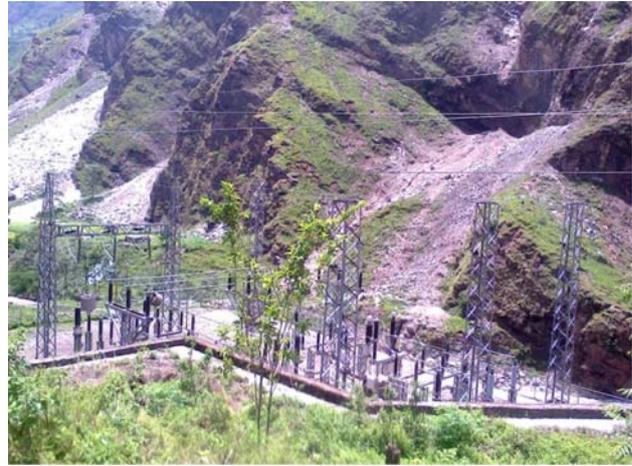
Fig. 10 – Switching station in Upper Bhotekoshi.

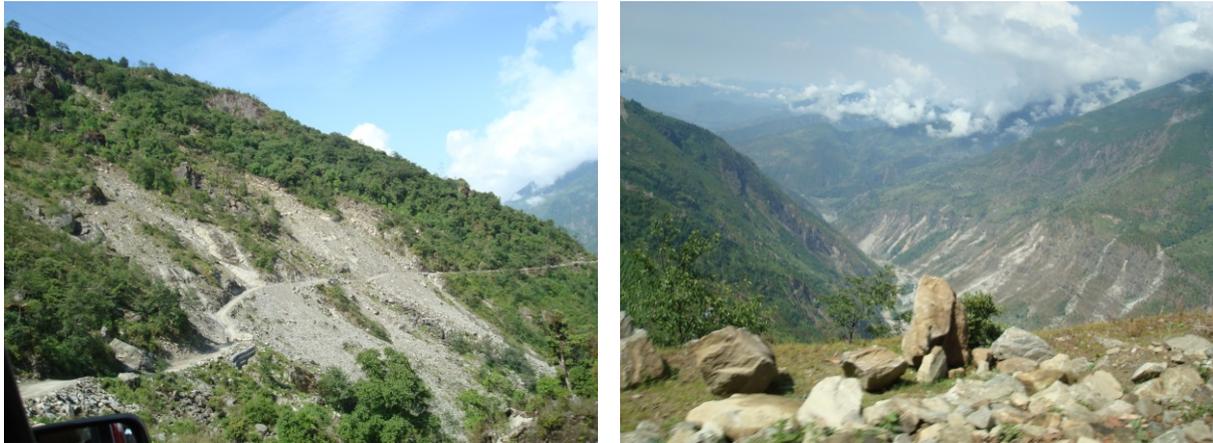
Fig.12 – The interruption caused by the earthquake-induced landslides on Pasang Lhamu Highway.

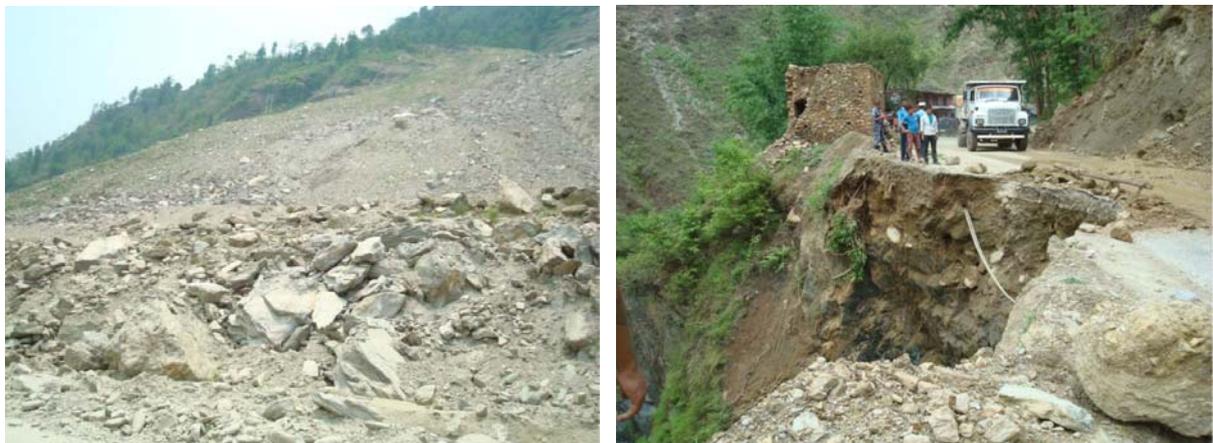
Fig.13 – The interruption caused by the earthquake-induced landslides on Araniko Highway.

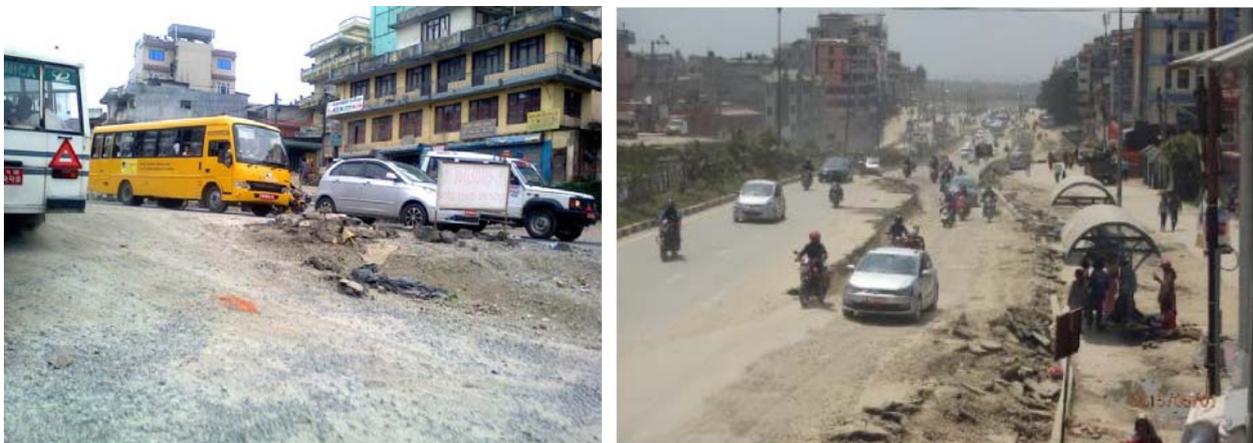
During the earthquakes, some road subgrades were subsided. For example, the Kathmandu–Bhaktapur Road of Araniko Highway was heavily damaged in the Lokanthali area (Fig.14). The subsidence of soft soil sand their lateral spreading in this area may have exacerbated the damage to this road.

Fig.14 – Slope failure and subsidence in the Lokanthali area.

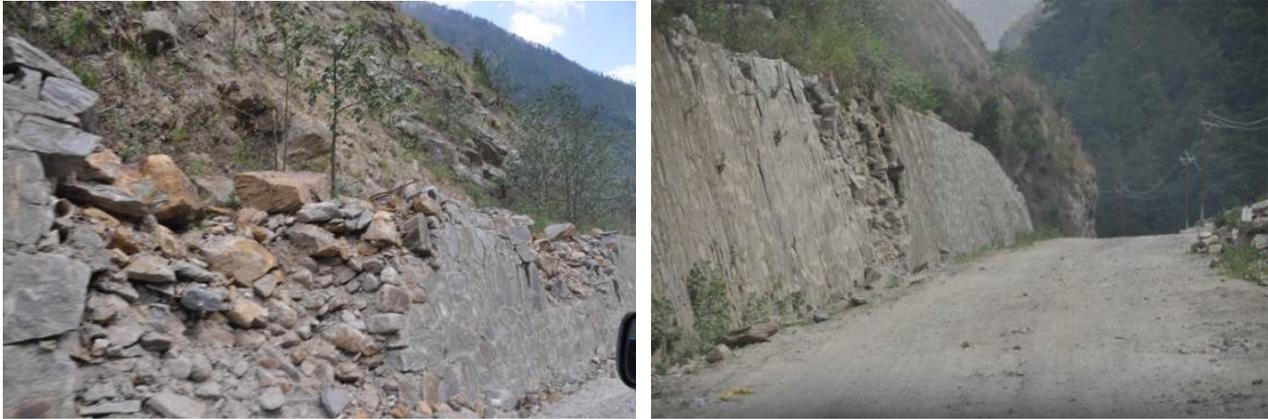
There are two types of retaining walls, one is a reinforced retaining wall and the other is a gravity retaining wall. During the earthquakes, gravity retaining wall was damaged heavily by falling rocks (Fig.15) and shaking.

Fig.15 – Gravity retaining wall was damaged heavily by falling rocks.

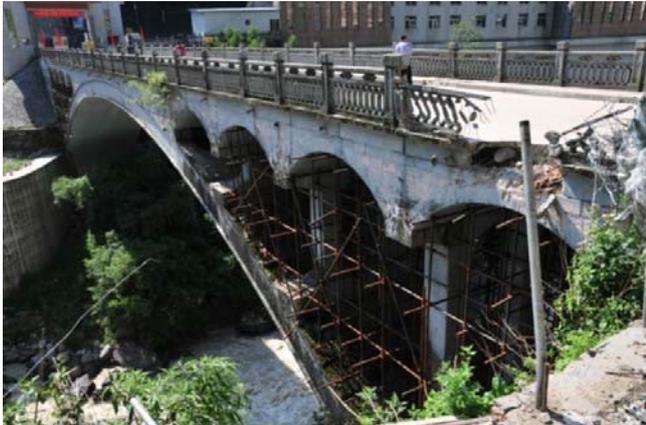
(a) Friendship Bridge

We can find RC Arch Bridge is one of the types which did not resist earthquakes this time. In the total four severe damaged bridges, there are three arch bridges, which built in 1960's, and located in the Arniko Highway near the Chinese Border. The damage patterns consist of inner-arch rig and sign pillar cracked due to strong shaking, bridge deck and guardrail damaged by fall rocks, taper revetment crushed. Both RC box arch bridge (Friendship Bridge and Phulping Bridge, 1*60m) and RC two-way curved arch bridge (Sukundo Bridge, 1*31.4m) was damaged severely, as shows in Fig.17 (a-c).

Fig.17 – Severe damaged bridges in investigation.

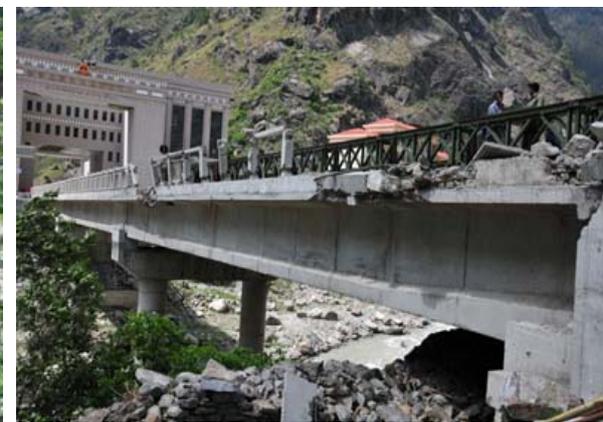
(d) Jilong Port Bridge

The other severe damaged bridge is Jilong Port Bridge which is 3*40m RC simple supported girder bridge, located in the Pasang Lhamu Highway close to the Jilong Port on the Chinese Border. The flange slab of main girder, bridge deck and guardrail were smashed by falling rocks, as show in Fig.17 (d).

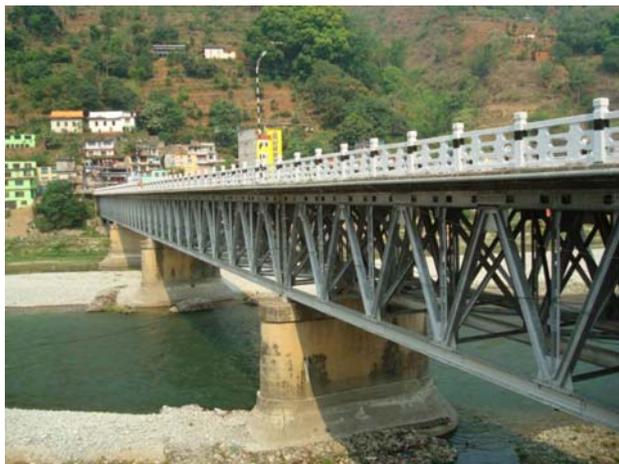
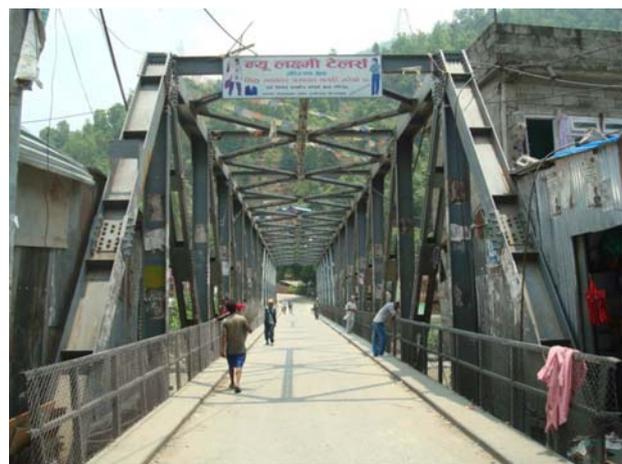
Steel truss bridges performed relatively well in the earthquake affected areas, but because build in 1960's, some steel truss diagonal bracing deformed during earthquakes, steel beam and bearing corroded. Some outer wrapped concrete of piers was cracked. Show as Fig.18.

Fig.18 – Moderate damaged steel truss bridges in investigation.
