## Damage trends in residential RC building after 2015 Nepal earthquake

### Abstract

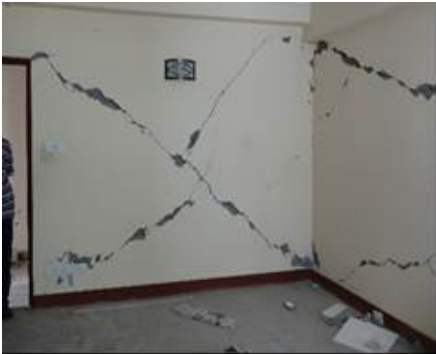
In our investigation, little damage was found in structural member. on the other hand significant damage was found in non-structural infill brick walls. Notable damage in the observed buildings included shear failures in brick walls (Fig. 6), cracks along brick joints (Fig. 7), cracks along the joint between bricks and RC frames (Fig. 8), and brick wall collapses (Fig. 9). Gypsum board damage that resulted from ceiling buckling was found in some buildings (Fig. 10). In such cases, the steel furring was often found to be directly attached to the RC frame with nails (Fig. 11).

Fig. 6 – Shear failure in infill brick walls (KM)

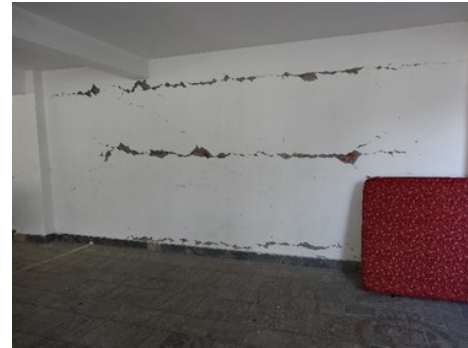
Fig. 7 – Cracks along brick joints (KM)

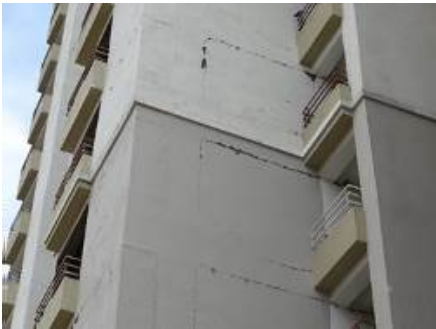
Fig. 8 – Cracks along joints between  
brick wall and RC frame (KP)

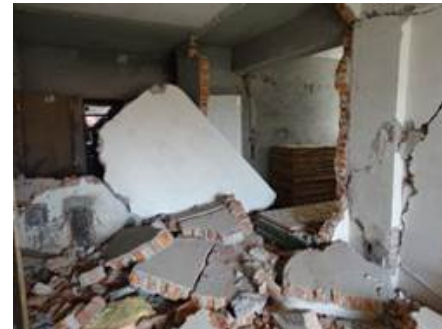
Fig. 9 – Brick wall collapse (KP)

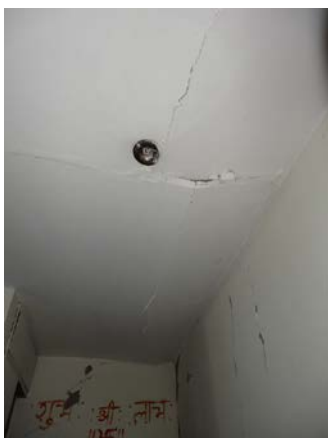
Fig. 10 – Ceiling damage (KD)

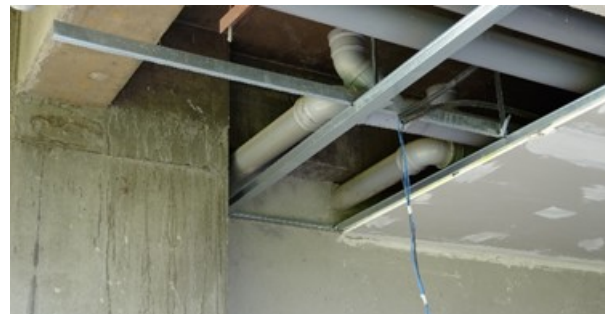
Fig. 11 – Joint between  
steel furring and RC frame (KE)

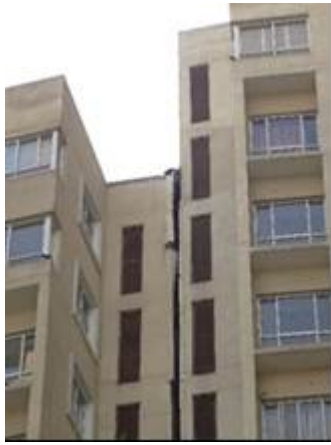
In Section 3, it was noted that damage and collapse were found in the covers of numerous buildings with expansion joints (Fig. 12). After checking the expansion joint covers in building KD, it was clear they had been connected to the building RC frame using screws (Fig. 13) and that pounding behavior occurred due to the narrow clearance between the joint and the RC building structure (Figs. 14, 15). In addition, there was the movie in which the pounding behavior of Building KD was recorded [e.g. 2].

Fig. 12 – Expansion joint damage (KA)

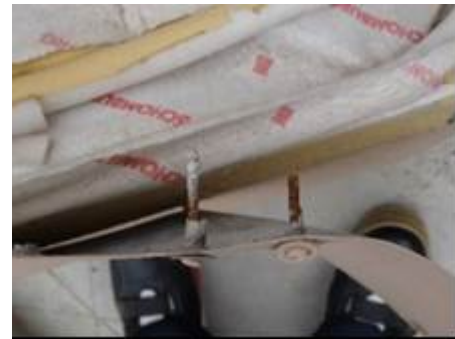
Fig. 13 – Screws connecting the joint cover and RC frame (KD)

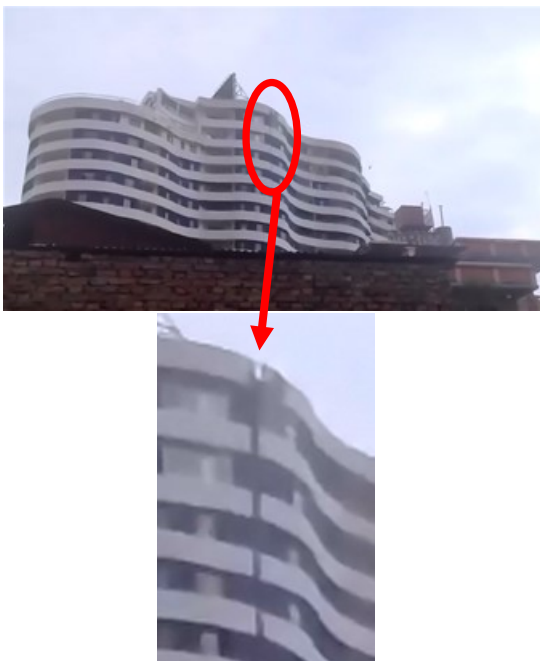
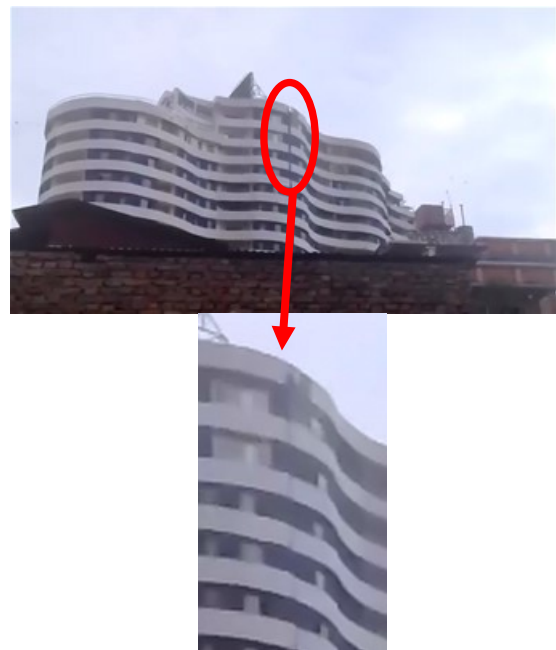
Fig. 14 – Building KE pounding behavior <sup>[2]</sup>

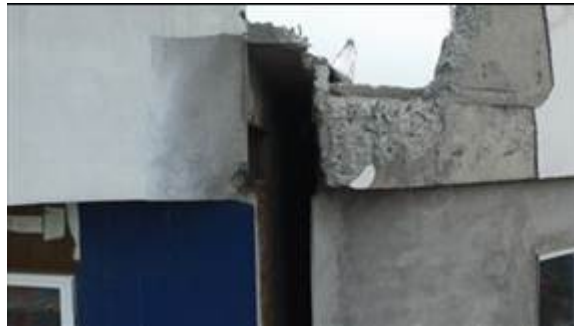
Fig. 15 – Damaged parapet of Building KE

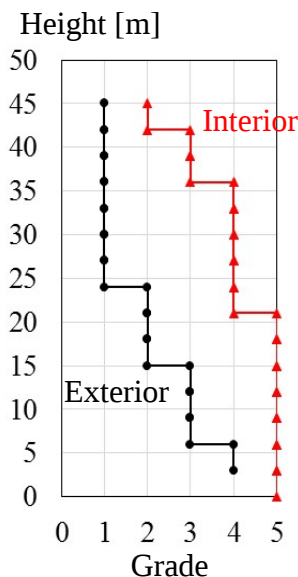
The results of the building KM damage inspection are shown in Fig. 16. The vertical axis shows the height from ground level to the topmost floor level, while the horizontal axis shows the observed damage grade. In Fig. 17, the black line shows the result based on exterior damage and the red line shows the result based on interior damage. Our original method was able to determine that damage to the lower floors was more severe than upper floor damage, and that damage to the interior of the building was more severe than exterior damage. This indicates that life continuity plans based on our evaluation results (Fig. 16) would match the actual life continuity plans (Fig. 17 and Section 4.2) produced after the event.

Fig. 16 – Results of damage inspection  
(Building KM)

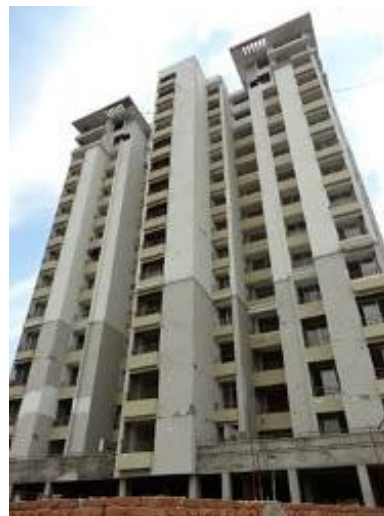
Fig. 17 – Building KM damage
