## SEISMIC VULNERABILITY INDEX FOR LOW-RISE COMPOSITE REINFORCED CONCRETE AND MASONRY BUILDINGS IN NEPAL

S. Brzev<sup>(1)</sup>, B. Pandey<sup>(2)</sup>, D. Kumar Maharjan<sup>(3)</sup>, C. Ventura<sup>(4)</sup>

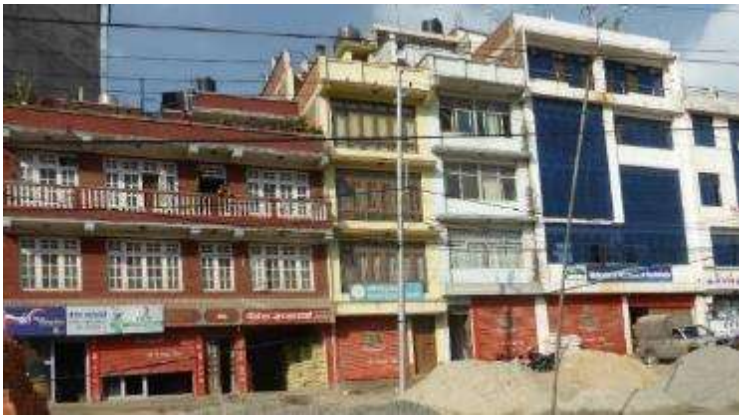
Most buildings of this type have one or more structural irregularities. For example, RC buildings with an open storefront are characterized by a torsional irregularity in plan (due to the absence of walls on one or two sides). These buildings are also characterized by a weak storey irregularity, since the shear capacity of the bottom storey is less than the upper storeys. Very often, the top floor in these buildings has a setback with significantly smaller plan area than the lower floors, which is considered as a half-floor (see Fig. 1b).

Fig. 1 - RC buildings with irregularities: a) open storefront buildings, and b) a setback at the top floor level (Photos: Svetlana Brzev)

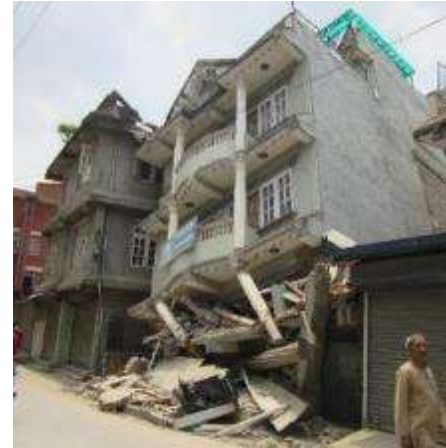
RC frame buildings subjected to severe earthquake ground shaking can experience either a flexural or a shear failure. A flexural failure mechanism is characterized by the development of flexural hinges in RC columns and/or beams. Alternatively, RC frames with masonry infills can experience a shear failure, which is characterized by diagonal shear cracking of masonry infill walls and adjacent RC columns. Most extensive damage usually occurs at the ground floor level of a building where the seismic demand is largest and it may lead to the collapse at that level once the base shear capacity has been exhausted (Fig. 2). The capacity of an RC frame with a shear failure mechanism is largely governed by the shear capacity of masonry walls. Essentially, the behaviour is similar to confined masonry walls which are enclosed by RC confining elements (tie-columns and tie-beams), and the lateral seismic loads are resisted by composite action of masonry walls and RC confining elements.

Fig. 2 - Shear failure of a RC frame with masonry infill walls: a) an illustration of the failure mechanism [6], and b) a shear failure of a RC frame building with masonry infills in the 2015 Nepal earthquake (photo: D.K. Maharjan)

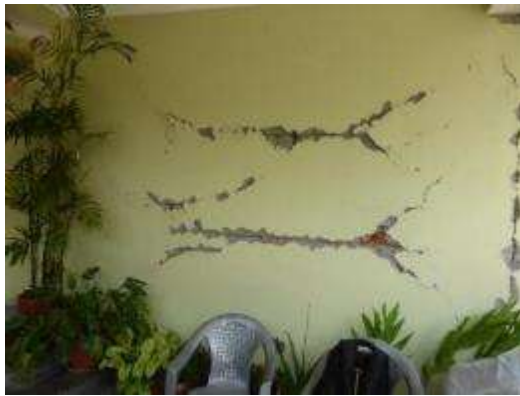
Fig.4 – Examples of Damage Grade 3 (DG3) from Nepal: a) cracks in a masonry wall, and b) shear cracking in a RC column (photos: S. Brzev)

| Damage Grade | Shear-dominant behaviour<br>(proposed damage classification) | | Flexure-dominant behaviour<br>(EMS-98) [8] | |
|---|---|---|---|---|
| Damage Grade 3<br>(DG3): Substantial to heavy damage | Diagonal cracks in most walls, but they are not severe and there is no sign of fallen bricks/blocks and wall segments. | Visible shear cracks in RC columns. | Large cracks in partitions and infill walls; failure of individual infill panels. | Cracks in columns and beam-column joints of frames at the base; spalling of concrete cover, buckling of reinforced rods |

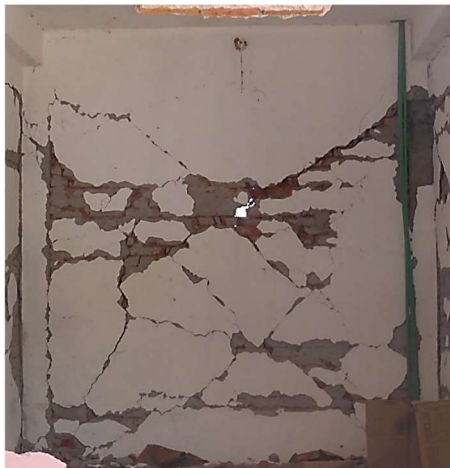
Fig.5 – Examples of Damage Grade 4 (DG4) from Nepal: a) shear failure of a wall at the ground floor level of a severely damaged building (S. Brzev), and b) a vertical separation crack between the wall and the RC column and a major diagonal shear crack extended from the wall into the column (B. Pandey)

| Damage Grade | Shear-dominant behaviour<br>(proposed damage classification) | | Flexure-dominant behaviour<br>(EMS-98) [8] | |
|---|---|---|---|---|
| Damage Grade 4<br>(DG4): Very heavy damage | Wide diagonal shear cracks in walls; severe damage at the wall intersections; partial structural failure of roof and floor structures. | Wide shear cracks and/or tilting of RC columns. | Not described <sup>2</sup> | Large cracks in structural elements with compression failure of concrete and fracture of rebars; bond failure of beam reinforced bars; tilting of columns; collapse of a few columns or a single upper floor. |

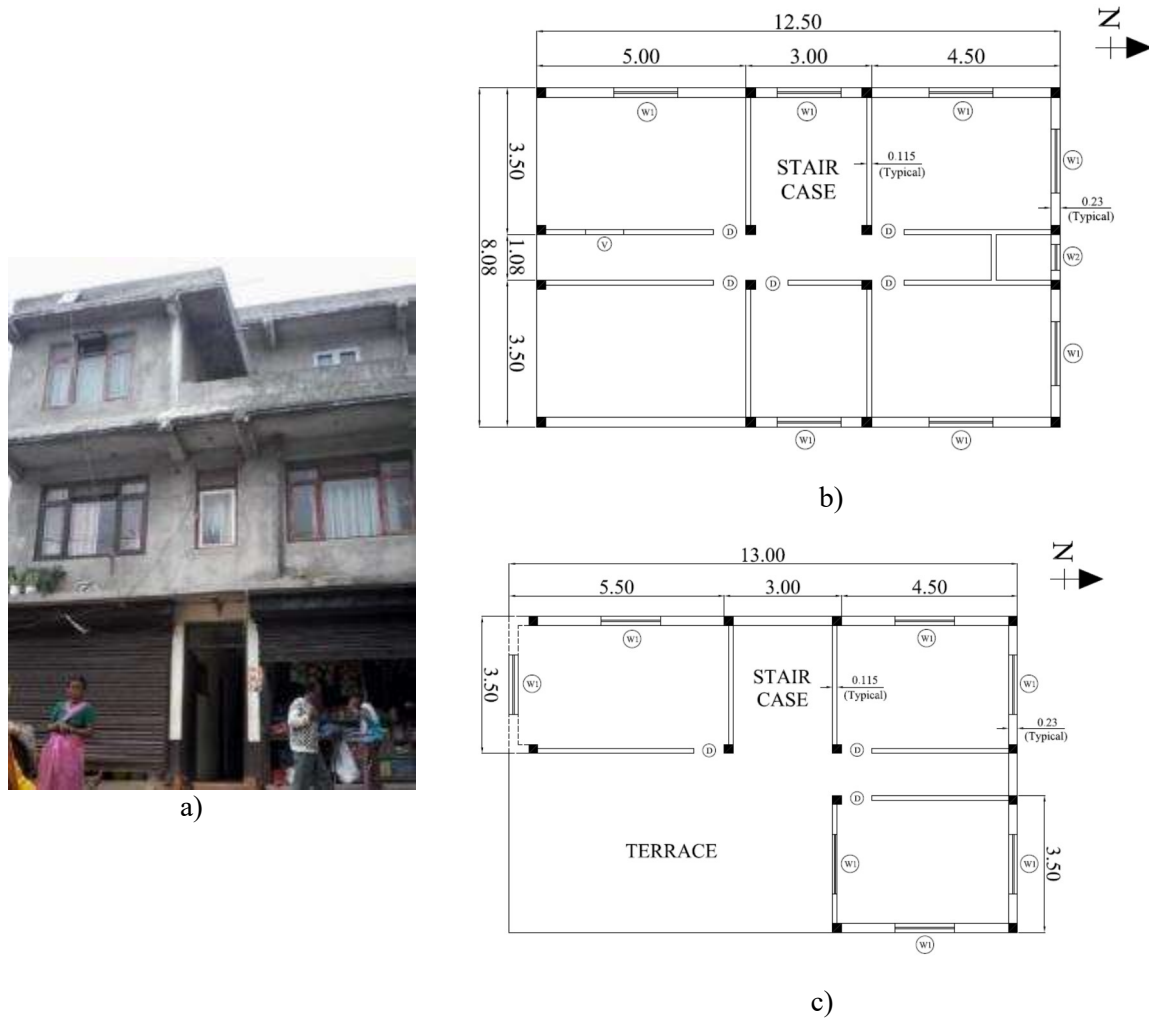
All surveyed buildings were RC buildings with brick masonry infill walls. Most buildings were characterized by a regular (usually rectangular) plan shape. The south façade of a typical building surveyed in Sitapaila, Kathmandu is shown in Fig. 7a, and its ground floor plan is shown in Fig. 7b (note open storefront at the ground floor level). Plan dimensions are typical for the surveyed buildings: 12 m x 8 m (length x width). It was found that the average area of the ground floor plan for the surveyed buildings was 70.3 m.sq., with the standard deviation of 22.04 m.sq. The plan area of the ground floor ranged from 22.23 to 175.6 m.sq. Fig. 7 shows an example of an open storefront building. The building had several window openings at the perimeter. Windows were 1220 mm high with variable width (either 600 or 1220 mm). Doors were 2130 mm high by 780 mm wide. All exterior walls were 230 mm (one-brick) thick brick masonry while all interior walls were 115 mm (half-brick) thick. Typical RC columns were 227 mm (9 inch) square. This building was irregular in elevation. The top floor had a terrace which covers approximately 25% of the plan area, and the south wall at the same level was offset with regards to the lower floors (see Fig. 7c). The calculated wall density index for this building is 1.12 and 0.54% for x- and y-direction respectively. Note that x-direction coincides with the N-S direction shown on the plan in Fig. 7. The damage was in the form of diagonal cracks at the two bottom storeys (the top floor experienced less damage) and it was classified as DG 2 by the survey team. The cracks in mortar joints along the wall-to-frame interface were also observed. The damage mostly occurred in the North-South walls.

Fig.7 - An example of a surveyed building in Kathmandu: a) a photo showing the south façade (entrance); b) ground floor plan, and c) top floor plan (note that x-direction is horizontal – it coincides with N-S direction)
