# ANALYTICAL STUDY OF RESIDENTIAL MASONRY CHIMNEYS DURING RECENT CALIFORNIA EARTHQUAKES

B. Maison<sup>(1)</sup> and B. McDonald<sup>(2)</sup>

## Abstract

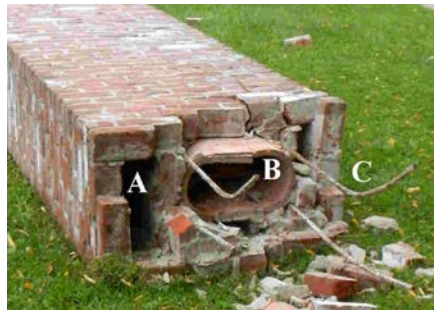
- Construction in apparent violation of the building code seemed to be an important contributor to the failures of reinforced chimneys. Poor quality grout was common and many chimneys had construction debris at the bottom of grouted spaces. Many collapsed chimneys had vertical rebar, but lacked grout to bond the steel to the masonry. Other cases it appeared that vertical rebar had insufficient splice lengths so they pulled out. Still other cases appeared to lack lateral anchoring to the building, and/or anchorage to the foundation so that the chimney overturned. Figure 1 shows the internal features of a Napa chimney that failed during the 2014 South Napa earthquake.

Fig. 1 – Masonry chimney in Napa. (a) Tall reinforced chimney constructed in 1973 that failed at the roofline and collapsed during 2014 South Napa earthquake. Hollow cavity at A indicating chimney not grouted solid. Clay tile flue at B held in place by bricks and mortar not interconnected to perimeter wythe of bricks. Note how chimney failure plane went through the joint between two flue segments. Bent rebar at C that pulled out apparently due to insufficient bond strength (total four bars). (b) Section view depicting chimney internal features.

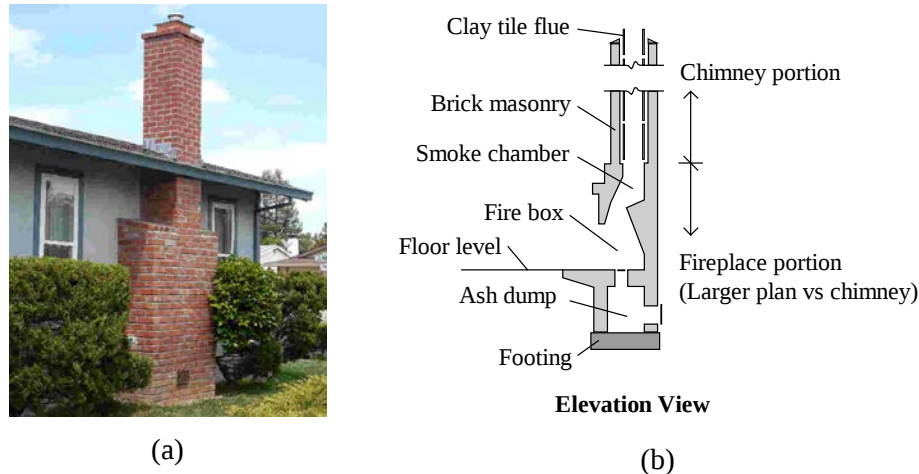
Yountville (0.51g, 16 in/s) and South Napa (0.43g, 37 in/s) earthquakes. Building permit records indicated that chimneys were damaged in both events. Noteworthy was a cluster of homes located on three blocks within 500 feet southwest of the fire station having 17 chimneys damaged in the Yountville earthquake, but the same area had virtually no damage from the South Napa earthquake (Figure 5). Analyses presented below suggests a likely reason for the discrepancy was poor construction quality and/or lack of adherence to building code provisions at the time of original construction with better repair/replacement construction quality after the Yountville earthquake.

Fig. 4 – Typical brick masonry fireplace and chimney associated with homes near the Fire Station recording station. (a) Chimney damaged and rebuilt after Yountville earthquake that survived the South Napa earthquake unscathed (home built in 1973), and (b) Section view depicting typical features.

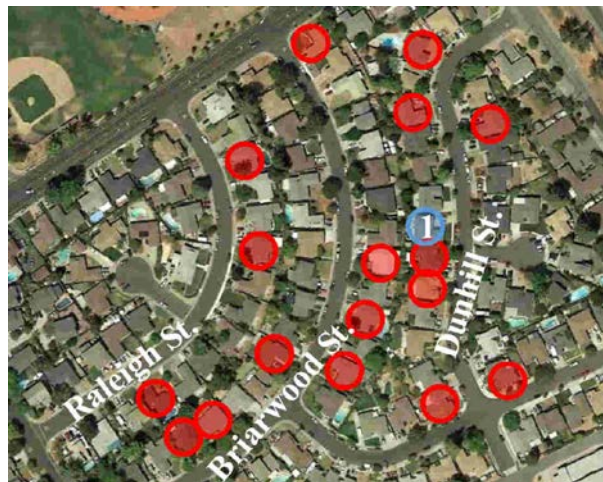
Fig. 5 – Aerial view of Fire Station area depicting homes on three streets having chimneys damaged by the Yountville earthquake (denoted by circles). Investigation shortly after the South Napa earthquake found only one damaged chimney (denoted by “1” in the image).

the event had more stringent requirements (e.g., city inspection sign-off verifying construction including steel reinforcement) and this could explain why fewer were damaged during the South Napa earthquake (Figure 5).

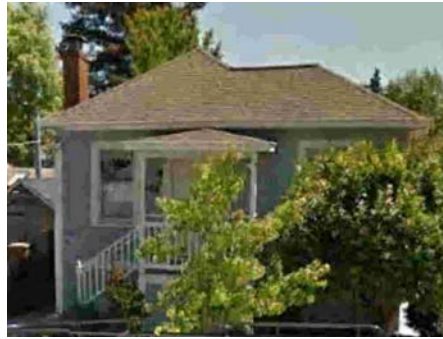
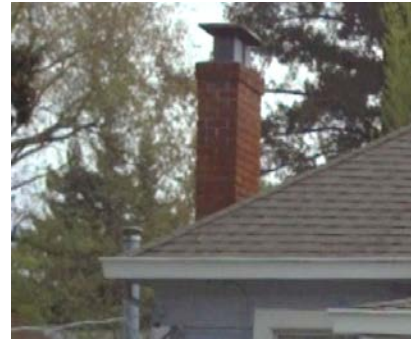
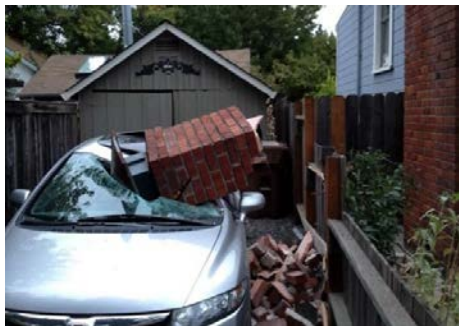
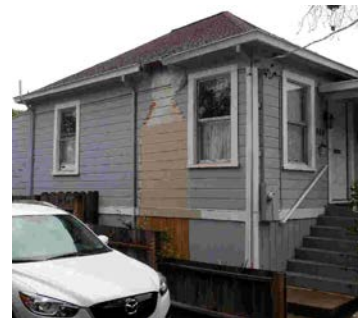
Fig. 6 – Chimney damage for home located southwest of downtown Napa (home built in 1902). (a) House and chimney before earthquake, (b) Close-up view of chimney portion above roofline, (c) Damage to auto from collapse of upper portion of chimney during South Napa earthquake (house at right), and (d) Photo taken several months after earthquake showing house after removal of fireplace and chimney.

The house-chimney arrangement shown in Figure 6 is used as the case study. The chimney was assumed to extend five feet above the roofline with plan dimensions of 16.5 by 25.5 inches. The distance from the ground level to the roofline (chimney crack plane) was assumed as 12 feet. The model ultimate strengths are contained in Table 1. Figure 15 shows the IDA graphs using the NS acceleration component recorded during the South Napa earthquake. Like the Fire Station chimney case study, both the masonry strength and house flexibility influenced chimney performance. However, in this case the chimney would survive the South Napa earthquake (scale factor = 1.0) only if it were connected to a rigid house or perhaps had 60 psi masonry. Considering the age of the home (built in 1902), the chimney undoubtedly lacked steel reinforcement and was constructed with lime mortars having low strength. Hence, the behavior might be like the 10 psi masonry case that indicates chimney failure at shaking intensities less than about one-half that from the South Napa earthquake (Figure 15a). This agrees with the observed actual collapse (Figure 6).

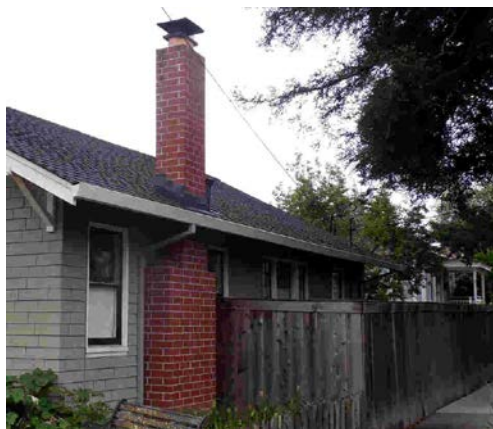
chimneys in the area. Noteworthy is the home in Figure 7a that had its chimney rebuilt after damage from the Yountville earthquake and it was unscathed by the South Napa earthquake.

Fig. 7 – Examples of chimneys located within 3,000 feet southwest of the Main Street recording station. (a) Chimney rebuilt after damage from Yountville earthquake, and was unscathed by the South Napa earthquake. This home, built in 1922, is next door to the home that suffered chimney collapse during the South Napa earthquake (visible in lower right; also shown in Figure 6). (b) Chimney damaged by South Napa earthquake and repaired. Note fresh bricks and mortar at upper portion of chimney. Home built in 1940.

The neighboring home had its chimney rebuilt including reinforcement (Figure 7a), and the chimney survived the South Napa earthquake unscathed. Its strength would be greater than the 60 psi masonry case and the IDA graphs indicate it would easily survive the earthquake which agrees with observation (Figure 15c).
