Structural Characterization of RC Buildings of Kathmandu Valley after Gorkha Earthquake 2015

Rajan Suwal¹, Hugo Rodrigues², Humberto Varum³

ABSTRACT

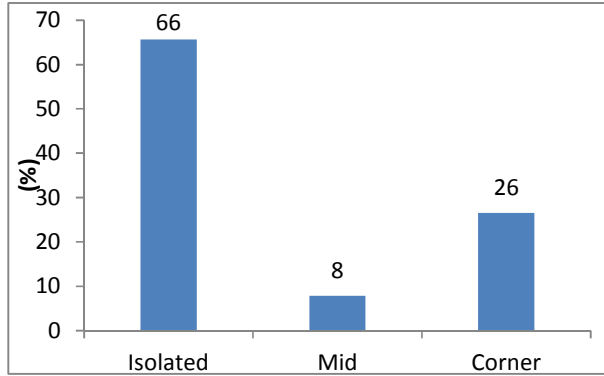
Figure 3.1.c : Position of buildings

Figure 3.1.c shows the categorization of building according to position among the buildings. The results shows that position of building plays vital role relating to vulnerability as 8% buildings which are located in mid are damaged by earthquake out of 64 studied buildings. Isolated buildings were damaged more which reached 66% whereas 26% buildings which are in corner were found damaged. Mid buildings were damaged lesser due to the support in both direction.

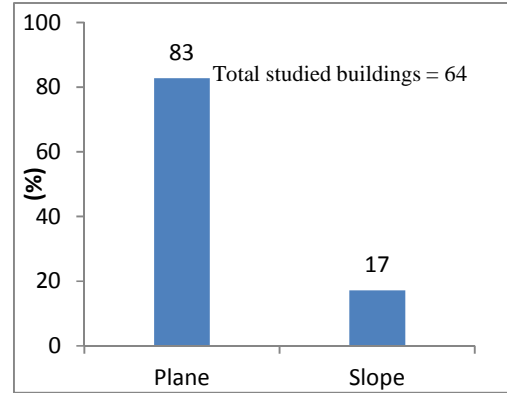
Figure 3.1.d : Classification of buildings according to surrounding terrain

In the geographic terrain building lies in not only in plane but also in sloppy area. So, from the result of graph chart in Figure 3.1.d, it is found that out of studied total 64 numbers buildings, 83% were constructed in plane area whereas 17 % in sloppy ground area. Most of the buildings which were constructed in slope area were severely damaged due to unequal settlement of foundations.

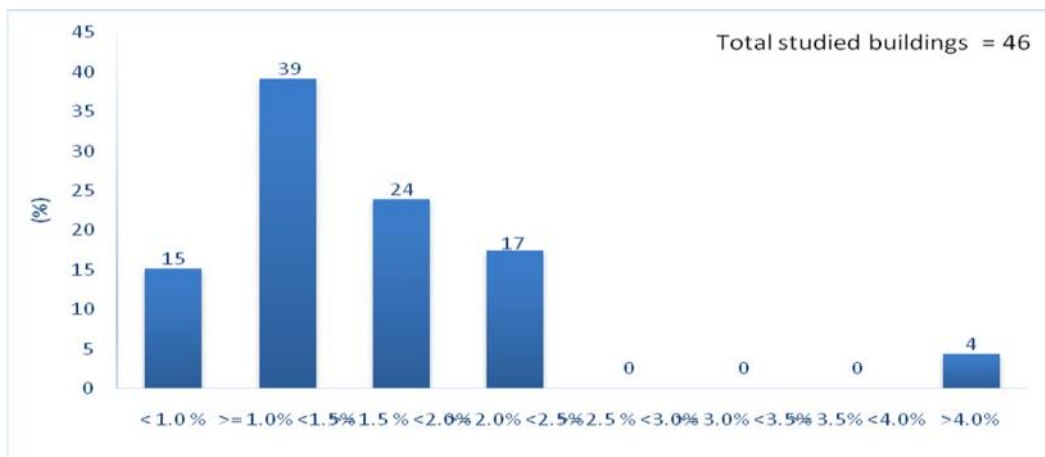
Figure 3.4.a : Longitudinal reinforcement percentage in columns

Longitudinal reinforcement is one of the important parameter that signify the vertical load and bi-axial bending moment capacity of column. Figure 3.4.a shows 15% buildings have less than 1% reinforcement. The highest numbers of buildings of 39% have longitudinal reinforcement of equal and greater than 1% and less than 1.5% followed by 24% of building have reinforcement of equal and greater than 1.5% and less than 2%. Similarly, about 17% of the buildings have longitudinal reinforcement equal and greater than 2% and less than 2.5%. Only 4% of buildings have reinforcement >4%. There are no buildings found which have reinforcement from 2.5-4%. Actual reinforcements in columns are less than required even though in chart it shows higher value because sizes of columns sections are quite smaller than required otherwise it would be lesser than that.

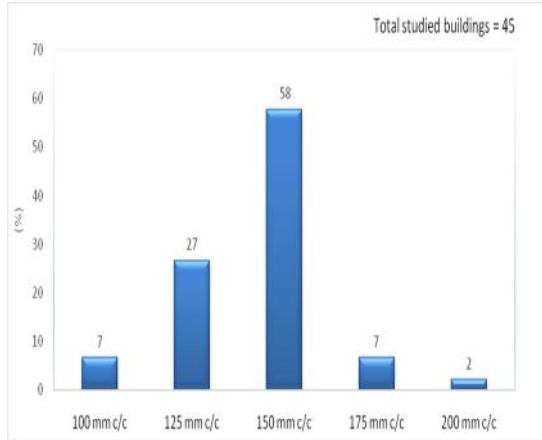
Figure 3.4.b : Stirrups spacing at support of columns

Transverse reinforcement in column are not visible in most of the cases, however most of the building(58% out of considered 45 buildings) have spacing of 150 mm with diameter of 7 and 8 mm at near the support of column (see) even though in approximate calculation it needs 100 mm center to center but it is seen that only 7% buildings have this amount of reinforcement. Diameter of transverse reinforcement is mainly used of 7 mm diameter and 8 mm diameter. shows that out of considered 25 buildings, at the mid height 52% building has 150 mm center to center transverse reinforcements. From this two charts, it can be seen that at mid height of column, shear reinforcements are quite good but near the support of columns, they are not enough.

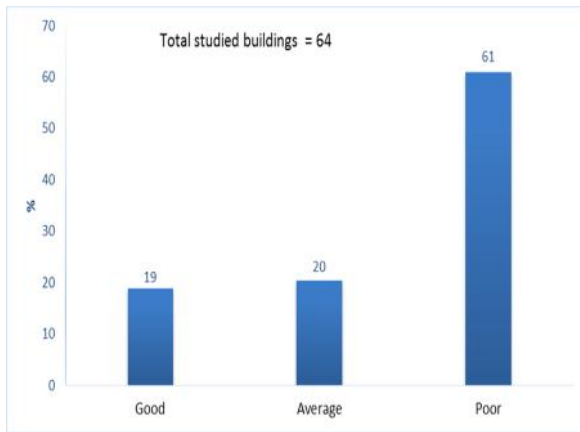
Figure 3.5.a : Quality of concrete

Quality of material also influence the strength of the structural members and consequently to structural system itself. Figure 3.5.a shows that out of studied 64 numbers of buildings, 61% of buildings have poor quality of concrete. Similarly, Figure 3.5.b shows that the quality of concrete in vibration shows 52% buildings have poor quality. This is the cause for the crushing of concrete in the column support and joint.

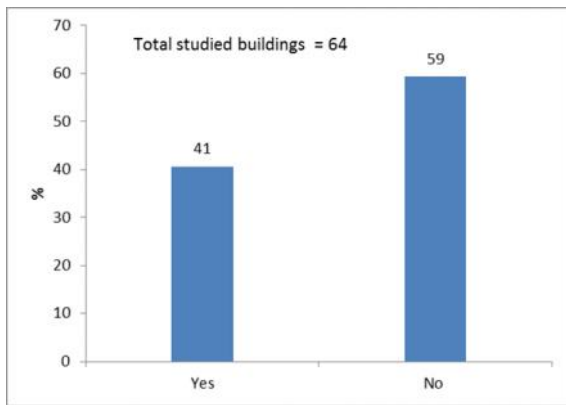
Figure 3.6.a : Classification of building according to soft story

The analysis of data collected from field survey (Figure 3.6.a) shows that soft story failure evidence is observed in 41 percent of building. Fully collapse of ground floor, most of the damages of ground floor columns with respect to above stories is considered as a soft story evidence.

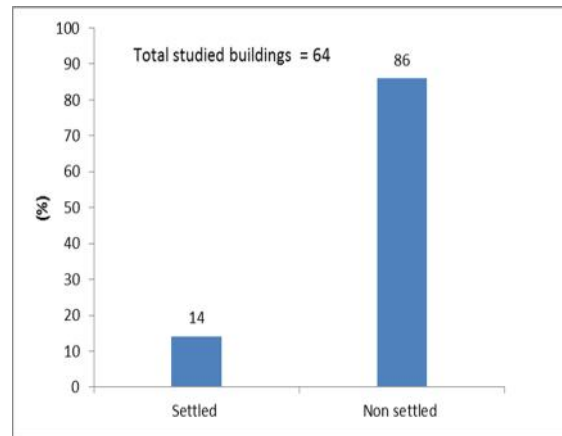
Figure 3.6.b : Classification of buildings according to settlement

Due to very weak soil deposit area, soil amplification, settlement and liquefaction are most probable in this zone. The graph in Figure 3.6.a. shows out of studied 64 buildings, 14% building are settled. It happens due to foundation in weak soil, not enough size of foundations, heavy load in small foundations, unequal level of foundation footings, different soil strata in different footing, high water table and other causes.

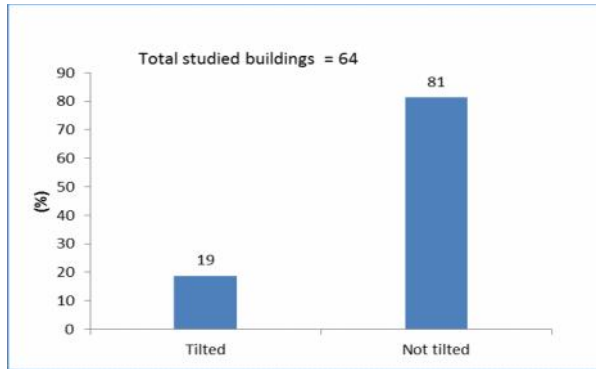
Figure 3.6.c : Tilting of buildings

It is believed that Kathmandu valley have high soil deposited of up to about 600 m (source: slide of B. N. Upreti). Tilting of building is observed in some of the building. It is observed that 19% of buildings from the 64 studied buildings seem tilted (see Figure 3.6.c). It is due to weak soil, very slender building, unequal mass in plan is and in elevation.

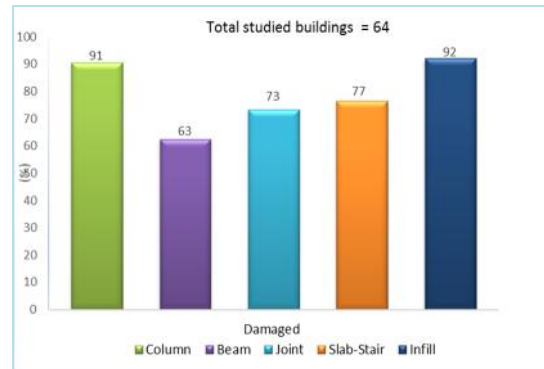
Figure 3.6.d : Damage of structural elements

Damage of the structural elements such as column, beam, joint, slab-stair and infill are plotted in Figure 3.6.d. The results show that the most probable damage are observed in column and infill followed by slab-stair and joint. The least damage was observed in beam, this might be because of strong beam weak column mechanism.
