WATER TANK DAMAGE DUE TO THE 2011 EAST JAPAN EARTHQUAKE IN CONSIDERATION OF STRONG GROUND MOTION AND DESIGN CODES

Abstract

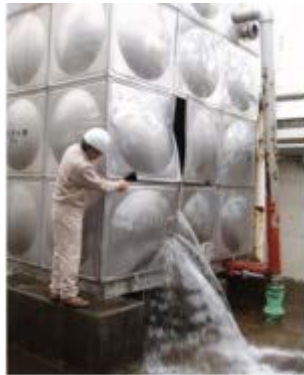
Table 3 shows the number of the damaged tanks classified by damage pattern, in which the damage patterns are separated by the mode of tank collapse into side wall, roof, inside wall, anchor bolt, base frame, pipe-connected part, base plate and inside reinforcement types. In Fig. 2 the examples of side wall collapse and roof collapse are shown. In Table 3 we duplicate the number of the damaged tanks in the case with plural collapse modes. From Table 3, we can see that the number of the tanks damaged with side wall collapse mode overwhelms the one with the other collapse modes, and that many tanks with the other collapse modes are accompanied with side wall collapse mode at the same time. Thus, one of the characteristics of the damage of water tanks during the earthquake is that the damage with side wall collapse mode is very predominant. The

(a) On-ground stainless tank
(Tsukuba, Ibaraki Pref., 1985)

Fig. 2 – Examples of side wall collapse and roof collapse

The main cause of side wall collapse including inside wall collapse in Table 3 is considered to be the dynamic water pressure acting upon side and inside walls during the earthquake. Also, other collapses other than the roof collapse are considered to be mainly caused by the increase of the dynamic water pressure or of the

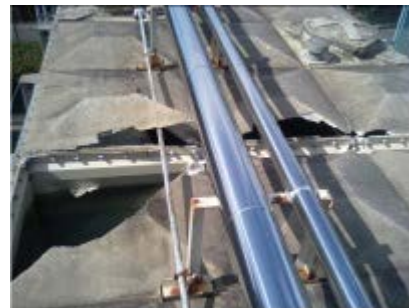
(b) On-ground FRP tank (Sendai, 1988)

The cause of roof collapse is considered to be the impact pressure upon tank roofs acted by sloshing with excessive wave height over the clearance (Yamamoto [15], Minowa [16]). In order to estimate how high sloshing wave response, we need to know the first natural period of sloshing T_s given by the following equation (Senda and Nakagawa [17]):

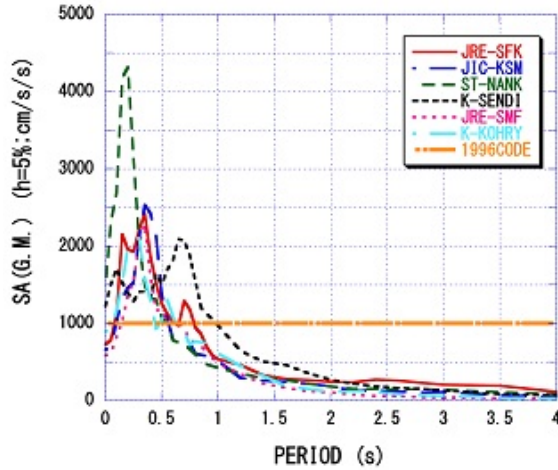
Fig.3(a) shows the curves of typical response spectra SA at 7 stations in Miyagi and Fukushima Prefectures, in which the SA level for T_B around 0.15 to 0.4sec is dominant and the locations of which are near the sites of bulging-damaged tanks. Fig.3(b) shows the curves of typical response spectra PSV at 5 stations in

(a) Absolute accerelation response spectra at 7 stations located nearby bulging damaged tanks.

In both figures, the orange horizontal lines show the maximum design values for on-ground tanks in the current specifications, i.e., $SA=1,000\text{cm/s/s}$ and $PSV=150\text{cm/s}$, respectively, and it can be found that the SA level in the period range of 0.15-0.40sec reaches about 1500-4000 cm/s/s and remarkably exceeds 1,000cm/s/s the maximum design value, and that the PSV level in the period range of 1.4-4.0s reaches about 200-500 cm/s and distinctly exceeds the maximum design value, and that these facts lead us to the origins of the bulging and sloshing collapse in the tanks located nearby the stations.

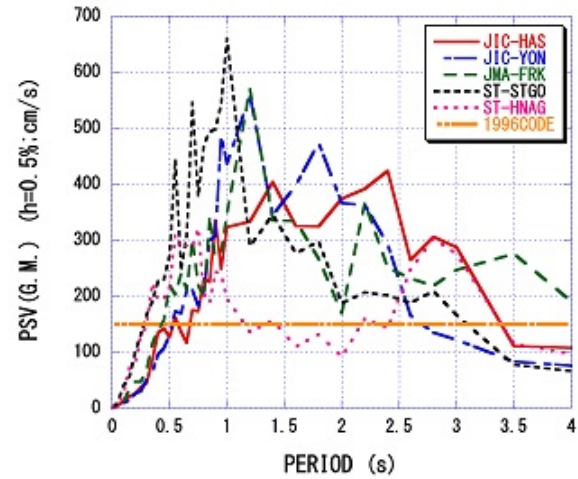
(b) Pseudo velocity response spectra at 5 stations located nearby sloshing damaged tanks.

Miyagi Pref., in which the PSV level for T_s around 1.4 to 4.0 sec is domonant and the locations of which are near the sites of sloshing-damaged tanks.

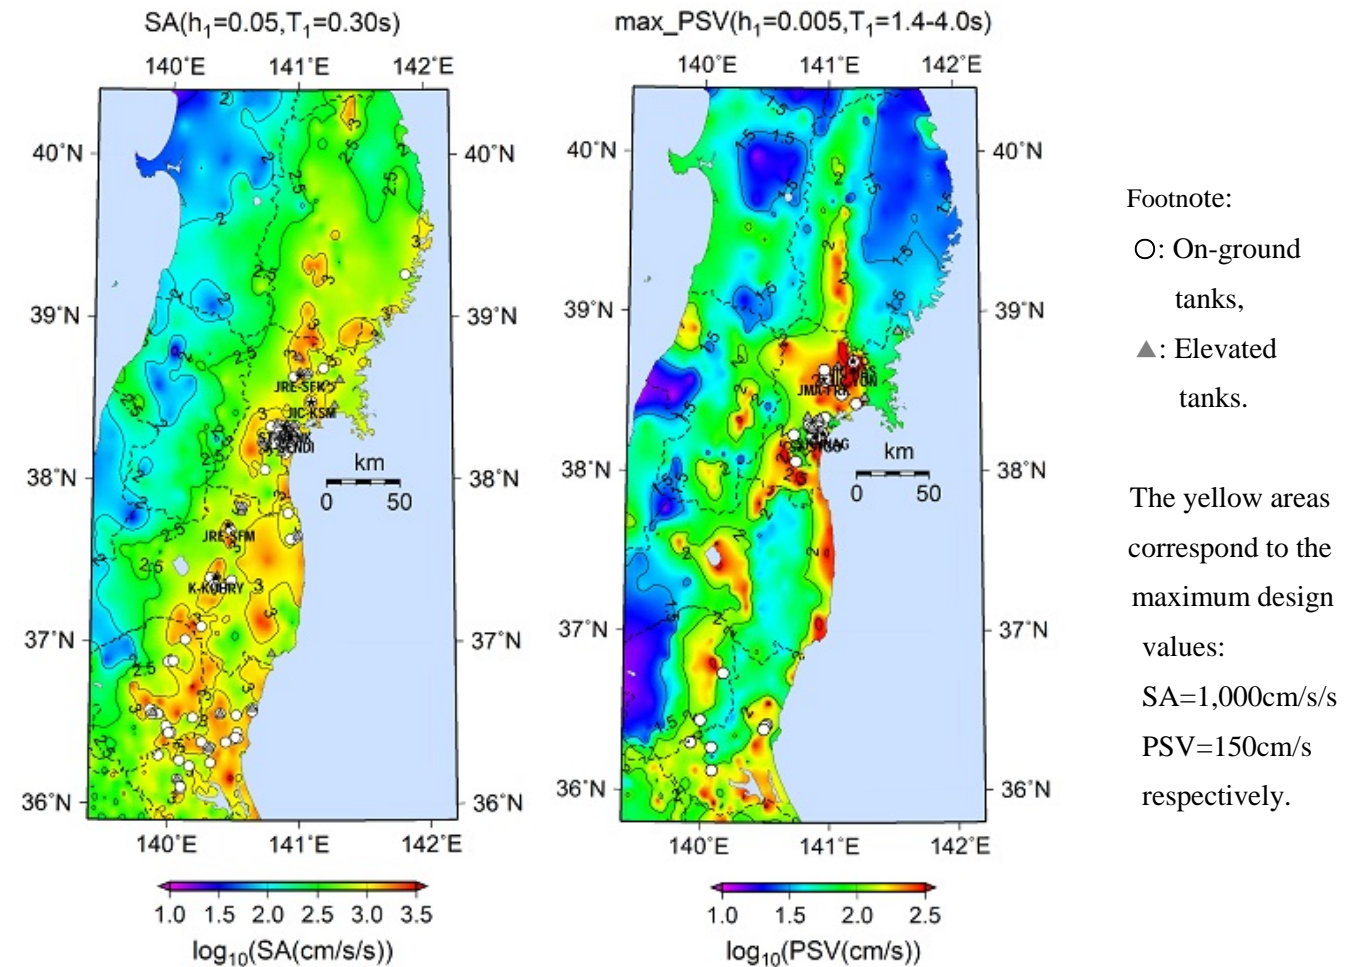
Fig. – 4 Contour maps of response spectra and locations of damaged water tank

In Fig. 4(a) the location of each tank damaged with collapse by bulging is plotted, from which it can be seen that the areas with the SA level between 1,000cm/s/s and 2,000cm/s/s exist broadly in the five prefectures and that almost all of the bulging- damaged tanks are located in such areas.

In Fig. 4(b) the location of each damaged tank with collapse by sloshing is plotted, from which it can be seen that the areas with the PSV level spectra between 200cm/s and 300cm/s are distributed dispersively in the five prefectures and that almost all of the sloshing-damaged tanks are located in such areas.
