EVALUATING AND QUANTIFYING CASE STUDIES OF LIQUEFACTION-INDUCED FLOODING FROM CANTERBURY EARTHQUAKE SEQUENCE

C. Davis⁽¹⁾ and J. Hu⁽²⁾

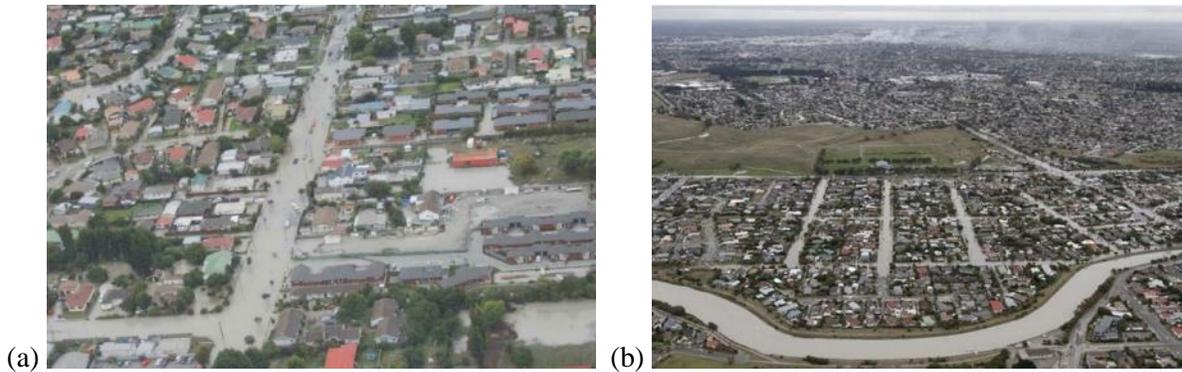
Fig. 1 – Liquefaction-induced flood in Christchurch City following the February 22, 2011 earthquake. (Crown Copyright 2011, NZ Defence Force – Some Rights Reserved)

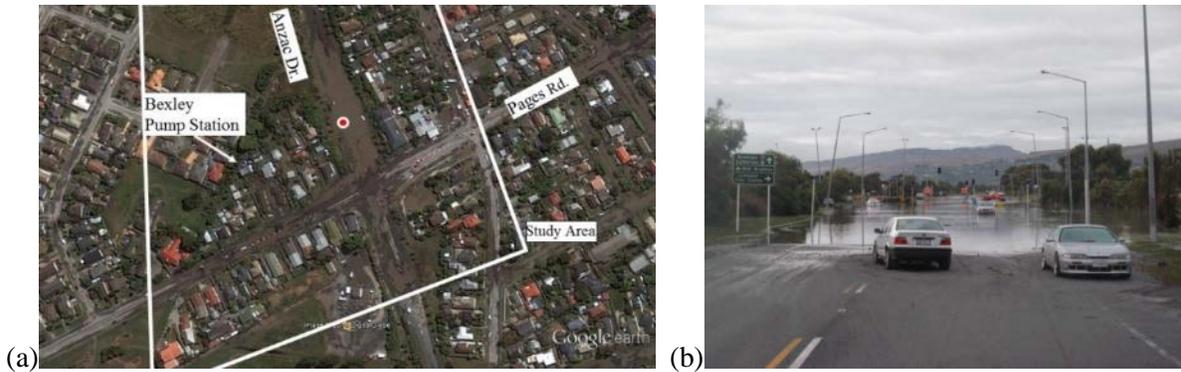
Fig. 5a is a Google Earth image the day after the earthquake (the image time is marked as 4PM 2/22/2011 GMT, NZ is 12 hours ahead) showing flood water remaining at the intersection of Pages Rd. and Anzac Dr. in the Bexley suburb of Christchurch city. Fig. 5b shows a vehicle driving north on Anzac Dr. The water depth is below the car bumper (the defined object in Table 1) and estimated to be about 20 to 30 cm. The exact N-S object location is difficult to identify within 5 m to 10 m from the Fig. 5b perspective. Fig. 5b is at mid-height of Fig. 1b, right side.

Fig. 5 – (a) Google Earth image intersection Pages Rd. and Anzac Dr. after February 22, 2011 earthquake in the eastern suburb of Bexley, dot locates object. (b) Flooding at the intersection (Courtesy T. O’Rourke)

The LiDAR data analysis indicates the measured settlement at this location is approximately 10 cm, however measured settlement in cells surrounding the object are between 17 cm to 30 cm. The study area is about 300 m x 600 m selected over the intersection. The settlement volume is 33,440 m³, and the potential flood volume ranges from 16,720 m³ to 26,020 m³, assuming 20 cm to 30 cm for the water depth at the car shown in Fig. 5b. The measured settlement agrees very well with the observed inundation depth in the area surrounding the object, but the settlement volume is larger than the observed inundation volume. The observed inundation depth is smaller than the estimated settlement, but within the range of measurement accuracy. The damaged artesian well at Bexley Pump Station contributed to flooding at this location. However, based on analysis results, the relative contribution from the well to overall flooding appears to be minor. This is reasonable considering the estimated 150 m³/hr flow within 6 hrs is 900 m³, which is small relative to that observed in Figs. 5b and 1b within this timeframe and the observed inundation and settlement volumes.

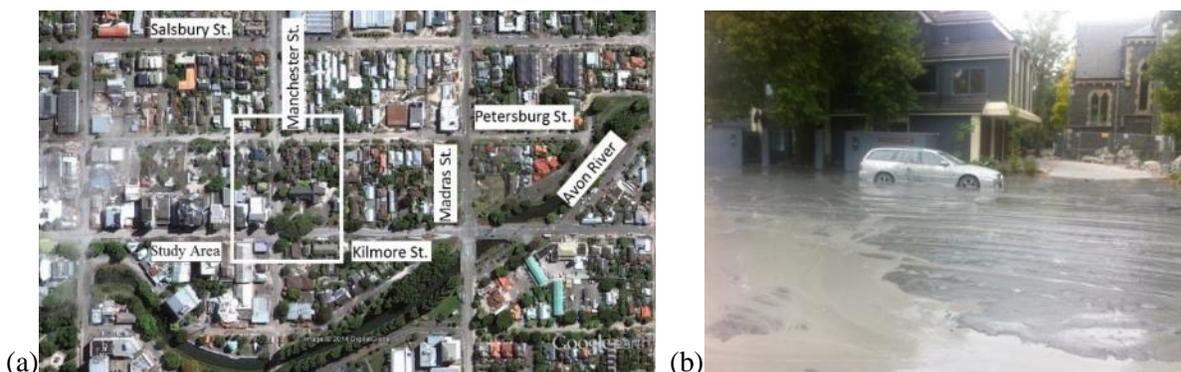
Fig. 6a shows a Google Earth image of the area covering the photograph in Fig. 6b about four days after the earthquake. Fig. 6b shows flooding of Manchester St. between Petersburg St. and Kilmore St. in the northern area of the Central Business District following the February 22, 2011 earthquake. The water was reported to be ankle deep liquefaction at Salisbury St. and south [10]. The depth is estimated to be about 20 to 30 cm based on depth of water at car tire in Fig. 6b and depth described as “ankle deep”. The object location is identified with high accuracy.

Fig. 6 – (a) Google Earth image covering locations in the northern area of the Central Business District following the February 22, 2011 earthquake, (b) Flooding at 250 Manchester St., between Petersburg and Kilmore Street looking east (Courtesy The Alfmeister, 2011).

The LiDAR data analysis indicates the measured settlement at the object location is approximately 29 cm. The study area is about 130 m x 160 m selected along Manchester St. between Kilmore and Petersburg Sts. The settlement volume is estimated to be about 3,800 m³. The observed inundation volume ranges from 1,824 m³ to 2,940 m³ for the observed inundation depths. Approximately 35 cm to 40 cm of water depth is needed to reach

the calculated settlement volume, which is reported in Table 4 as estimated settlement. The information used for this case is known to have been obtained before the ejection process was completed, so the observed inundation depth may have increased greater than seen in Fig. 6b. The observed inundation depth reported in Table 1 agrees very well with the measured settlement, but the settlement volume is higher than the observed inundation volume. The estimated settlement is larger than the observed inundation depth but is within the range of measurement accuracy.

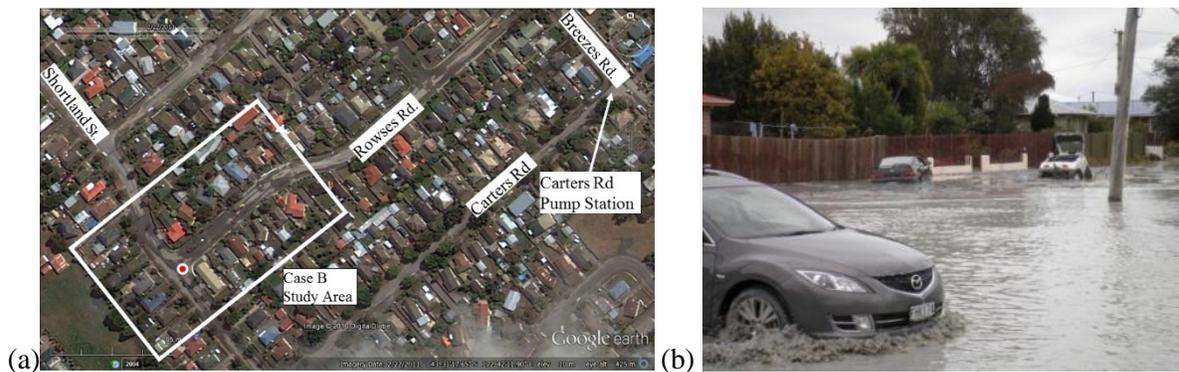
Fig. 7a shows a Google Earth image taken the day after the earthquake. This image shows large areas of liquefaction and remnant flooding. Fig. 7b shows a car driving south on Shortland St. The water at this location is estimated to be about 20 cm to 25 cm based on it reaching the front bumper. This is the defined object in Table 1, which is expected to be located with accuracy of 5 m in each direction. Estimating water and sediment depth for Fig. 7 is difficult because there is no observable reference to the street surface, so the observed inundation depth assumes there is no significant sedimentation on the street. The damaged artesian well at Carters Road Pump Station may have contributed to these flood waters, but is a relatively small influence just as found for Case A.

Fig. 7 – (a) Google Earth image taken four days after February 22, 2011 earthquake showing Case C and D study areas, dots locate objects. (b) Flood water at Rowses Rd. and Shortland St. (Courtesy M. Lincoln, nzraw.co.nz)

The LiDAR data analysis indicates the settlement at this location is approximately 12 cm, but the settlement in the adjacent grid is 15 cm. The study area is about 100 m x 200 m selected over the intersection. The settlement volume is 2,200 m³, but the observed inundation volume ranges from 1,059 m³ to 1,408 m³ for the range of observed inundation depths presented in Table 1. It would require about 30 cm to 35 cm of water at this location to reflect the settlement volume, as reported in Table 4 as estimated settlement. The observed inundation depth is higher than the measured settlement and lower than the estimated settlement, but within the measurement error.

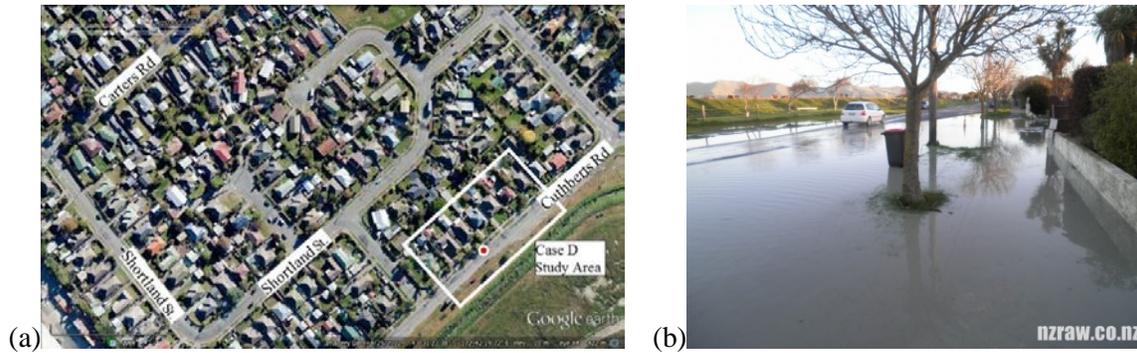
Fig. 8a shows the location of Case D. This case is located just a little south east of Case C. Liquefaction damage in Aranui in the June 13, 2011 earthquakes was reported to be about as bad as from the February 22, 2011 earthquake [11] in this area. Fig. 8b shows flooding on Cuthberts Road in the Aranui suburb, located with relatively high accuracy. The inundation shown in Fig. 8a covered the street curb and sidewalk along the wall. The water depth is estimated to be about 10 cm to 15 cm based on standard curb height. Photographs of some surrounding streets taken about the same time indicate the flooding shown in Fig. 8b did not exist everywhere in the suburb.

Fig. 8 – Cuthberts Rd. following the June 13, 2011 earthquake in the eastern suburb of Aranui. (a) Google Earth image 4/25/12. (b) Flooding on Cuthberts Rd., June 13, 2011 (Photo courtesy M. Lincoln).

The LiDAR data analysis indicates the settlement at this location is approximately 6 cm to 8 cm, depending on which portion of curb is selected. The study area is about 60 m x 110 m selected along Cuthberts Rd. The settlement volume is 160 m³, and the observed inundation volume range is around 140 m³ to 300 m³. The observed inundation depth and volume agree well with the measured settlement and the settlement volume, within the data accuracy range. The estimated settlement results match the observed inundation depth.

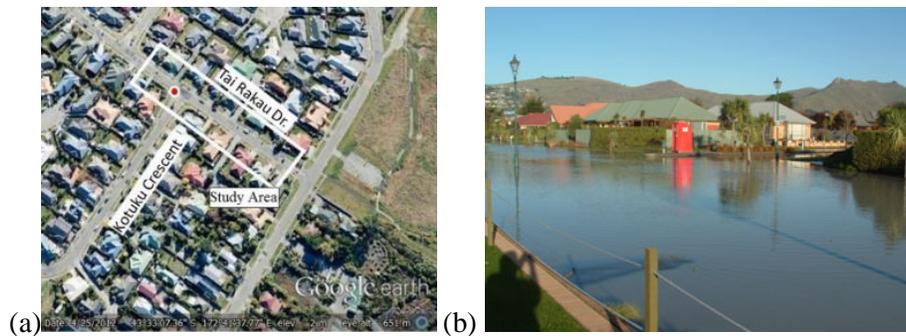
Fig. 9 – Ti Rakau Drive at intersection with Kotuku Crescent (a) Google Earth image after the June 13, 2011 earthquake in Woolston suburb, dot locates object. (b) Observed flooding (Courtesy of Brookhaven).

Fig. 9a shows a Google Earth image of Ti Rakau Drive in the Brookhaven neighborhood of the Woolston suburb in eastern Christchurch city. As shown in Figure 9b, the liquefaction-induced flooding is great enough to cover the street curbs and lawn. The observed inundation depth is about 20 cm to 25 cm based on curbs located with high accuracy. Drainage catch basins, observable in Google Street View, were unable to drain the flood waters.

The LiDAR data analysis indicates measured settlement at this location is approximately 20 cm. The study area is about 60 m x 180 m selected along Ti Rakau Dr. The settlement volume is 370 m³, and the inundation volume ranges from 300 m³ and 470 m³, for the range of estimated observed water depth. As seen in Table 4 for this case, the observed water depth, measured settlement, and expected settlement all agree very well. Additionally, the ground settlement volume agrees with the observed inundation volume.

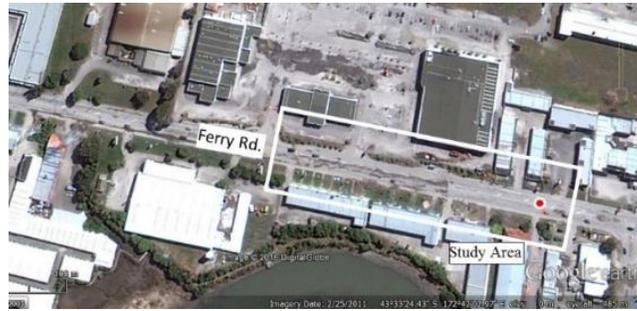
Fig. 10 shows a Google Earth image of Ferry Rd. on February 25, 2011. This Case F is for the June 13, 2011 earthquake, but the image identifies areas where liquefaction ejecta arose from the previous CES earthquake. The photograph used to identify the object and location is seen at <http://www.gettyimages.com/detail/news-photo/vehicle-drives-through-water-on-ferry-road-near-sumner-news-photo/115959085>. The location is near 1013 Ferry Road, looking west, however there is difficulty in identifying the object location in the east-west direction due to the skewed distance perspective in the photograph. The photograph shows the water depth varies in this area. The observed inundation depth is estimated to be about 20 cm to 25 cm.

Fig. 10 – Google Earth image near 1013 Ferry Road dated February 25, 2011 in the eastern suburb of Ferrymead, dot locates object.

The LiDAR data analysis indicates the measured settlement at this location is approximately 25 cm. The study area is about 50 m x 100 m selected along Ferry Rd. The settlement volume is 615 m³, and the observed inundation volume ranges from 700 m³ to 890 m³. As seen in Table 4 for this case, the observed water depth, measured settlement, and expected settlement all agree very well. Additionally, the ground settlement volume agrees closely with the observed inundation volume.
