EFFECTS OF TSUNAMI ON WATER SUPPLY NETWORK IN CASE OF THE 2011 TOHOKU EARTHQUAKE IN JAPAN

M. Miyajima⁽¹⁾, N. Iwamoto⁽²⁾

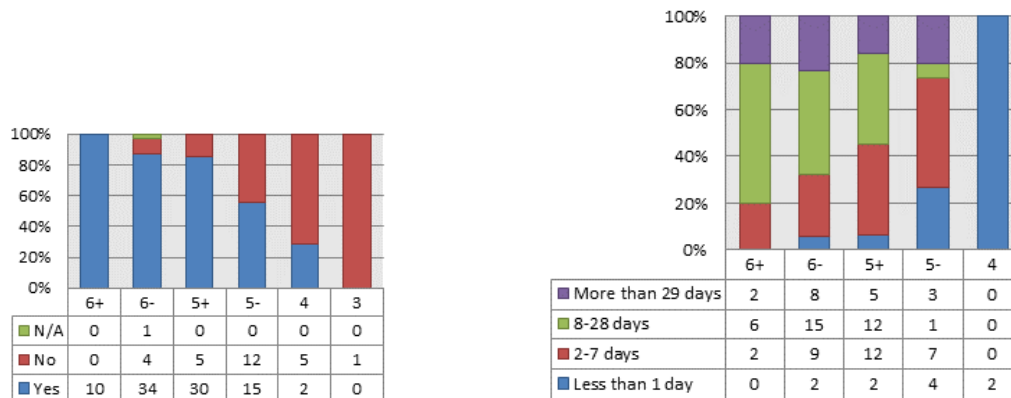
Fig. 1 - Occurrence of water stoppage and its duration in relation to seismic intensity

Fig. 1 shows numbers of waterworks bureaus caused water stoppage and its duration after the earthquake in relation to JMA seismic intensity. The water stoppage occurred at more than 50% of the waterworks bureaus in seismic intensity more than 5-. Number of waterworks bureaus that suffered water stoppage in more than one week rapidly increase in seismic intensity 5+. No waterworks bureau recovered within one day in seismic intensity 6+. The number of waterworks bureau that suffered water stoppage of more than four weeks does not depend on the seismic intensity. This means that long water stoppage was caused not only by strong ground motion but also by another cause.

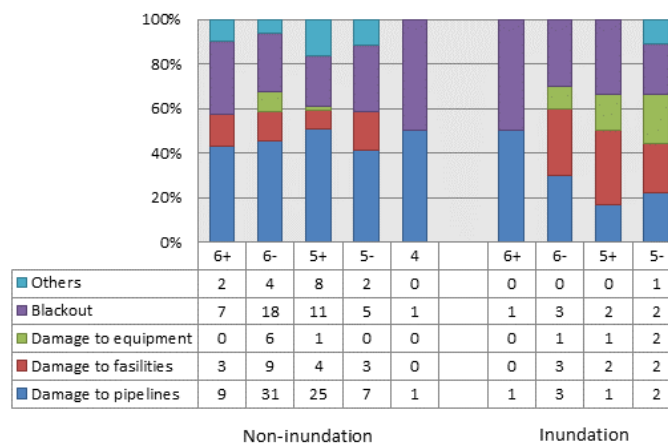
Fig.2 - Causes of water stoppage in relation to JMA seismic intensity

Fig. 2 indicates causes of water stoppage in relation to JMA seismic intensity in multiple answers. Damage to pipelines and blackout were the main reasons in more than 70% of the non-inundated waterworks bureaus. On the other hand, the damage to pipelines was the main reason in less than 30% of the inundated waterworks bureaus except of 6+ of seismic intensity. This means that most of the damages to pipelines have been left unrepaired and the damages to pipelines in inundated areas were not clarified. Percentage of damage to facilities and equipment of inundated waterworks bureaus is twice of that of the non-inundated waterworks bureaus. These damages seem to affect the duration of water stoppage crucially.

- (1) Percentage of damage to facilities and equipment of inundated waterworks bureaus is twice of that of the non-inundated waterworks bureaus as a cause of water stoppage. These damages seem to affect the duration of water stoppage crucially.

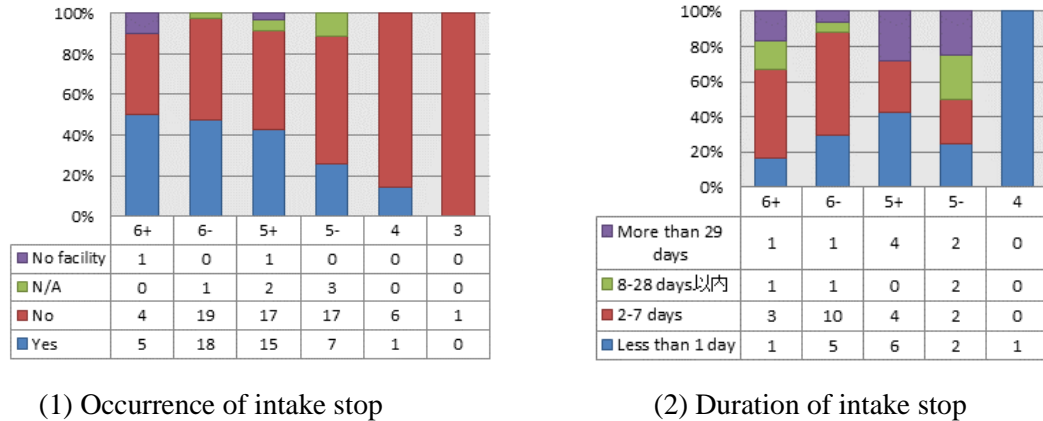
Fig. 3 - Occurrence of intake stop and its duration in relation to seismic intensity

Fig. 3 shows number of waterworks bureaus caused intake stop and its duration after the earthquake in relation to JMA seismic intensity. Most of waterworks bureaus reopened intake in less than one week in spite of seismic intensity. The number of waterworks bureau that suffered intake stop of more than one week does not depend on the seismic intensity. This means that long intake stop was caused not only by strong ground motion but also by another cause.

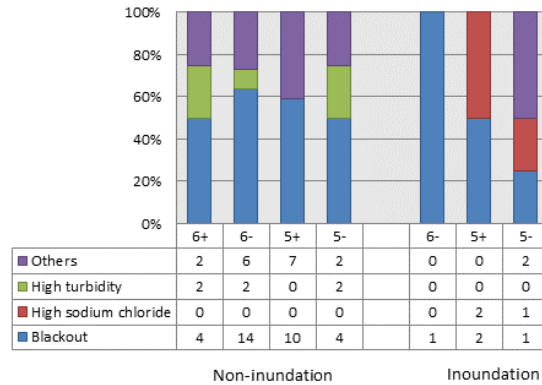
Fig. 4 - Causes of intake stop in relation to seismic intensity

Fig. 4 indicates causes of intake stop in relation to seismic intensity in multiple answers. Blackout was the main reason in more than 50% of in the inundated and non-inundated waterworks bureaus except of 5- of the seismic intensity. High sodium chloride by tsunami is listed as a reason in inundated waterworks bureaus and high sodium chloride was observed not in river but in the water of shallow well. On the other hand, high turbidity is listed as a reason in non-inundated waterworks bureaus. It seems that landslide of a slope at upper stream of intake facility seems to be affected to the high turbidity.

- (3) Blackout was the main reason in more than 50% of in the inundated and non-inundated waterworks bureaus except of 5- of the seismic intensity. High sodium chloride by tsunami is listed as a reason in inundated waterworks bureaus. On the other hand, high turbidity is listed as a reason in induced in non-inundated waterworks bureaus.

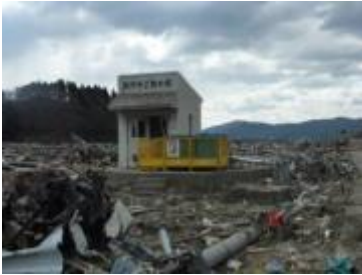
Causes of damage by a tsunami are roughly classified into three categories: inundation, washing away and scouring of surface ground. Some intake facilities were inundated and had not functioned for a long time because of high concentration of sodium chloride in groundwater (Photo 1). Photo 2 shows damage to a water pipe bridge, which was completely washed away. It is unknown yet which caused this kind of damage, water pressure,

Photo 1 - Inundated intake facilities
(Sukedukuri No.2)

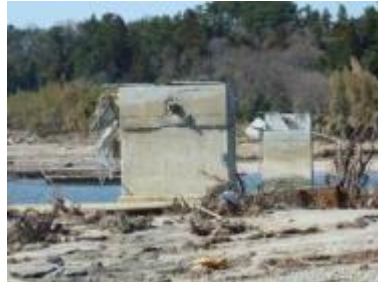
Photo 2 - Washed-away water pipe bridge

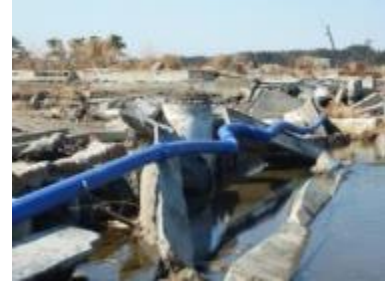
floating wreckage or both. We should study the force acted on the water pipe bridge during the tsunami through a damage analysis. Photo 3 shows damage to buried pipeline. The pipe appeared as the covered soil had been scoured by the tsunami. The mechanism of damage to the pipe, that is, how much force was acted on the pipe in what way, is still unknown, waiting to be clarified in future.

Photo 3 - Damage to pipe by tsunami-induced scouring

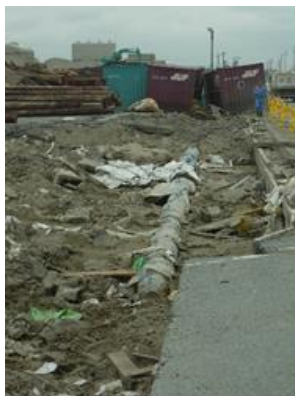
The earthquake resistant joint ductile iron pipes (ERDIP) did not suffer damage at all in the 2011 Tohoku Earthquake. A field survey was conducted on surviving ERDIP buried in the tsunami-hit area at Ishinomaki City in Tohoku region. Photo 4 shows an ERDIP appeared above ground surface by scouring caused by the tsunami. The exposed pipelines were covered by debris of crushed wooden houses and a steel container as shown in Photo 5. This pipeline is ERDIP with NS joint with 300 mm of nominal diameter, installed in 2010. Deformation of pipeline, displacement and bending angle at each joint were measured for fourteen pipes as shown in Fig. 5 [1].

Photo 4 - ERDI exposed above ground

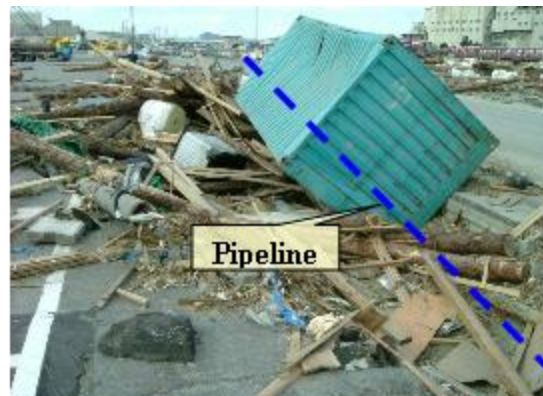
Photo 5 - ERDIP covered by debris

- (4) A field survey was conducted on surviving ERDIP buried in the tsunami-hit area at Ishinomaki City in Tohoku region. The pipeline exposed above ground by the scouring, hit by a steel container and debris in undertow of the tsunami, and moved to the coastline. There was, however, no damage to ERDIP and water suspension did not occur.

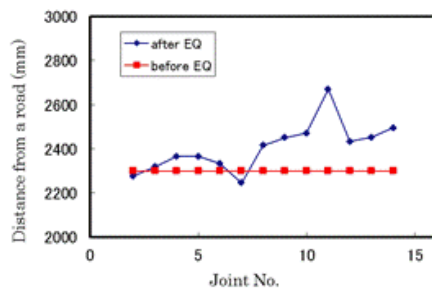
Fig. 6 - Distance of the pipeline
from a road edge before and
after the earthquake

Fig. 6 illustrates a horizontal distance to a pipeline from the edge of a road before and after the earthquake. Because the road was not dislocated horizontally or deformed by the earthquake and tsunami, this figure indicates that the pipeline moved about 40 cm. Fig. 7 shows bending angles at joints measured at the field. The maximum bending angle is 7.5 degrees at the joint No. 11. It seems that the pipeline appeared above ground by the scouring, hit by a steel container and debris in undertow of the tsunami, and moved to the coastline. There was, however, no damage to ERDIP and water suspension did not occur.

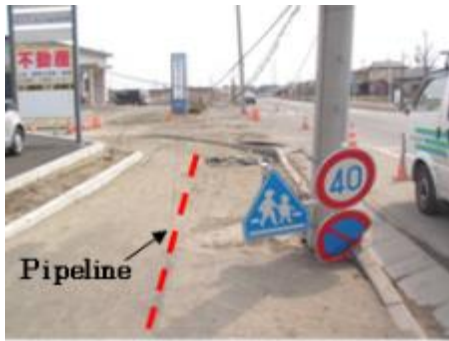
Performance of surviving ERDIP buried in tsunami-hit area at the eastside of Sendai City was surveyed, where liquefaction also occurred. This area was about 2m flooded by the tsunami after the earthquake. Road was undulated, utility pole and traffic sign subsided about 1m by liquefaction as shown in Photo 6. Measured pipeline is ERDIP with SII type joint in the nominal diameter 300 mm. The behavior of the pipes of about 80m intervals was measured by TV camera inserted in the pipelines [1].

Photo 6 - Subsidence of utility pole induced by liquefaction in Sendai City

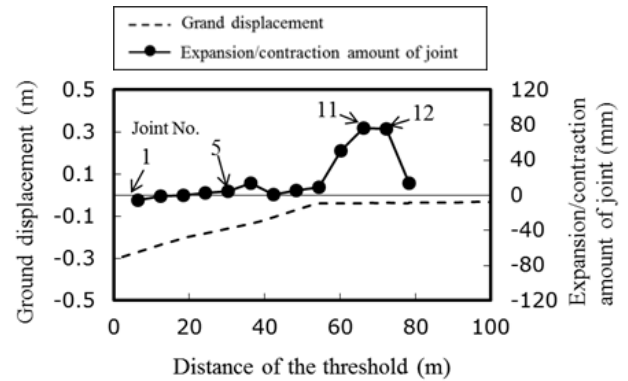
Fig. 8 - Expansion/contraction amount of joints and vertical displacement of ground surface

Settlement of the ground surface of the surveying site occurred about 0.3m in a section of about 50m from the threshold by the earthquake as shown in Fig. 8. The pipelines followed the ground displacement. Two consecutive joints near 70m point had been fully expanded nearly. The sum of amount of expansion and contraction of each joint is 240 mm; amount of expansion was equivalent to 0.3% of the pipe length. This amount was small enough compared with the capacity of 1 percent, expansion amount of the pipeline.

The measured pipelines could absorb ground displacement by expansion / contraction performance to allowance limit of some joints. Moreover, the behavior of joints has locally concentrated. It is considered that the ground strain was also concentrated locally because of ground uniformity. In such places, the pipelines had absorbed the large ground strain by expanding the adjacent joints, even if a joint expanded up to allowance limit. In other words, the effectiveness of the chain structure pipeline absorbed ground deformation has been demonstrated.

- (5) The earthquake resistant ductile iron pipe had absorbed the large ground strain by expanding the adjacent joints in liquefaction area in Sendai City.
