## THE COLLAPSE OF NEW RC BUILDINGS DURING THE MARCH 4, 1977 VRANCEA EARTHQUAKE

I. Vlad <sup>(1)</sup>

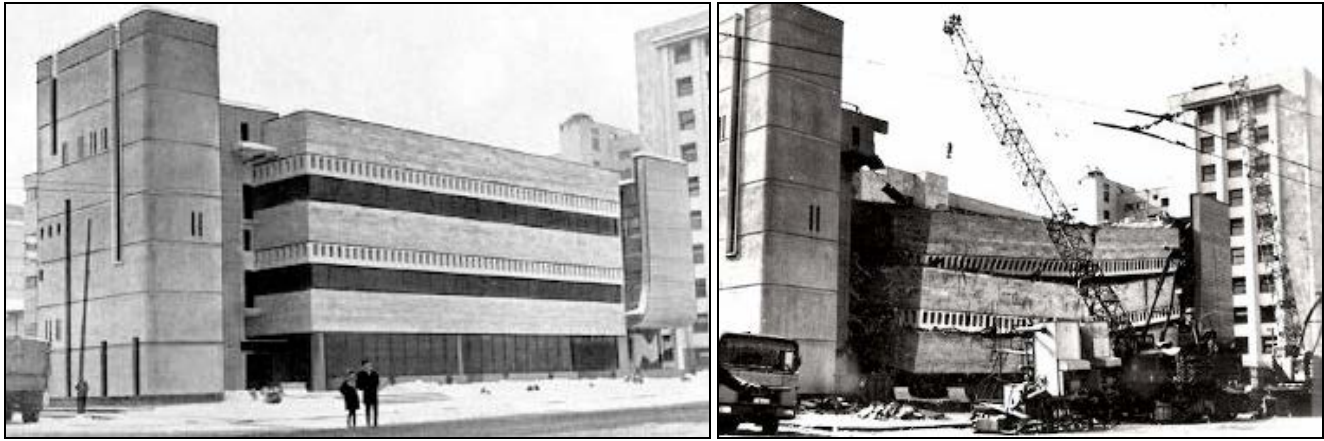
two levels ( $H = 5$  m). Since the collapse occurred only at the technological central body, the other two lateral bodies being practically undamaged, in what follows we will refer exclusively to the affected one (Fig.1).

Fig. 1 – The “Computing Center” building before and after the March 4, 1977 earthquake (INCERC)

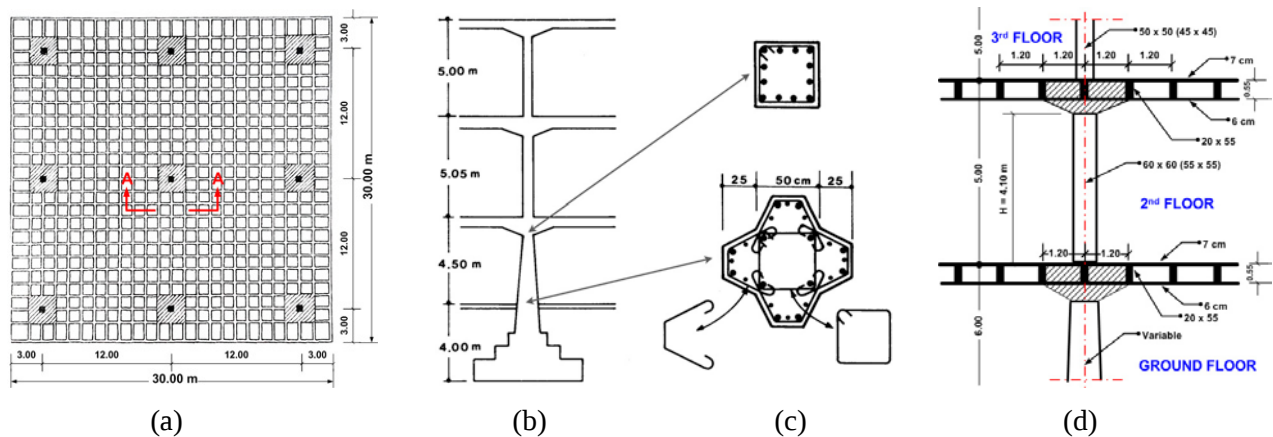
Fig. 2 – Floor structure, sections and typical column reinforcement (adapted from [1] and [4])

As it can be noticed in Fig.2,c, the ground floor columns were reinforced in an unusual manner. A typical ground-story column had 12 Ø25 mm round bars, that have been stopped at short distance from the full heights of the columns, in addition to 12 Ø20 mm round bars that extended from the base up to about 2/3 of its height. 4 of the 12 full-height bars were enclosed in square hoops all the way; the remaining bars were outside the square ties except at the very top of the ground story, and were restrained by hairpin bars serving as auxiliary ties (Ø8 mm round bars). The tie sets were spaced at 15 cm in the bottom 1.25 m of each story and at 20 cm for the rest of the free height [5].

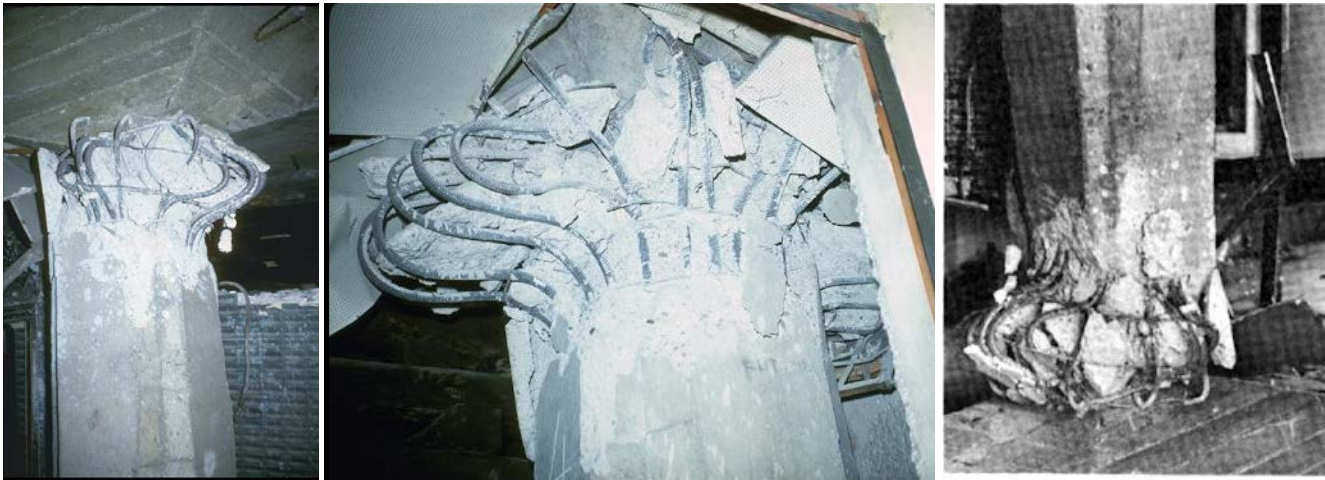
The collapse of the central body of the building occurred by column breaking at its three levels, followed by a gradual collapse of the floor structures. As it was found on site and by studying the available photos, it resulted that the columns of the three stories were broken, in the most cases, at about 50 cm below the capitals. At the ground floor there were columns that were broken at different heights and at the other two stories there were columns broken at their bases. The column breaking was produced by the crushing of the entire concrete section on variable lengths, but there were also present breaks in inclined sections on the direction of the dominant action of the seismic motion. The phenomenon of destruction of concrete in columns was more present at the 2<sup>nd</sup> floor, as a result that the central column was destroyed at its base. In the breaking areas, the longitudinal reinforcement was strongly buckled, went out completely from the sections and was twisted as a result of a torsion phenomenon produced at the floor levels. The column heights were reduced with about 0.5 ...1.0 m, fact that led to the collapse of the floors which didn't break in motion, but were strongly deformed. During their falling they found new bearings, i.e. the broken columns and the exterior reinforced concrete elements (Fig.3).

Fig. 3 – Ground story top and bottom column failures (EERI collection)

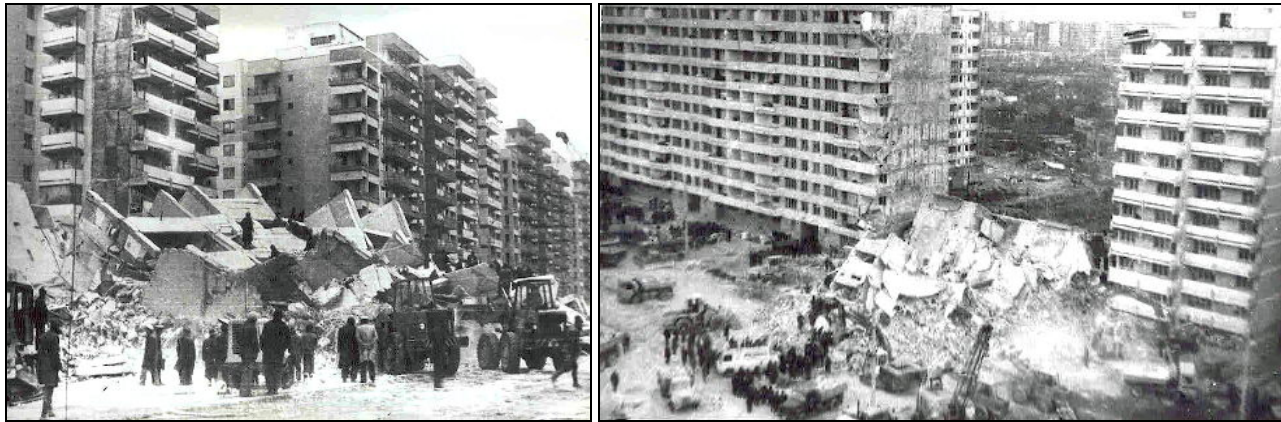
During the March 4, 1977 earthquake, the last section of the block (F) completely collapsed by transversal overturn towards the middle of the boulevard, rotating relatively to the ground floor (Fig.5).

Fig. 5 – Images of the section “F” that collapsed (AGERPRES)

The cause of the collapse was the destruction of the strength capacities of the ground floor RC structural walls which were positioned on the transversal direction of the section to gravity loads. This mode of failure defines the structural collapse form of “*overturning*” type (Fig.6). The phenomenon of “*overturning*” was highlighted by two elements: the first one was the fact that the upper part of the block has reached the middle of the boulevard on the tram rails, and the second one consisted of a proof of rotation recorded on site, by visible traces in the form of circular arcs (scratches) left on the joint separation wall of the “E” section by some existing irregular growths on the unfinished wall of the section “F” that collapsed.

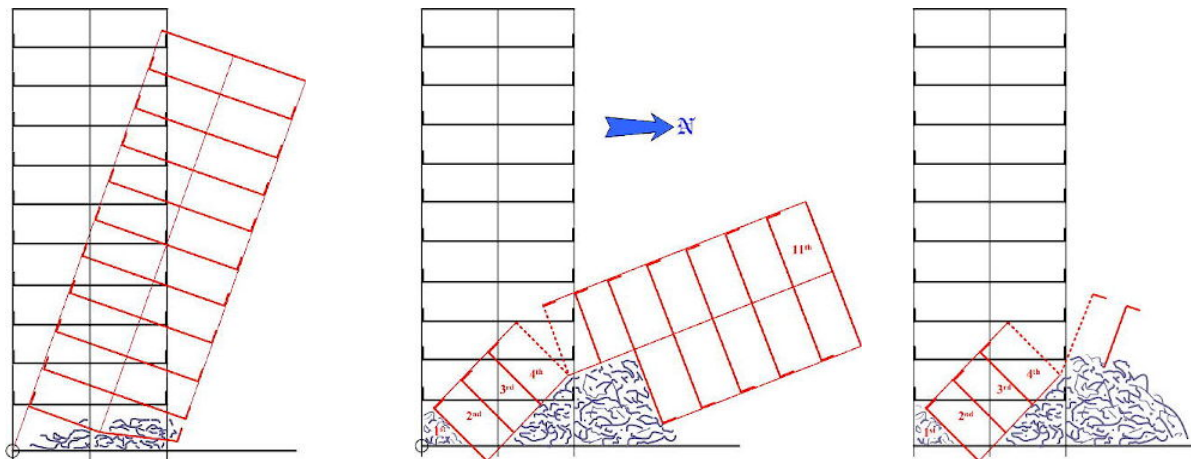
Fig. 6 – The “overturning” collapse mechanism

It can be said that the overturning always occurs under the action of gravity loads. The action of an earthquake on the structural system of a building takes place until its vital structural elements are destroyed. Then, the structural system can no longer sustain gravity loads and collapses. In the case of section “F” of the block OD16, the seismic action caused the destruction of the compressed areas at the basis of the structural walls located at its ground floor and disposed on the transversal direction (a process of complex breaking, generated by the combined action of the interior generalized forces  $M+N+T$ , which caused crashing, shearing and detaching

of the concrete, together with the buckling of the longitudinal steel bars of the reinforcement). Under the action of the large forces of compression due to gravity loads, whose values were increased by the seismic action, begun the destruction of the bulbs of the structural walls. The poor transversal reinforcement of the bulbs led to concrete crashing and, finally, to their destruction.

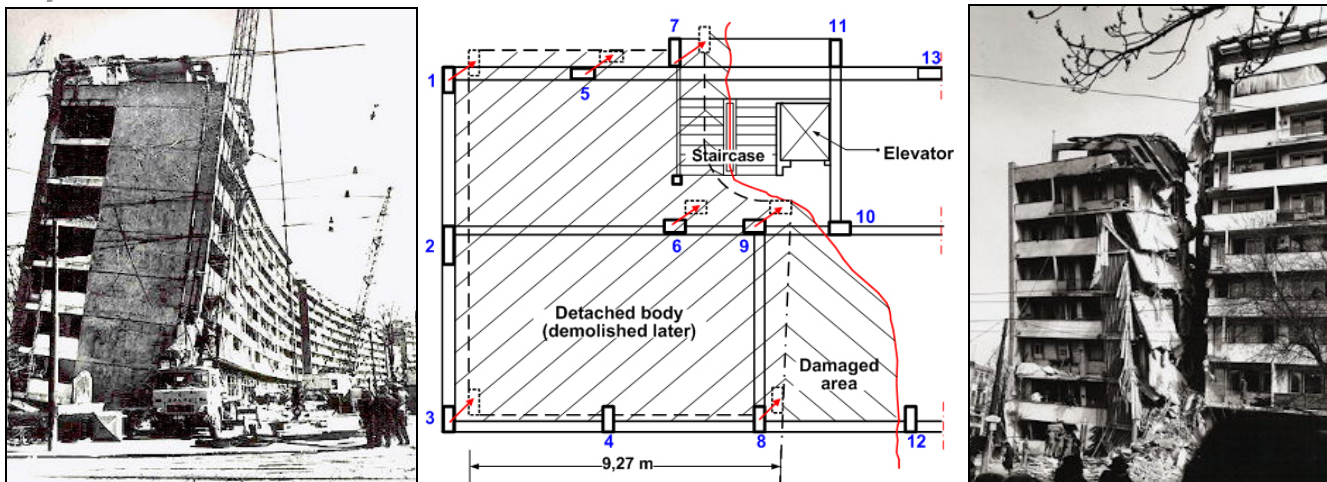
Given the above mentioned aspects, the partial collapse of the section “a” of the “Lizeanu” building could be explained by the failure of some columns at its ground floor where the highest loads were focused. This was caused by a complex mechanism of rupture (bending moment with shear force), phenomenon that was triggered by the low ductility cross-sections of the columns and favored by an insufficient resistance to shear forces.

Following the failure of these columns, other columns were driven in the breaking process, causing the dislocation and the tilting towards South of the destroyed area.

Fig. 8 – The “Lizeanu” building partial collapse photos and the detached body [1]

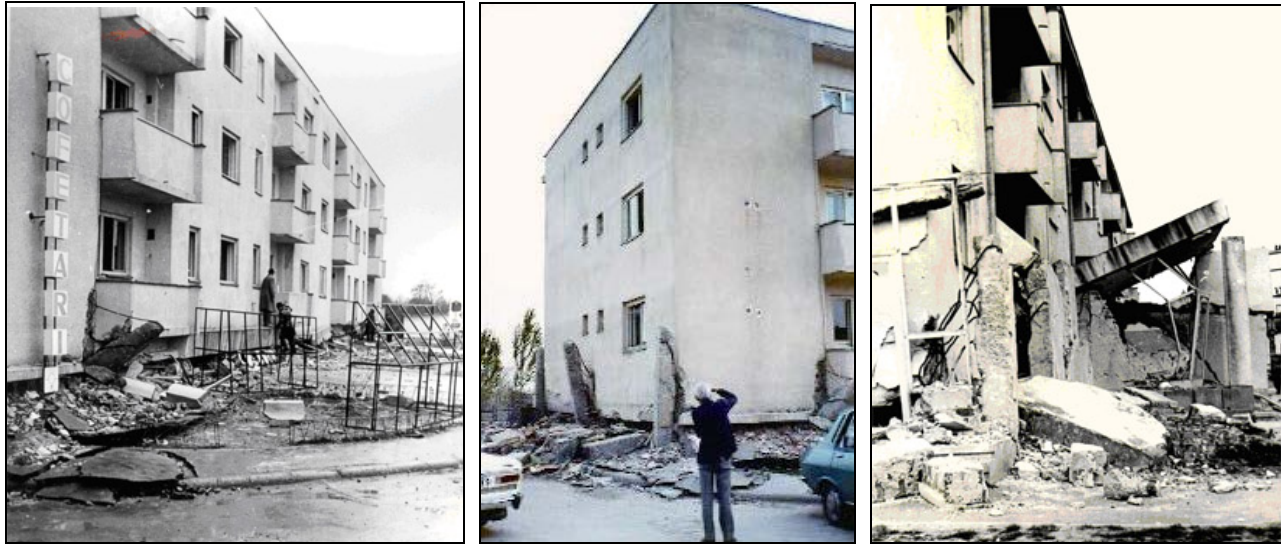
During the seismic motion, the ground floor of the “Valea Călugărească” block completely vanished, the upper three-story ensemble “*vertically fell*” practically without serious damage, and the second floor structure reached the ground (Fig.9).

Fig. 9 – The “Valea Călugărească” building with its “vanished” ground floor (ICCPDC-INCERC and JICA)

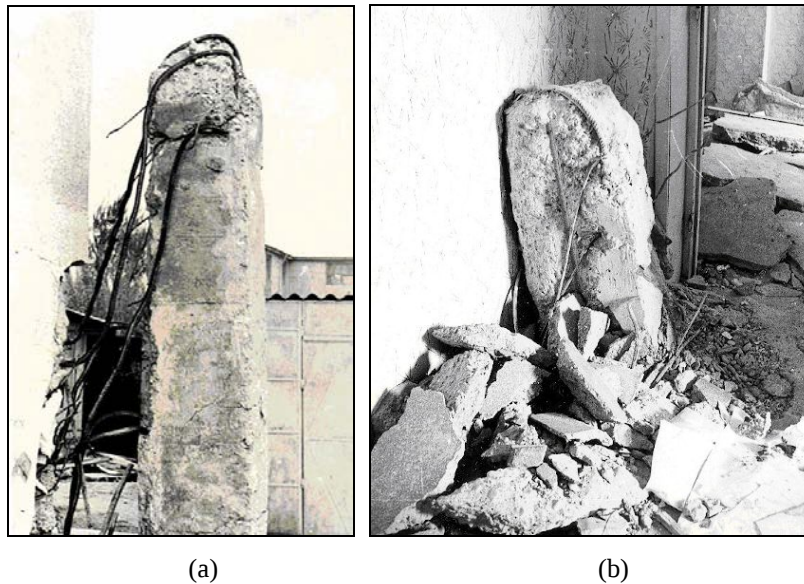
It follows that the plastic hinges of the ground floor columns were subjected to deformations produced by both bending moments and the associated shear forces, thus leading to the exterior columns breakage in inclined sections at their upper extremities. These columns, with their vertical reinforcement pulled apart in the lateral and the stirrups in the damaged area cut through or unfastened, were pushed outwards during the vertical fall of the compact ensemble consisting of the three upper floors. Without the support of the exterior columns, a compression overstress of the interior columns generated by the shock of the vertical falling of the three floors package was reached, having as consequence their total destruction. Some of them penetrated the floor structure above the ground floor, entering in the space of the former second floor (Fig.10).

Fig. 10 – The “Valea Călugărească” building. (a) Rear facade column pushed outwards. (b) Interior column that penetrated the floor structure and reached the 2<sup>nd</sup> floor [ICCPDC-INCERC].
