ASSESSMENT AND RESTORATION OF AN EARTHQUAKE-DAMAGED SPORTS STADIUM IN NEW ZEALAND

The Lancaster Park (formerly AMI) stadium spectator stands in Christchurch, New Zealand were of modern reinforced concrete design and construction, with the two larger stands supported on stone-column foundations. This paper summarises the damage that occurred as a result of the Canterbury earthquake sequence (CES) of 2010-2011 and the engineering assessments that were carried out. The Canterbury earthquake sequence included several strong and damaging ground motions, with the most severe shaking being from the 22 February 2011 magnitude M_w 6.3 event at an epicentral distance of only 6km from the stadium. That event resulted in peak ground accelerations at the stadium site of approximately 0.5g horizontally and 0.75g vertically. Damage to the stands included bulging, loosening and contamination of the stone column foundations, global and differential settlement of the structures, and structural damage including extensive cracking of concrete, yielding and strain damage (and in some cases fracture) of reinforcement. Engineering assessments included mapping of observed damage, material testing and ana

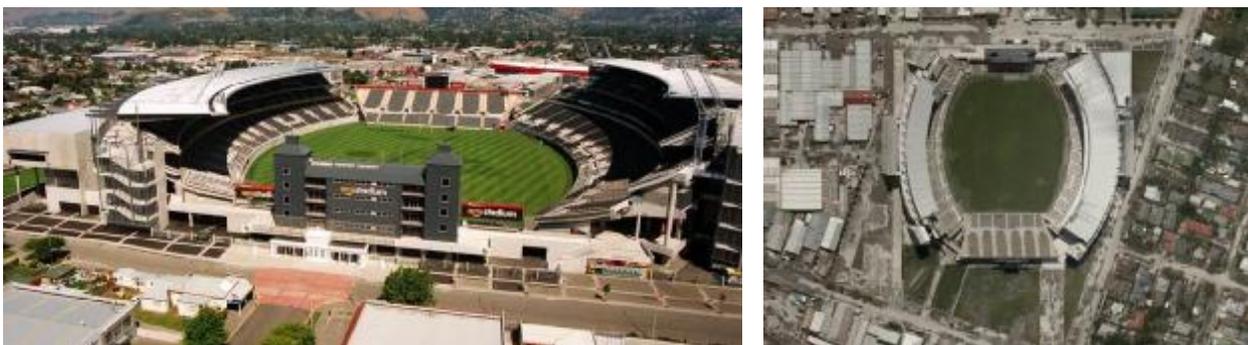
Fig. 1 – Lancaster Park Stadium prior to earthquakes looking south (left), and post-earthquake aerial taken 24 February 2011 (right - from Koordinates.com)

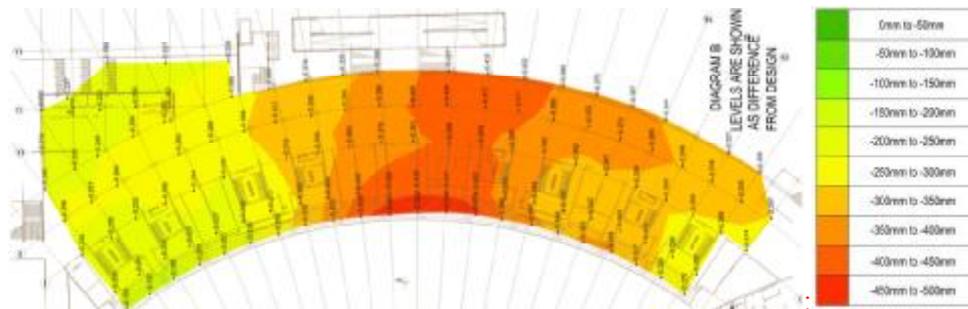
Ground level changes and building settlements were measured by level surveys and by reference to LiDAR data from before and after the earthquakes. Total settlement of between 200 and 600mm was recorded at the four stands following the February 2011 earthquake. Marked differential settlement was apparent between elements of structures on different foundation types, and across the structures themselves. The Paul Kelly Stand tilted away from the playing field fairly uniformly by around 100mm at roof level. The main body of the Deans Stand settled by between 200 and 500mm (refer Fig.3), with each end tilting backwards by around 100mm and the central portion settled approximately 300mm relative to the ends and

tilted towards the field by 150mm. It is unclear whether these settlements occurred during or after earthquake shaking. Examples of surface expressions of ground damage are shown in the photographs in Fig. 4.

Fig. 3 – Deans Stand surveyed settlement contours

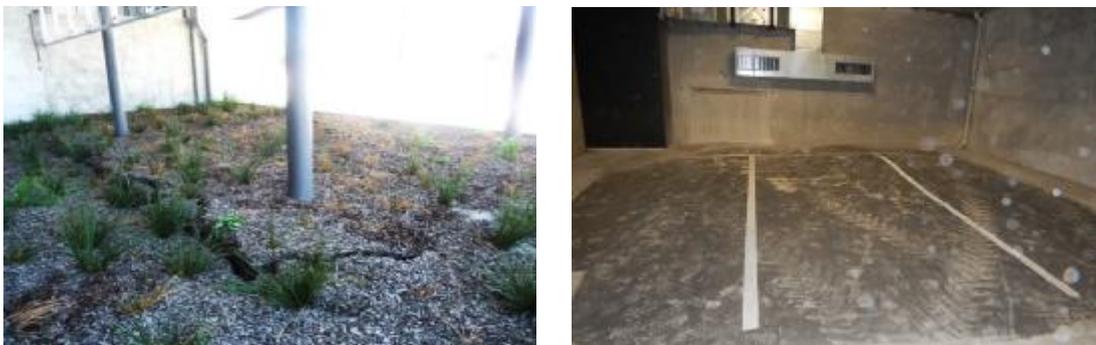
The area around the stadium experienced considerable liquefaction due to the 22 February 2011 earthquake. Large amounts of ejected sand (sand boils) were observed, together with differential settlement of commercial and residential buildings and uneven land surfaces. The extent of surface expressions of liquefaction within the confines of the stadium was generally less than for the surrounding area.

Fig. 4 – Settlement and liquefaction damage – ground surface disruption (left) and pavement bulging (right)

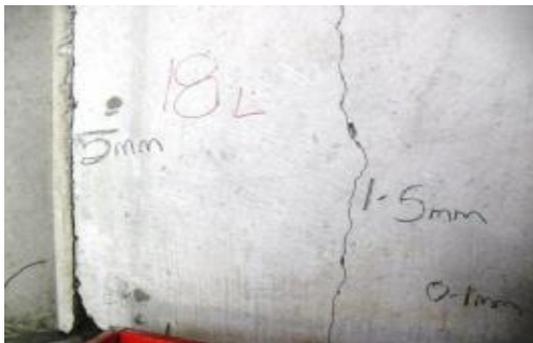
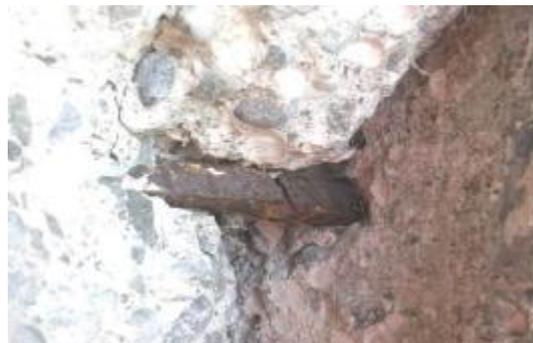
- Global and differential settlement across the stands and their associated structures as described in 4.1.
- Damage to the primary longitudinal load resisting structure in each of the stands included cracking and spalling in shear walls, beams and columns, and, in the Paul Kelly Stand, fractured and buckled beam reinforcement (refer Fig. 5). As expected from the design engineer’s reports, the longitudinal moment frame damage was typically concentrated at the ends of the beams, in intended plastic hinge zones.

Fig. 5 – Paul Kelly Stand longitudinal frame cracking (left), and fractured reinforcement (right)

- Re-levelling of parts of the building to bring them within acceptable functional tolerances.
- Replacement of structural elements with extensive cracking or strain damage to steel. This would likely include; the longitudinal frame of the Paul Kelly stand, localised areas of floor slab and shear walls in both stands, some foundation and secondary structure elements.

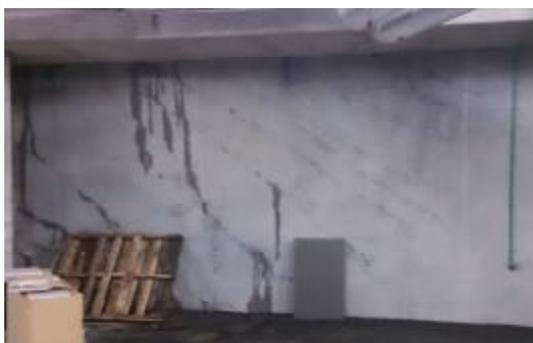
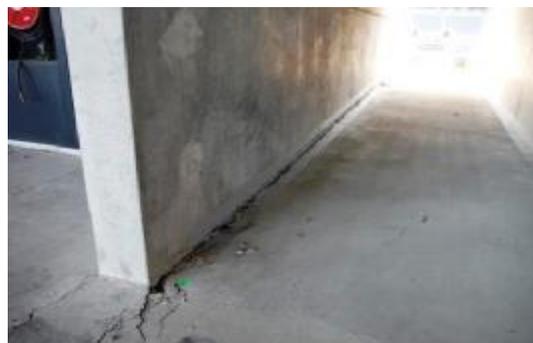
- Other damaged elements of the superstructures included; foundation beams and slab on grade structure, suspended floor slabs, secondary structure such as lift shafts, vomitories, precast panel elements - typically concrete cracking, localised areas of spalling and residual distortion. In the Deans Stand a severe tearing failure occurred over a length of approximately 10m between the Level 1 floor and its supporting radial wall structure near the middle of the stand, refer Fig. 6.

Fig. 6 – Deans Stand shear wall cracking (left) and failure of slab support (right)

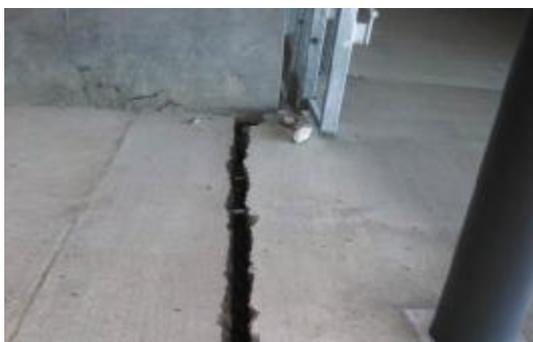
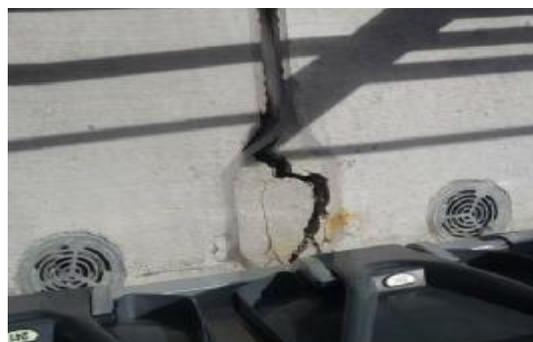
- The adjoining ramp halls were both left visibly distorted and tilted, with significant residual displacements/movements at seismic joint locations. The Paul Kelly ramp hall suffered damage to connections to the main structure including failure of link bridge connection pins, bolts and steel bracing. Connections between the Deans Stand and its ramp hall also failed; at Level 1 the concourse slab connecting the main stand and ramp hall fractured/failed (refer Fig. 7) and at Level 3 the bracing connections to the main stand floor slab/diaphragm also failed.

Fig. 7 – Deans Stand fracture of slab (~100mm horizontal separation) between stand and ramp hall (left), movement between adjacent bleacher units (right)

- Rebuilding of both access ramp halls, two of the access stair towers and various other structures.
- Rebuild of the demolished Hadlee stand.
- Replacement of drainage infrastructure and other underground utilities.

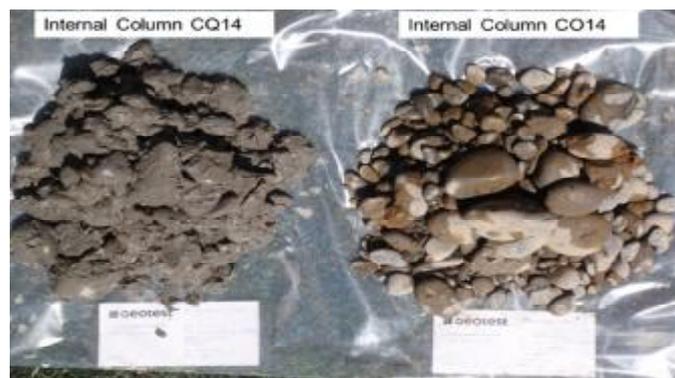
- The stone columns were contaminated with fine silty sand as liquefaction ejecta flowed in to and upwards through them during and following earthquake shaking (refer Fig. 8). It was estimated that this has reduced their drainage performance by approximately 50%, and they were left less able to relieve excess pore water pressure build-up (the precursor of liquefaction) in future earthquake shaking.

Fig. 8 – Stone column material samples: with liquefaction contamination (left) and clean (right)

- Construction of alternative ground improvement such as contiguous grout columns installed around the perimeter and in a cellular pattern under the stands.

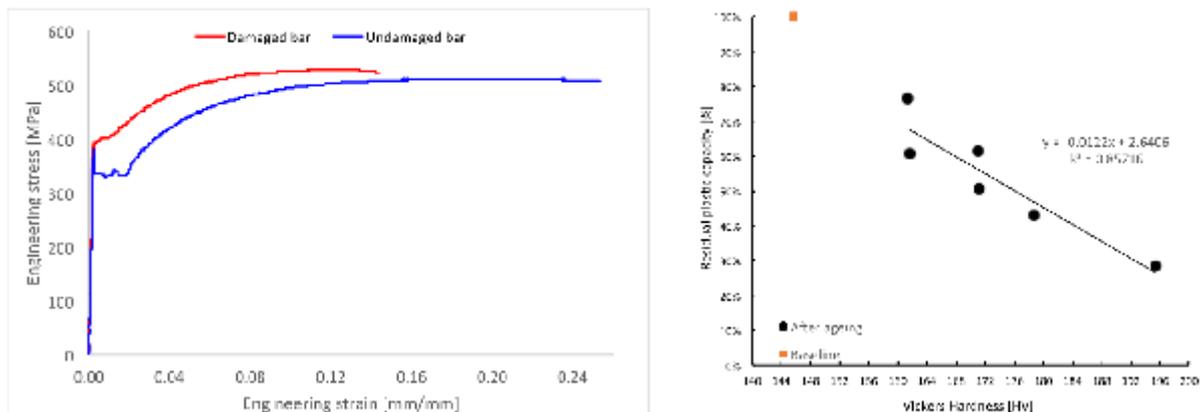
Professor Milo Kral from the University of Canterbury tested reinforcing from the stands using his laboratory Vickers hardness testing methodology [3] to quantify plastic strain damage to reinforcing bars including the effects of strain ageing. Fig. 9 shows the stress-strain behaviour of undamaged (blue) and earthquake damaged (red) bars and the correlation of residual strain capacity to measured Vickers hardness for Grade 300 reinforcing steel from the Deans Stand. Testing for the stadium also included physical tensile testing to failure of damaged and undamaged steel samples to compare actual (tested) residual strain capacity against predictions based on hardness measurements. The testing methodology and application to Lancaster Park structures is possibly a world first in quantifying damage to reinforcing steel in earthquake damaged buildings. Testing indicated that, in a number of critical locations of both stands, 30-50% of the original strain capacity of reinforcing steel had been lost, leaving significantly reduced residual strain capacity.

Fig. 9 – Stress-strain behaviour for undamaged and earthquake damaged bars (left), and hardness vs residual plastic strain capacity (right) for 25mm diameter Grade 300 bars from Deans Stand

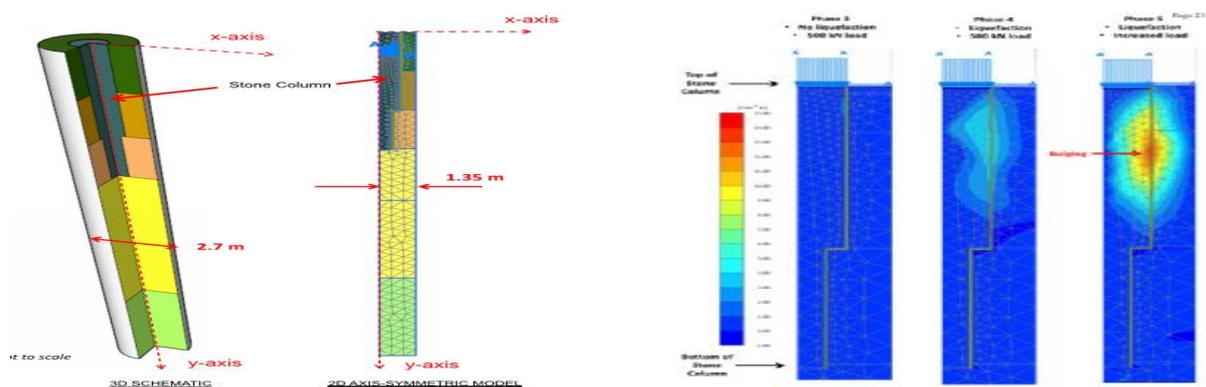
- The reduction in lateral support of the granular stone column material resulting from liquefaction both between and below the stone columns led to significant shearing and bulging of the columns, and loss of ability to support vertical structural loads.

- The infiltration of finer grained sand and silt particles into the stone columns, along with the loosening of the gravels due to shearing and bulging, led to reduced stiffness and strength of the granular stone column material.

- The degraded post-earthquake strength and stiffness left the stone columns with adequate capacity to support the applied load (from the ground beam) under non-liquefied conditions, consistent with observations that the stadium remained standing.

- Under liquefaction conditions for a future design-level earthquake, the load carrying capacity of a stone column would be reduced to the point where it would be unable to safely support the stadium.

Fig. 10 – Stone Column numerical analysis Plaxis 2012 graphics: axisymmetric finite element model (left) and horizontal bulging displacement contours (right)
