REVISED SEISMIC DESIGN CODE FOR TAILINGS DAMS AND ITS APPLICATION TO EXISTING DAMS IN JAPAN

Abstract

Keywords: Seismic design, Tailings dam, Liquefaction, Great East Japan Earthquake

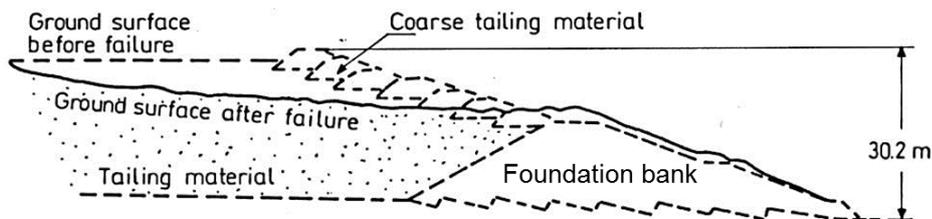
Japan compiled its first code for the construction of reservoirs for waste soils and tailings in 1954 and revised the code in 1973 to include company drainage facilities. Based on the revised code, all licensed tailing dams were inspected from 1974. The 1978 Izuoshima-kinkai Earthquake seriously damaged the Houzukizawa tailings dam due to the liquefaction of tailings materials. Fig. 1 shows a cross section of this dam. About 80,000 m³ of slime and coarse tailings flowed out of the dam and down a river into a bay. After this disaster, Japan started to study the liquefaction strength of tailings. Many cyclic triaxial tests and seismic response analyses were conducted (Ishihara et al., 1981 [1]). Based on the results of these tests and analyses, the code was revised in 1980 to include a consideration of the effect of liquefaction on the relevant structures (Japanese Mining Industry Association, 1980 [2]).

Fig. 1 - Cross section of Hoizukizawa tailings dam, which failed due to liquefaction of tailings materials during the 1978 Izuohshima-kinkai Earthquake

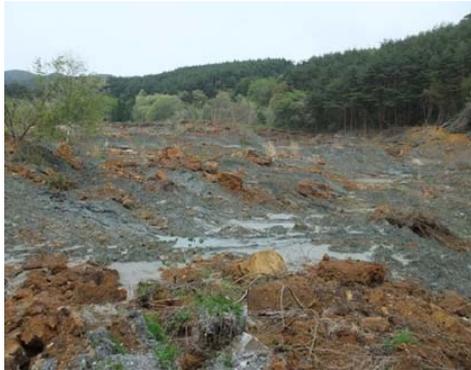
Name of tailings dam		
	Kayakari	Zenigame	Gengorou
Seismic intensity	5+ in JMA scale	5+ in JMA scale	5- in JMA scale
Failure and flow of tailings	Slime above the foundation bank slid, as shown in Fig, 4, and flowed 1 km downstream into houses and fields. A river was contaminated by arsenic.	Tailings in the upper slope of the dam failed, as shown in Fig. 5, and flowed onto a road and into a river. The road was temporarily closed.	Slime above the foundation bank slid and flowed onto a railway and into a river, as shown in Fig. 6. The railway was temporarily closed. A river was contaminated by lead.

Fig. - 4 Failure of the upper slope of the Kayakari tailings dam)

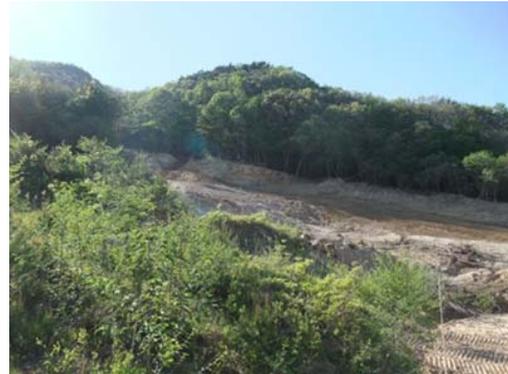
Fig. - 5 Failure of the upper slope of the Zenigame tailings dam

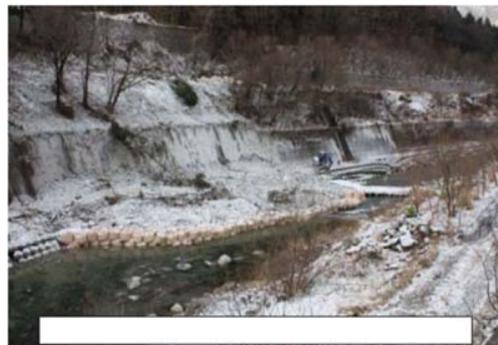
Fig. - 6 Tailings materials from the Gengorou tailings dam flowed into a river (quoted from Technical Committee for Administration of Reservoir of Waste Soils and Tailings, 2012 [3])

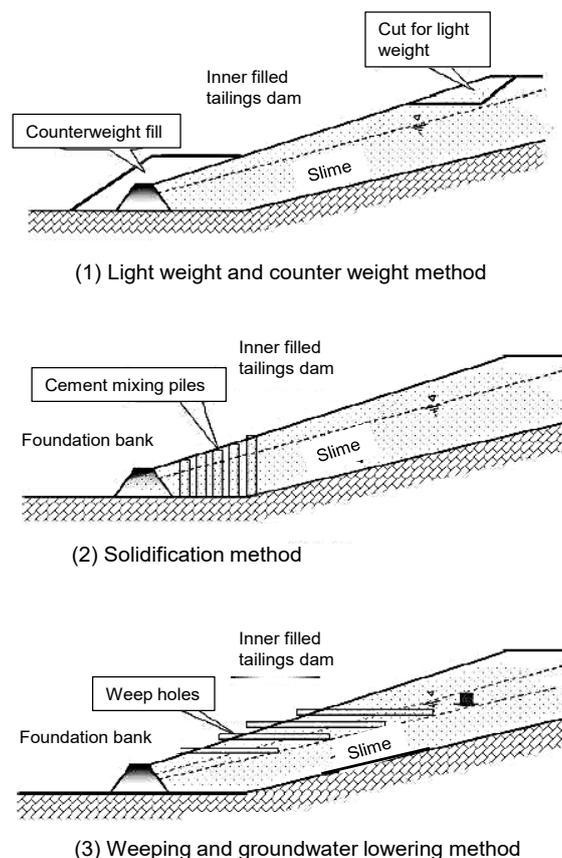
Fig. - 7 Appropriate measures to counter the deformation of tailings dams

This new design concept, a so called performance-based design, is rational. In performance-based design, two items must be decided: the allowable deformation or displacement of embankments, and the relevant method to estimate the deformation. After the Kobe Earthquake, three methods of estimating deformation were developed for water reservoir dams, river dikes, road embankments and railway embankments: empirical methods, static (residual deformation) analyses and dynamic (seismic response) analyses. It was recommended that these new techniques be applied in the inspection of tailings dams deemed susceptible to failure. The allowable deformation of these dams must be judged as unlikely to cause serious damage to structures, such as houses, if the dams were to deform. The recommended measures to counter dam deformation are shown in Fig. 7.

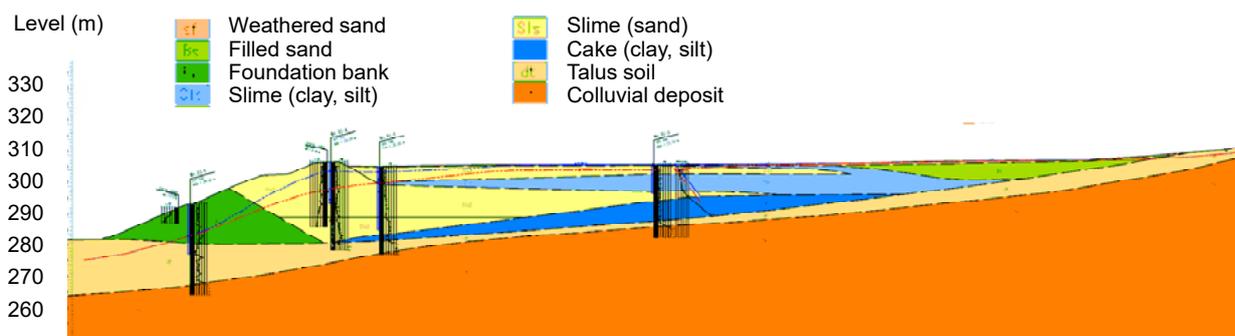
The location of the inspected tailings dam is shown in Fig. 3. The dam was not damaged during the 2011 Great East Japan Earthquake, although it was subjected to a slightly high seismic intensity of 5 in JMA scale. Detailed soil investigations, including borings, standard penetration tests, PS loggings, measurement of the ground water table, undisturbed samplings, triaxial tests, and cyclic triaxial tests, were conducted. The estimated soil cross section at the dam is shown in Fig. 8. The stability of the slope of the dam under Level 1 earthquake motion was analyzed first based on the seismic design code of 1980. The results showed that the safety factor against liquefaction, F_L , was greater than 1.0 and the safety factor against sliding, F_s , was 1.2 under a seismic coefficient of $K_h = 0.15$. Therefore, it was confirmed that this tailings dam was stable according to the current design code. Then, the stability of the slope of the dam under Level 2 earthquake motion was analyzed in the following four steps:

Fig. - 8 Estimated soil cross section at a recently inspected tailings dam

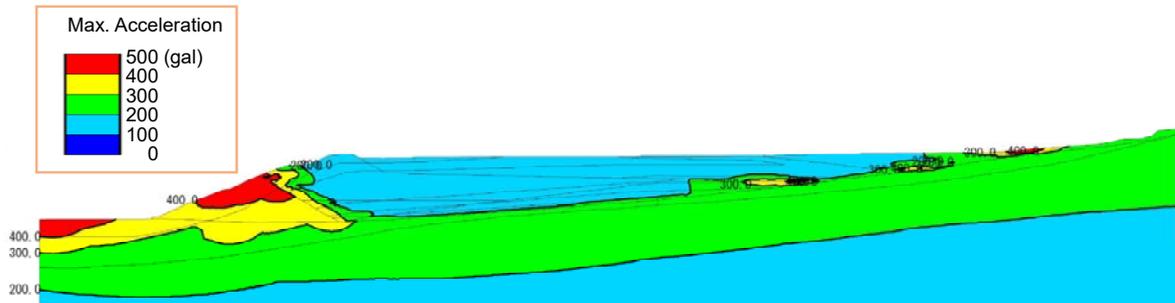
Fig. - 10 Distribution of peak acceleration under seismic wave 1

Fig. 10 shows the distribution of peak acceleration under seismic wave 1. The peak acceleration increased gradually from the bottom of the slope to about 500 gals (cm/s^2) at the surface of slope. Figs 11 and 12 show the distributions of F_L and the excess pore-water pressure ratio, respectively, under seismic wave 1. The shallow parts of tailings slimes in upper zone liquefy and the excess pore-water pressure ratio U_L/σ_v' reaches 1.0. The liquefy zone is almost same under the seismic waves 2 and 3. Figure 13 shows assumed several slip surfaces and sliding displacements along their surfaces under seismic wave 1. The maximum sliding displacement which occurs in upper zone is 16 cm. Figure 14 shows the time history of the input seismic wave 1, the excess pore-water pressure, the safety factor against sliding, F_s , and the sliding displacement along this slip surface. The estimated sliding displacement is not large to cause flow of the liquefied slimes. Therefore it was judged that the tailings dam is stable under Level 2 earthquake motion.

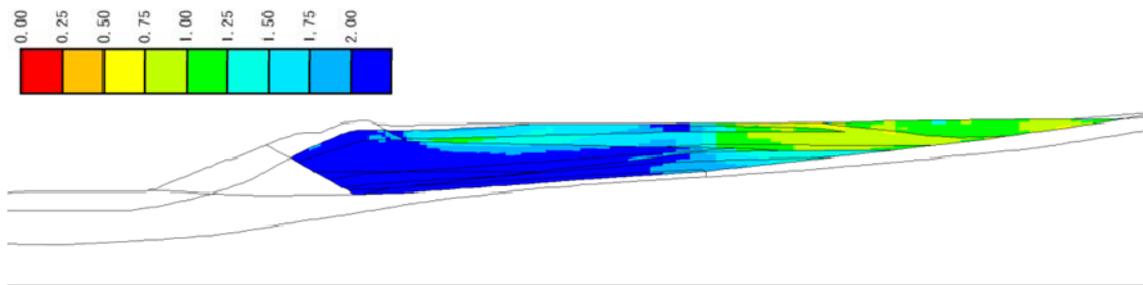
Fig. - 11 Distributions of the minimum F_L under seismic wave 1

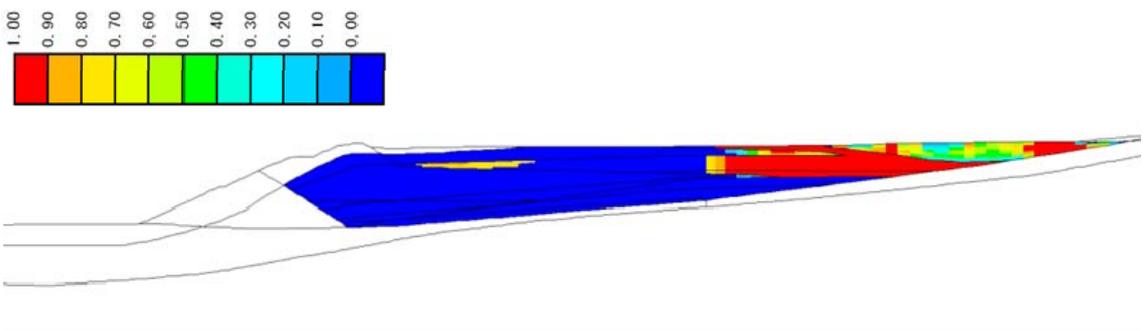
Fig. - 12 Distribution of the maximum excess pore-water pressure ratio under seismic wave 1

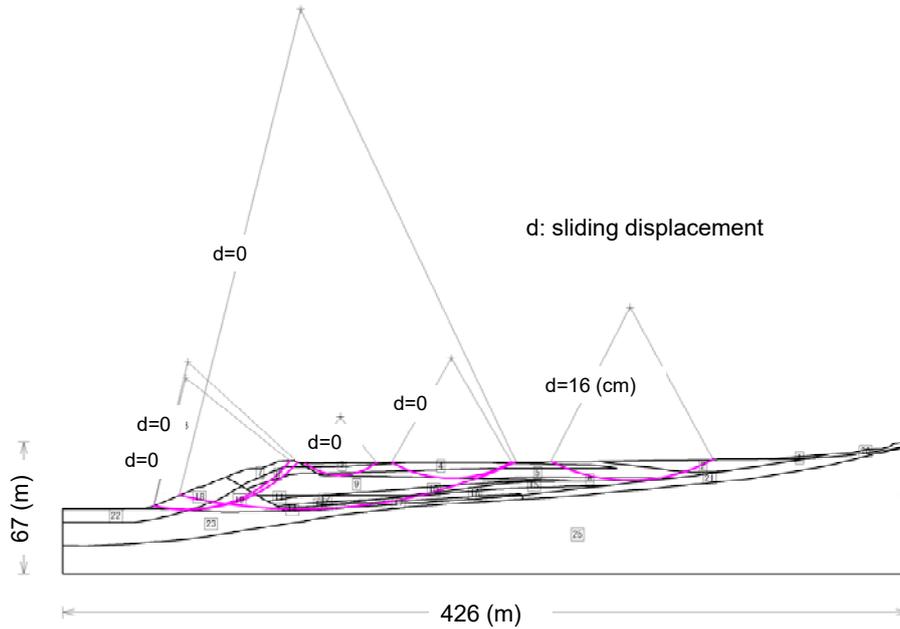
Fig. - 13 Sliding displacements of the input seismic wave No.1

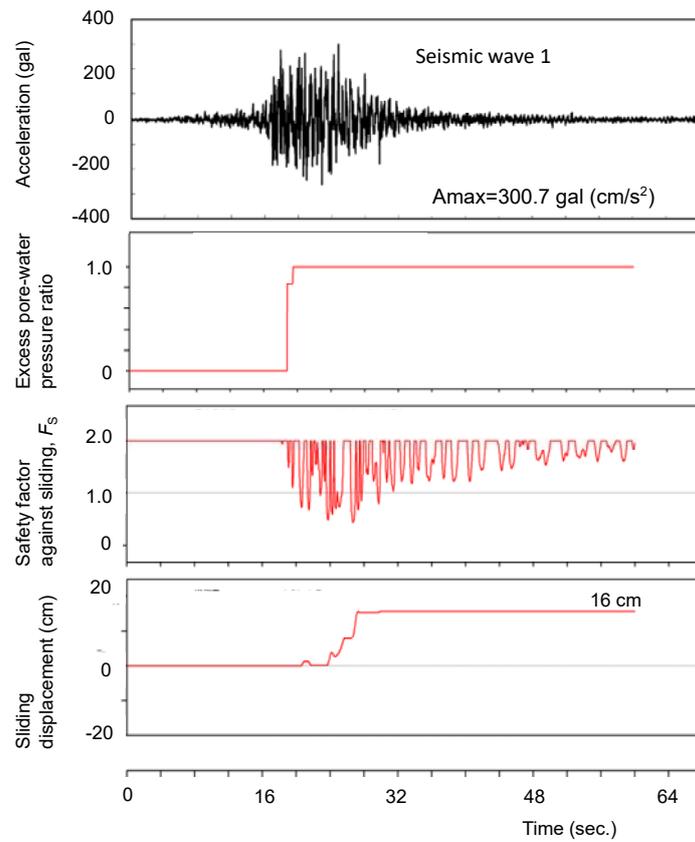
Fig. - 14 Time history of the input seismic wave 1, the excess pore-water pressure ratio, the safety factor against sliding F_s , and the sliding displacement
