A PRACTICAL METHOD FOR STRENGTHENING/REPAIRING POORLY DETAILED RC BEAM-COLUMN JOINTS IN DEVELOPING COUNTRIES: INSTALLING WING WALLS TO EXISTING COLUMNS

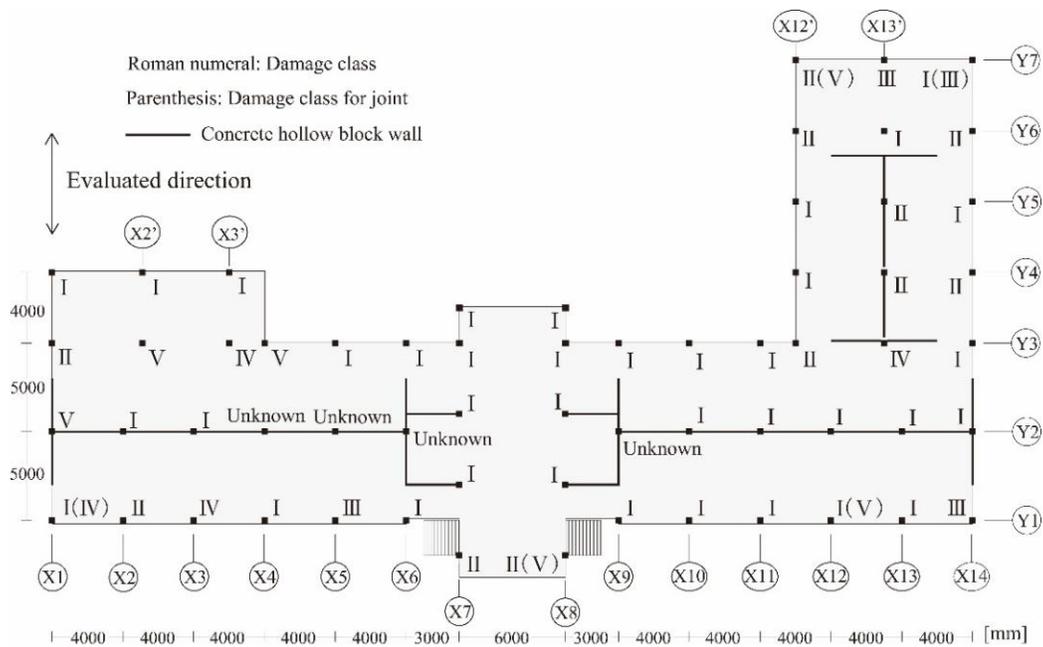
Fig. 4 – First story plan

The damage to columns in the first story was evaluated in the span direction as shown in Fig. 4, according to the Japanese guidelines for post-earthquake damage evaluation [6]. The Roman numerals in the figure indicate damage classes of columns, while those in parentheses indicate the beam-column joint damage classes. For the resultant residual seismic capacities of the building, refer to the authors' past report [7]. The damage indexes in Fig. 4 reveal that severe damage was observed mainly in the beam-column joints in the first story.

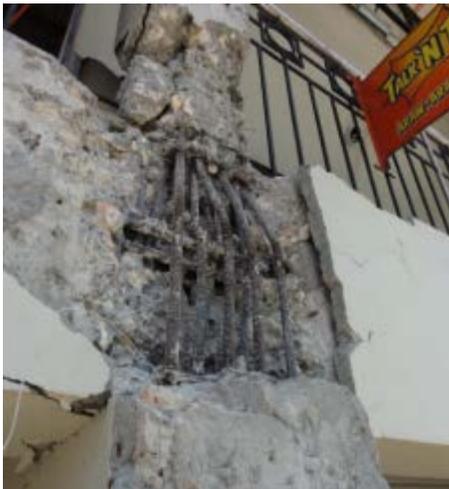
Figure 5 shows typical damage to the beam-column joint at X12-Y1 in Fig. 4, whose structural details are shown in Fig. 6. No hoop was provided in the joint region despite the design requirements of the Philippine building code [8]; hence, severe damage was observed in the core concrete, and the actual frame performance was lower than that expected for the design assuming beam yielding. A lack of hoops in the joint panel is commonly observed in earthquake-damaged RC buildings in developing countries [1 etc.]. Therefore, the following experimental study focused on a partial exterior frame representing the above building to investigate the existing performance and confirm the validity of the retrofitting/repairing method by installing RC wing walls.

Fig. 5 – Beam-column joint at X12-Y1 with Class V damage Fig. 6 – Structural details at the joint in Fig. 5

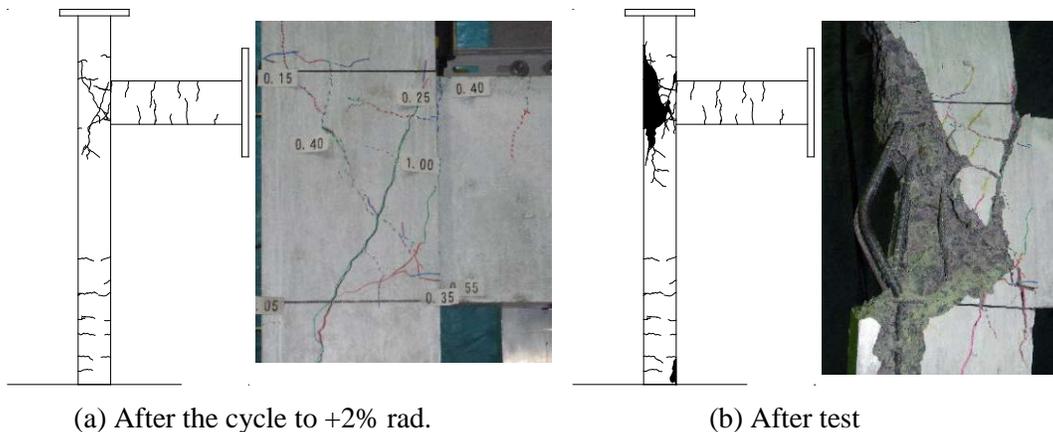
An initial flexural crack was observed at the end of the beam in the first cycle to $R = 0.25\%$ rad., after which flexural cracks appeared at both ends of the first story column and the bottom of the second story column. Diagonal cracks were observed to the joint panel during the cycle to $R = 0.75\%$ rad., which resulted in obvious stiffness reductions. The longitudinal column reinforcements yielded at the bottom of the first story column (C1 and C2 in Fig. 9) during the cycle to $R = 1.5\%$ rad., where a negative maximum strength of -10.8 kN was recorded at the peak drift. At a drift of +2% rad., a positive maximum strength of 9.4 kN was recorded (Fig. 12(a)). Subsequently, obvious strength deteriorations were observed in both loading directions. During the cycle to $R = 6\%$ rad., a substantial amount of concrete on the exterior surface of the column spalled off with buckling of the column longitudinal bars, as shown in Fig. 12(b). Concrete crushing occurred at the bottom of the first story column in the same loading cycle. Story collapse was observed to the second story in the final loading to $R = 8\%$ rad., as shown in Fig. 12(b). Consequently, severe damage was concentrated in the joint panel, which corresponded to the actual damage observed to the earthquake-damaged building, as shown in Fig. 5, while the applied axial load was still supported.

Fig. 12 – Crack patterns and photos focused on the joint for J3

Damage to the benchmark specimen was observed at the joint and the bottom of the first story column, as shown in Fig. 12(b). Joint failure occurred before the beam yielding. Meanwhile, in the case of the retrofitted/repared specimen J3-WI/J3A-WI, the beam (at wing wall end) and the bottom of the first story column with wing wall suffered severe damage, which revealed the beam yielding mechanism. This difference between the mechanisms of the specimens is analytically verified in the following section.
