GEOTECHNICAL OBSERVATIONS FROM THE 2014 IQUIQUE EARTHQUAKE

G. Candia⁽¹⁾, C. Ledezma⁽²⁾, G. Montalva⁽³⁾, K. Rollins⁽⁴⁾

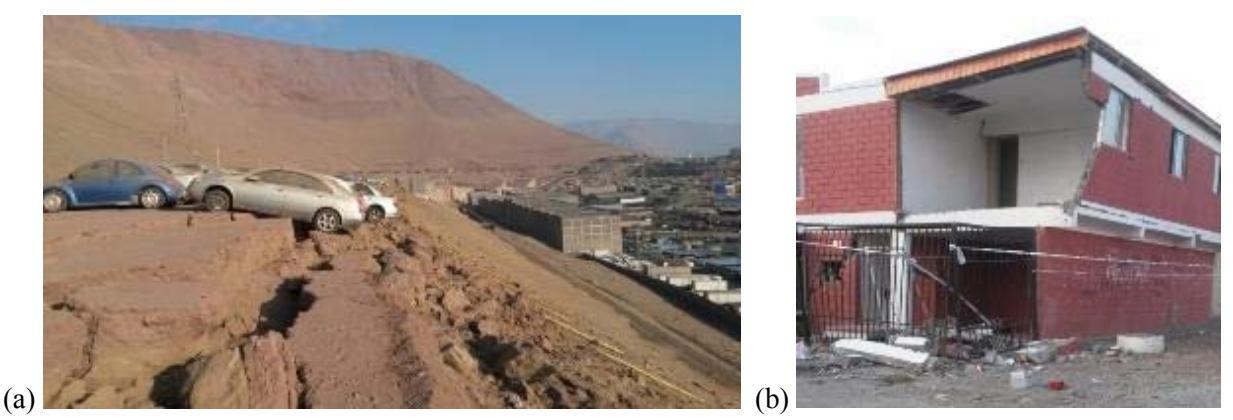
The tax exempt zone of Iquique, known by the acronym ZOFRI, is an industrial zone composed of mainly 3- to 5-stories confined-masonry warehouses. Most of this zone is characterized by a moderate to thick layer of marine deposits. Towards the east, the layer thickness decreases to about 20 m and mixes with eolian deposits. The observed effect of the ground motions in the area include the collapse of roof parapets, moderate to severe non-structural damage, and a landslide, which may have been aggravated by the topographic effects on the escarpment to the east side of ZOFRI. Although no site specific records are available, the measured H/V ratios [8] suggest a significant impedance contrast between the soil layers and the bedrock, which probably led to amplified shaking at the site. The slopes located to the east of ZOFRI have terraces, for vehicles' circulation and parking, built with shallow compaction and no reinforcement. Consequently, the landslides shown in Fig.2(a) were somewhat anticipated. The peak residual deformation was estimated in 1.3 m by adding the cracks openings across straight lines perpendicular to the direction of sliding.

On the other hand, Alto Hospicio is characterized by rigid gravels with a matrix of halite, also known as rock salt [9]. Most of the damage in this area was concentrated in masonry houses of up to 2 stories near the center of the city, Fig.2(b). It is hypothesized that partial dissolution of salts molecules may have opened voids that became unstable during the earthquake, since near the houses several cavities were identified in the surface as well as seismic induced cracks on the pavement.

Fig. 2 (a) landslides in the ZOFRI area, (b) partial collapse of masonry house in Alto Hospicio

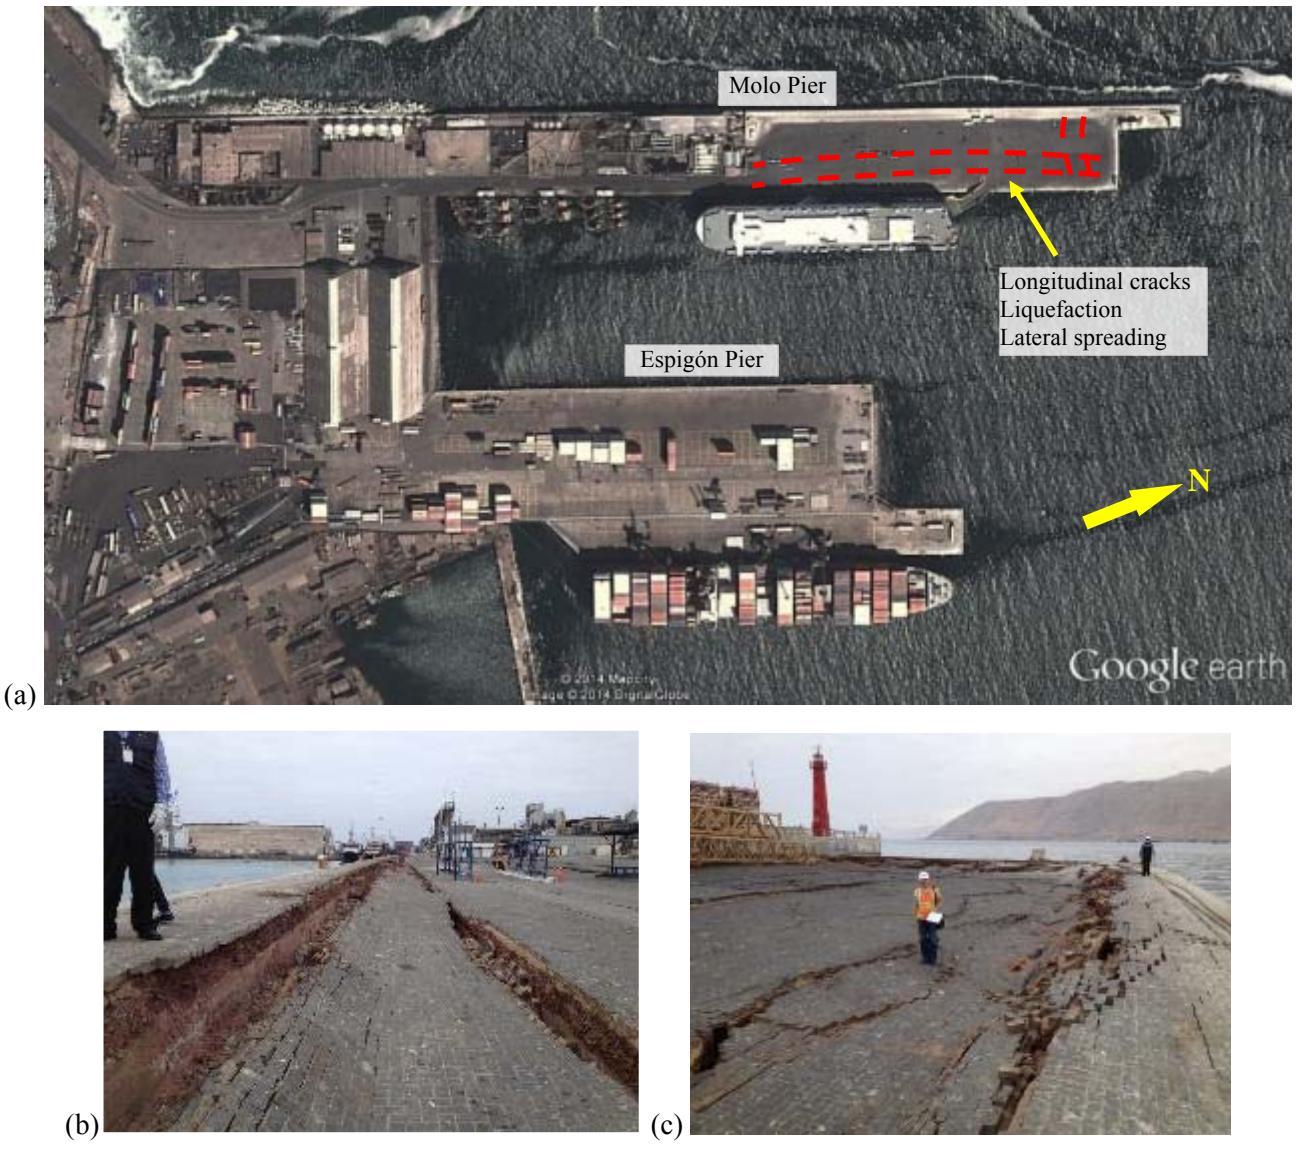
These contrasting subsurface soil conditions and the current state of the infrastructure led to a dissimilar seismic performance. After the earthquake, the Espigón pier was relatively undamaged and there was no apparent evidence of significant lateral spreading or distress to the pier. As a result of the seismic upgrade, the Espigón pier continued in operation following the earthquake. In contrast, differential settlements up to 1.1 m, liquefaction, and lateral spreading were observed in the Molo pier, as shown in the photographs of Fig.3 (b) and (c). Longitudinal cracks developed across the entire length and most of the lateral spread occurred towards the east side of the pier, with a cumulative displacement that varied between 1.0 m and 1.5 m. In addition, lateral spreading developed in

the transverse direction at the far northern end of the pier, creating a complicated cracking pattern on the surface. Observations showed that the lateral displacements increased an additional 0.5 m near the middle section of the pier in the weeks following the earthquake. In June 2014, five cone penetration tests (CPT) soundings were performed in the Molo pier to depths of 8 to 23 m. The CPT logs suggested that the dense sand layers were gravelly sands to sandy gravels, but most of them also revealed the presence of relatively loose liquefiable sand layers.

Fig. 3 (a) Google earth view of the Molo and Espigón piers, Port of Iquique, (b) and (c) photos showing typical settlement of the backfill and lateral spreading on the Molo pier

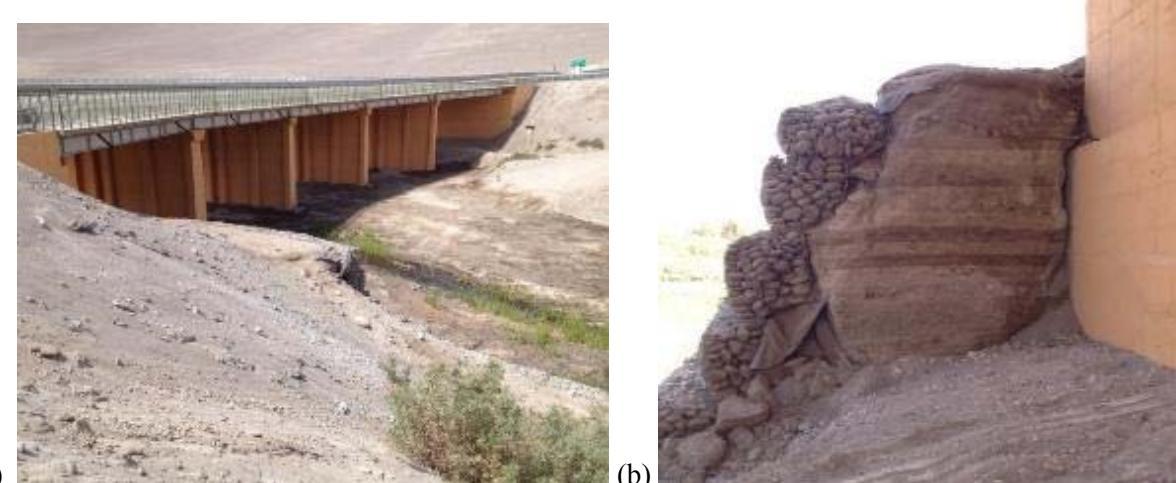
The Tana bridge is a curved steel girder bridge with five spans of about 16 to 18 m in length, supported on piers made of solid concrete walls. The curve is laid out along a 90 m radius and transects an arc of about 50°. Gabion walls were used to stabilize the steep slopes running west from the north abutment, as shown in Fig.4(b). No evidence of lateral or vertical offsets were observed in the bridge deck, nor significant cracks in the support piers or abutments. However, surface cracks developed at the top of the north slope adjacent to the gabion wall. Crack widths suggest a gabion displacement on the order of 30 to 60 mm. Tension cracks were visible at the interface between the bridge abutment and soil mass. Several cracks were also observed running perpendicular to the abutment wall in the slope adjacent to the north abutment.

Fig. 4 (a) View of the bridge from the southwest showing gabion walls against the abutment in the foreground, and (b) tension crack behind gabion wall in the north abutment.

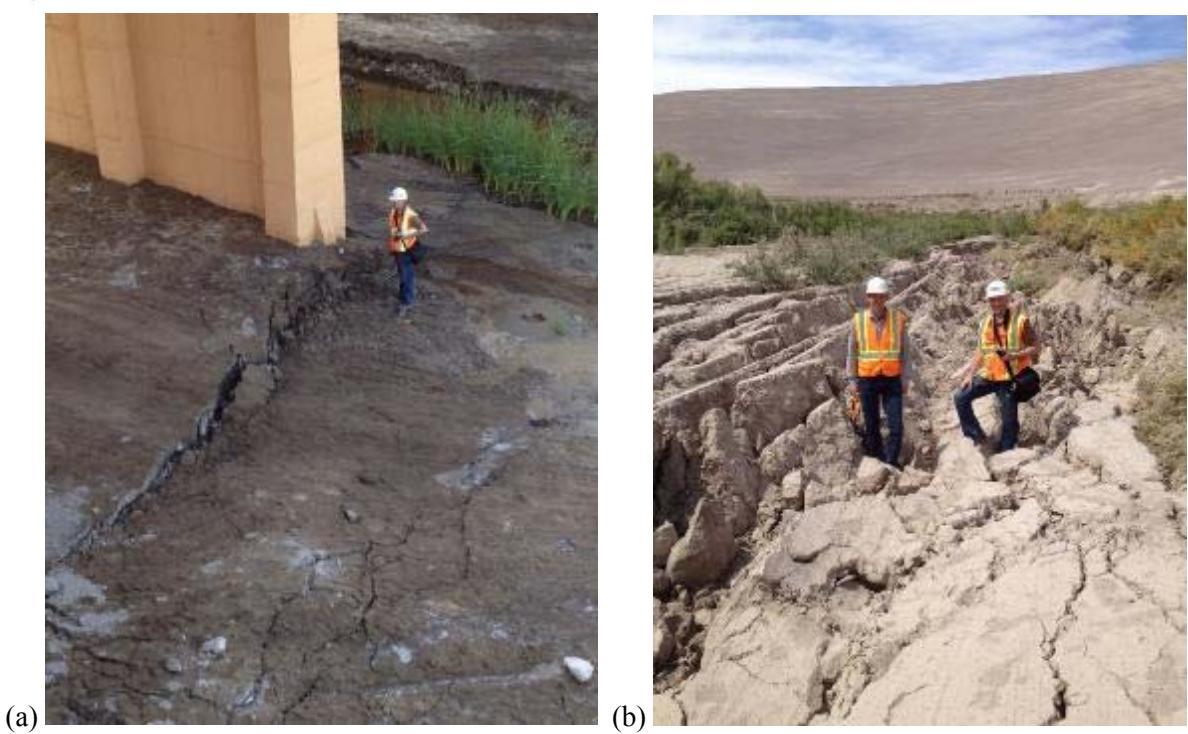
Although there was no evidence of distress to the bridge, a number of liquefaction features were evident in the alluvial soil deposits beneath the bridge. Several sand boils developed just downstream of the first pier south of the north abutment; while the ejecta was primarily sand, it was unclear at that point whether or not the gravel in the profile also liquefied. Liquefaction induced settlement produced an offset of approximately 15 cm adjacent to one of the bridge piers as shown in Fig.5(a). Liquefaction on the north side of the river running southeast from the bridge abutment led to significant lateral spreading along an \sim 80 m strip as shown in Fig.5(b). Although the lateral spread impinged upon the north bridge pier, the ground movement was insufficient to cause distress to the pier.

Fig. 5 (a) Settlement of soil adjacent to bridge pier as a result of liquefaction, (b) lateral spreading running parallel to stream channel flowing under the Tana bridge

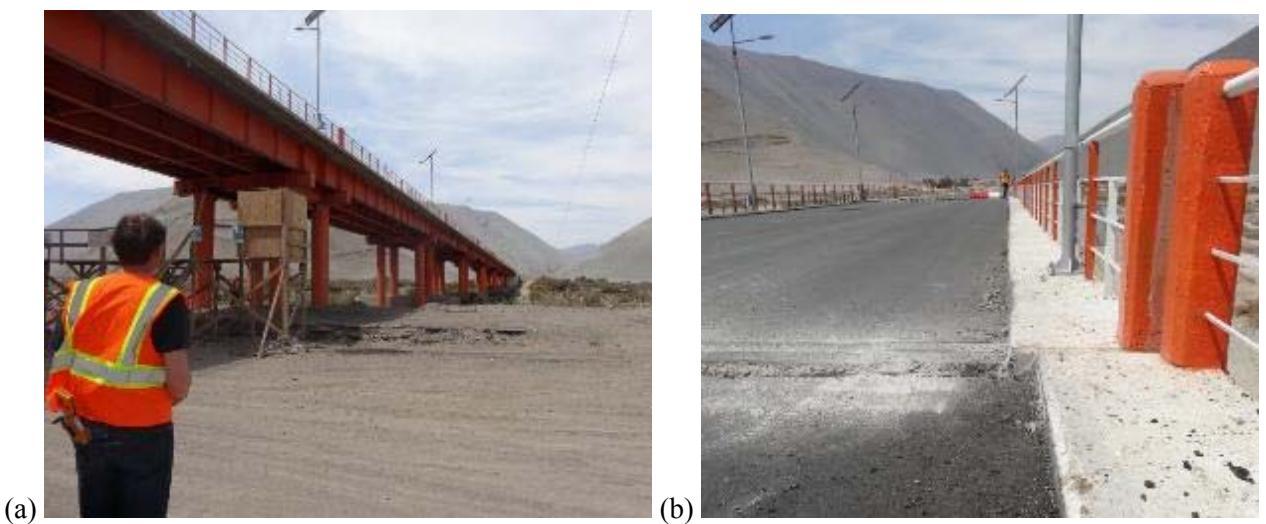
The Camarones bridge is a steel girder bridge consisting of eight spans each about 30 m in length, supported on steel frame portals, as shown in Fig.6(a). At the time of the reconnaissance, the bridge was closed to traffic due to a lateral offset of approximately 10-15 cm between two of the spans as shown in Fig.6(b), preventing a closer inspection of the superstructure. Relatively little evidence of soil liquefaction was observed in the alluvial sediments beneath the bridge; only a sand boil approximately 60 cm in diameter observed within \sim 10 m of the third bent from the northwest abutment. Small settlements of approximately 5-10 cm were evident in the fill surrounding the northwest abutment.

Fig. 6 (a) View of Camarones Bridge from the north end, (b) 10-15 cm lateral offset

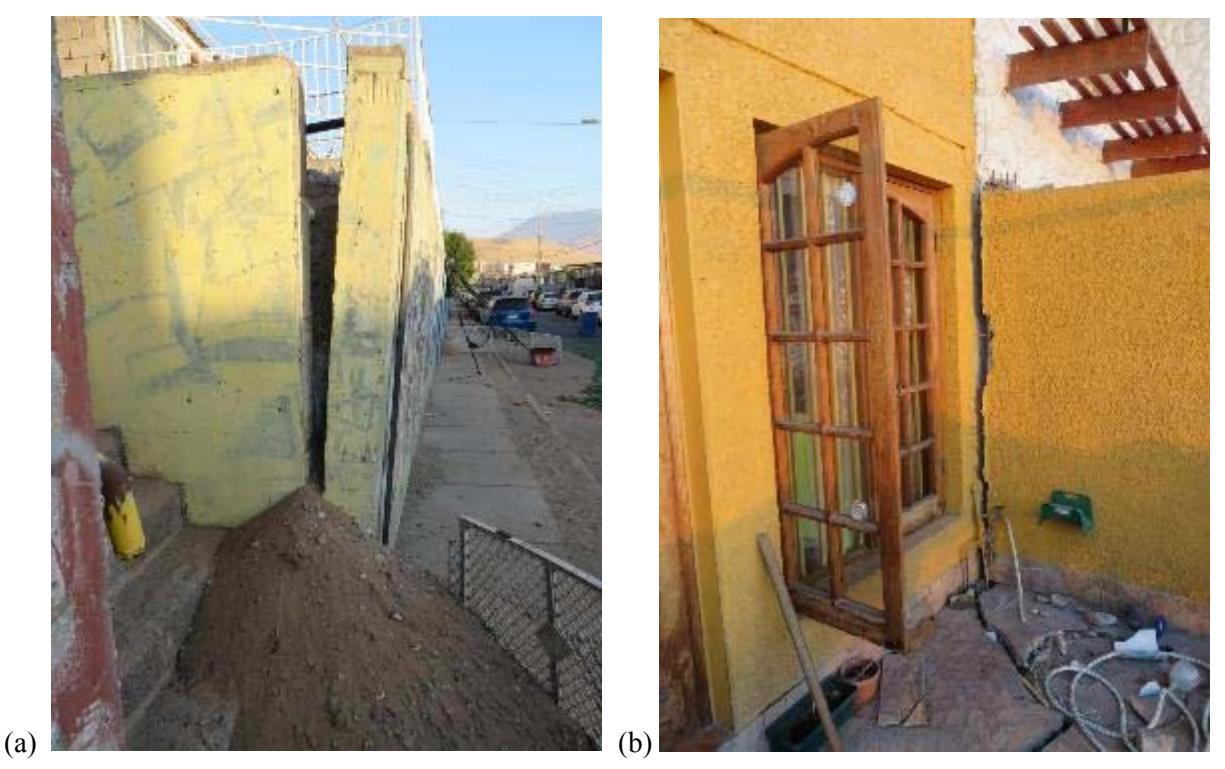
Several retaining walls in Los Algarrobos street at Cerro Dragon were damaged due to the insufficient size of the footing, the lack of restraining elements, and the low strength of the backfill. The observed failure mode was overturning, with measured tip displacement varying between $\Delta/H=8\%$ at the north end and $\Delta/H<1\%$ at the south end, as shown schematically in the Google earth photograph of Fig.7. The extent of the damage was significant considering that PGA at the site was less than 0.25g, and that retaining walls adequately designed for static loads may well resist ground shaking with PGA in the order of 0.3g [10].

The largest measured overturning was approximately 20 cm (Δ /H=8%), as shown in Fig.8(a). Based on Street View© photographs taken before the earthquake, it is concluded that most of the wall rotation occurred during the 2014 earthquake sequence. Large rotations were observed on other walls along Los Algarrobos street, however these walls had already overturned, presumably after the 2007 Tocopilla earthquake (M_w 7.7) and 2005 Tarapacá earthquake (M_w 7.8), and had not been retrofitted since. Large rotations on a retaining wall induced

backfill displacements and differential settlements on the house shown in Fig.8(b). Following the earthquake, people blocked the streets and many abandoned their houses for several weeks.

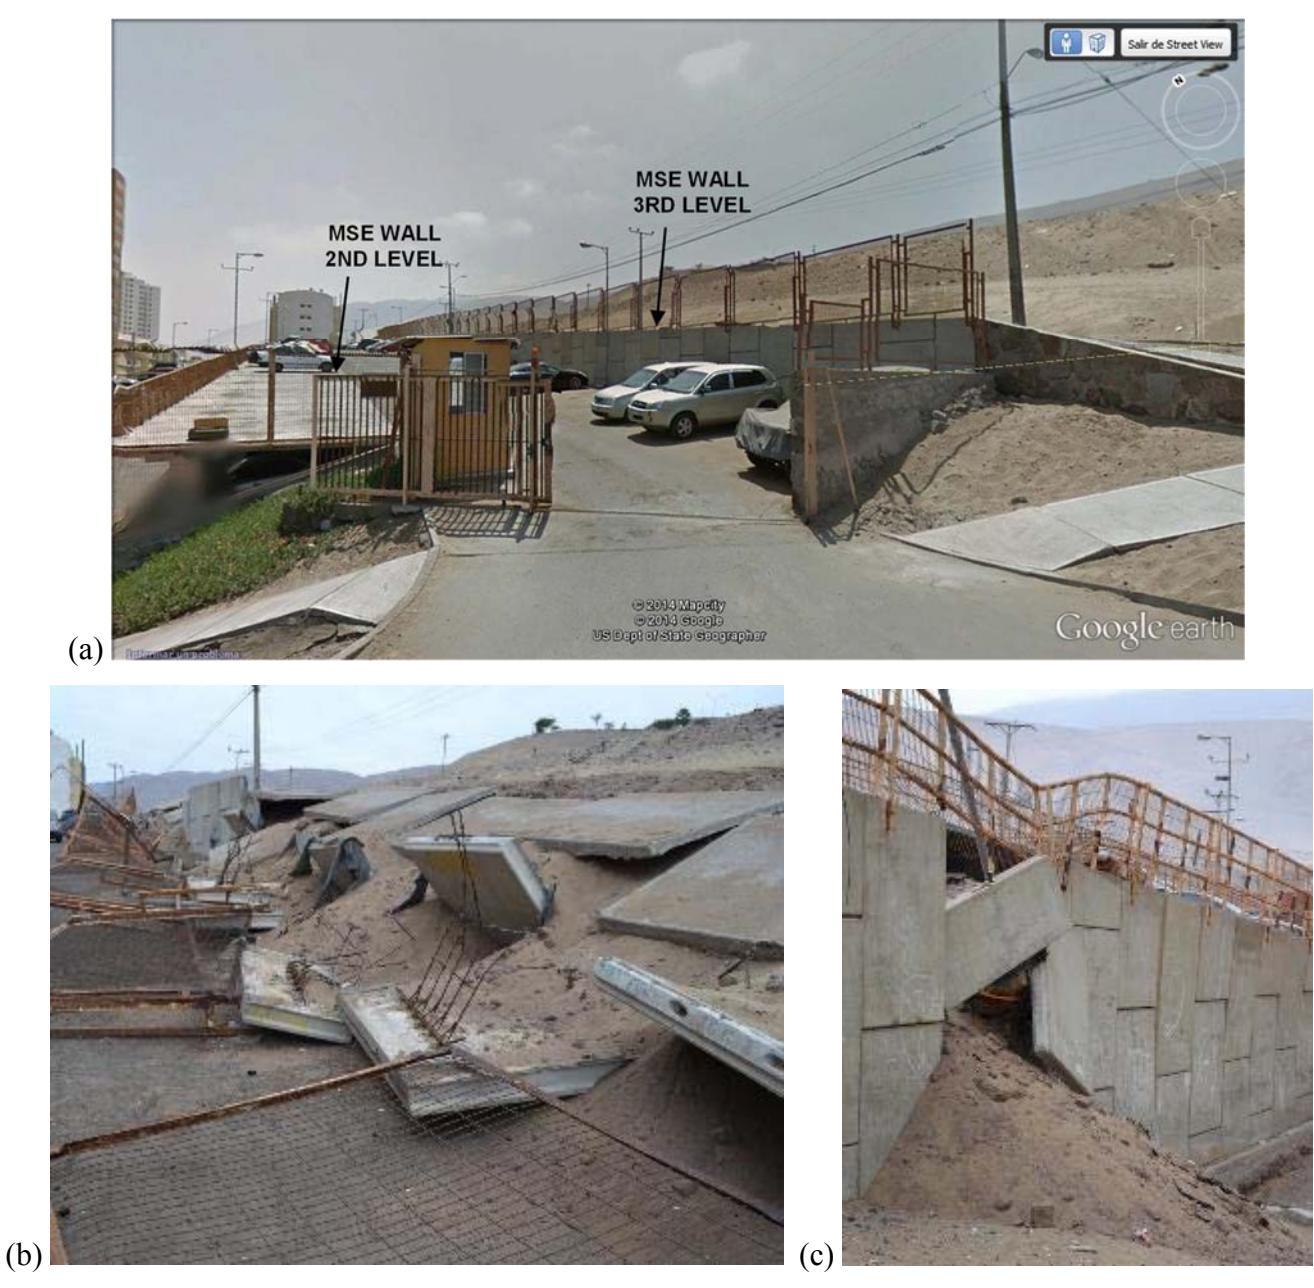
The seismic performance of mechanically stabilized earth structures was acceptable throughout the region, including overpass approaches and bridge abutments. No major damages were observed, with the exception of the retaining walls that collapsed near the south end of Cerro Dragón, at the intersection of Los Algarrobos and Cuatro Sur streets. These MSE walls formed a three level terrace to hold a parking garage and a public road, as seen in the photograph of Fig.9(a) taken before the earthquake.

As a result of the advanced corrosion in the soil reinforcement, added to the seismic loads on the backfill, approximately 60 m of wall in the 3^{rd} level collapsed. Localized failure of the walls in the 1^{st} level was also observed, as shown in Fig.9 (b) and (c). The failure mode was the rupture of the steel reinforcement and internal instability of the reinforced soil mass. The backfill material was the marine sands of Cerro Dragón, which have a great corrosion potential due to the presence of chlorides and sulfates, and the free exchange of moisture between the soil and the air. The steel reinforcement was made of hot-dip galvanized $\phi 10$ mm bars. In non-aggressive media, this reinforcement would have performed well, but the highly corrosive soils present at the site, led to a rapid reduction of the zinc coating of the rebar cross section, affecting its strength capacity.

Fig. 9. Photograph of retaining walls before the earthquake. Source: Google Street View. (b) failure of retaining walls in the upper level and backfill displacements, (c) local failure of MSE wall. Photographs (b) and (c) courtesy of Ramon Verdugo.

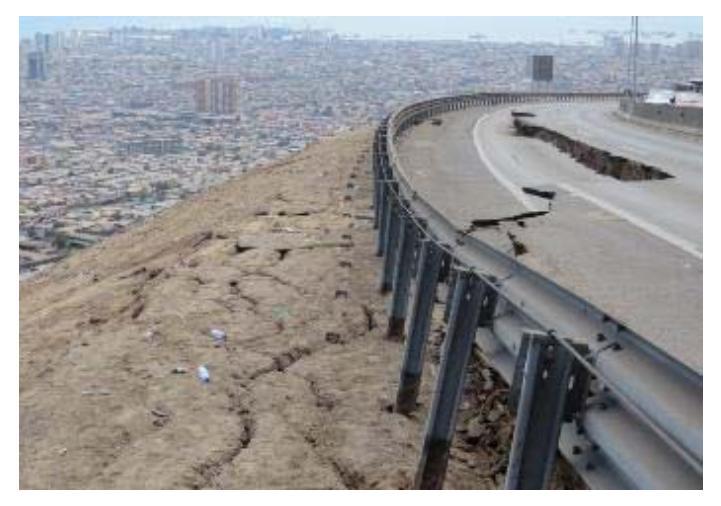
On Route A-16 between Iquique and Alto Hospcio, a cut slope failed 2.5 km south of the El Pampino roundabout (20.24337°S, 70.12389°W). The failed section, shown in Fig.10, extended over 400 m on the west lane, with the largest displacements concentrated on a 100 m strip. Vertical offsets of 20–40 cm and horizontal displacements of 10–30 cm were measured at the slope scarp, and the estimated volume of displaced soil was approximately 3000 m³.

The failure on route A-16 is located on the steep cliffs of Iquique, at an elevation of 215 m above sea level. The slope runs north-south, dips west at an angle of 24°, and is made primarily of marine sands underlain by Tertiary sedimentary rocks. The depth to bedrock is about 10–15 m and the estimated peak ground accelerations for the main shock were 0.3g-0.4g. Following the earthquake, traffic was permanently closed on the west lanes. The east lanes opened for emergency operations within a day and for regular traffic within three days. Shallow failures occurred at different locations along Route A-16, but they concentrated at higher elevations, near Alto Hospicio. Rockfalls on the hillside were pervasive, but the loose material was plowed off before the reconnaissance team arrived to the site on April 4th. While raveling failures of non-stabilized slopes occurred repeatedly, road cuts protected with shotcrete and wire mesh performed well and only minor damages were observed.

Fig. 10 Slope failure on Route A-16 (-20.243028°, -70.124056°).

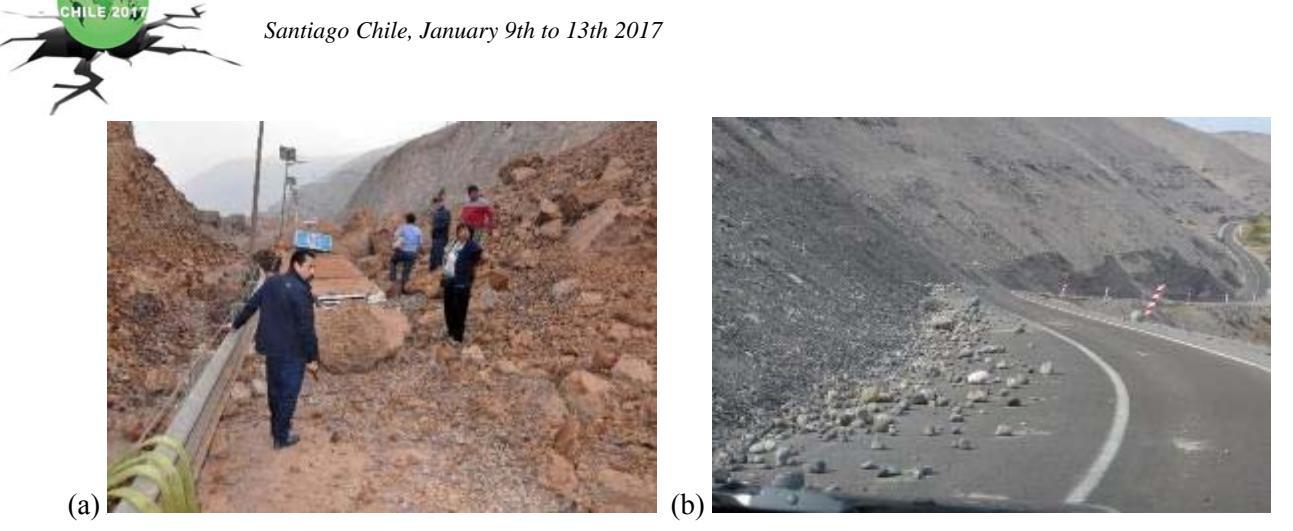
Rockfalls and raveling failures of disaggregated material were common on over-steepened cut slopes in the Regions of Tarapacá and Antofagasta. In most cases, the rock fragments and soil were plowed off the roads within a few days after the earthquake and the traffic flow was restored quickly. The extent and volume of the rockfall was in direct proportion to the slope angle, and decayed with increasing site-to-source distance. For example, slopes of sedimentary rock on route A-16 (96 km from the hypocenter) were significantly damaged, whereas steep loose-gravel slopes on Route 565 located 130 km east from the hypocenter, experienced only minor rockfall as seen in Fig.11.

Fig. 11 (a) Disaggregated rock failures on Route A-16 (photo courtesy of prensalibre.com), (b) minor raveling along Route A565, unimpeded traffic.
