# EARTHQUAKE DAMAGE TO BURIED PIPELINES NEAR A FAULT: A CASE STUDY IN HVERAGERÐI DURING THE 2008 M6.3 ÖLFUS EARTHQUAKE

A. Sigfúsdóttir<sup>(1)</sup>, R. Rupakhety<sup>(2)</sup>, S. Ólafsson<sup>(3)</sup>

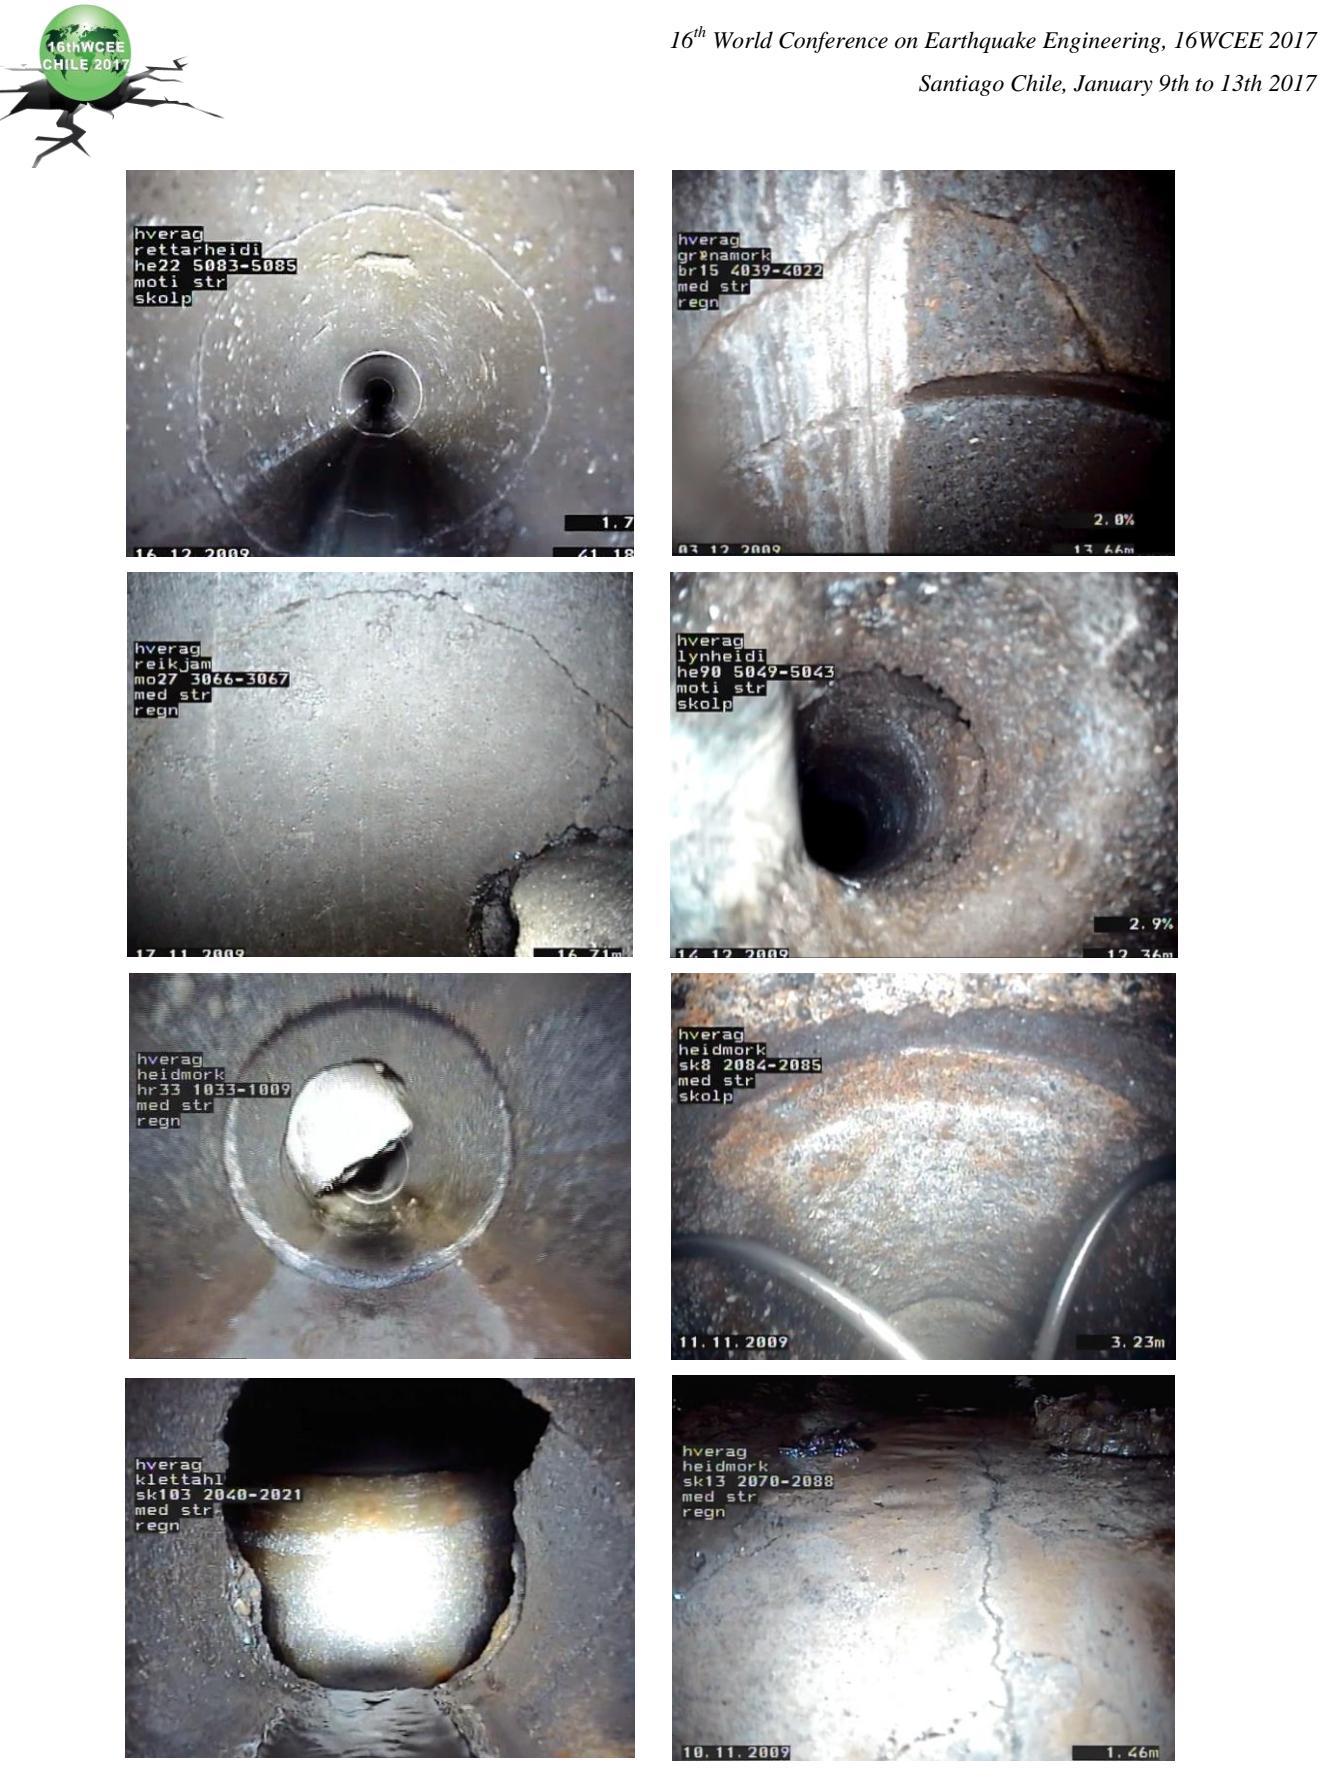
- Collapse of a part of a pipe due to extensive cracking is classified as category J (pipe collapse)
- Cracks/breaks at joints were classified as B (crushing of bell-spigot joints), C (blowout at tee), E

(compression at tee), or G (pipe break at a manhole-pipe connection)

- Tensile failures at joints were classified as D (pull out at Tee) or F (pull out at bell-spigot joints)
- Longitudinal cracks/breaks anywhere along the pipes were classified as type H (longitudinal crack along pipe segment)
- Circular cracks in the pipes except those at T-connections were classified as type A (pipe segment circular crack)
- Other breaks/cracks in the pipes were classified as type I (pipe segment break)

Fig. 3 – Some examples of the different types of damages sustained by the pipes in Hveragerði. The corresponding damage mechanisms are A to H, sequentially from top left to bottom right.

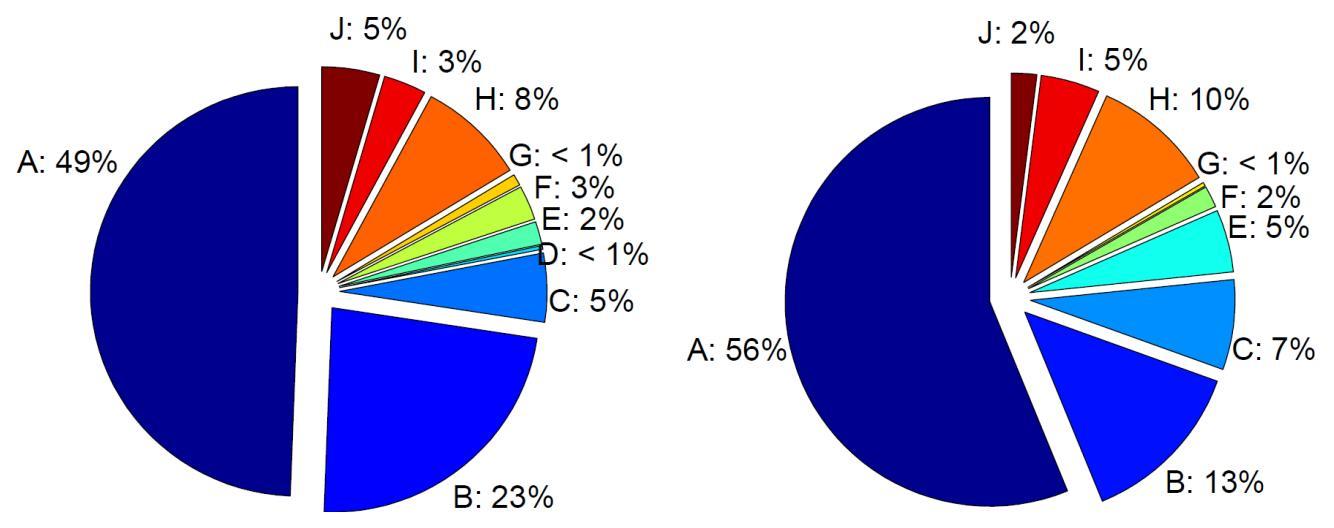
The distribution of different damage types in sewage and drainage pipes are shown in Fig. 4. Type A damage, which is pipe segment circular cracks, is found to be the most common damage mechanism. More than half of the damages are of this type. These damages are a result of flexural cracking induced by ground curvature. The distribution of damage types in sewage and drainage pipes seems to be similar, except damage type B, which is the crushing of bell and spigot joints, is less frequent in drainage pipes. The damage configurations for pipelines laid in 2000 and later are presented in Fig. 5. These pipes were fitted (in situ) with rubber gaskets at the bell-spigot joints and experienced significantly fewer joint-related failures than those constructed before the year 2000 in which the joints had been sealed with either hemp and cement-sand mortar or O-rubber rings. The distribution of different damage mechanisms in drainage and sewage systems was found to be similar, with type A being the most frequent damage mechanism.

Fig. 4 – Distribution of damage types in sewage (left) and drainage (right) pipes.

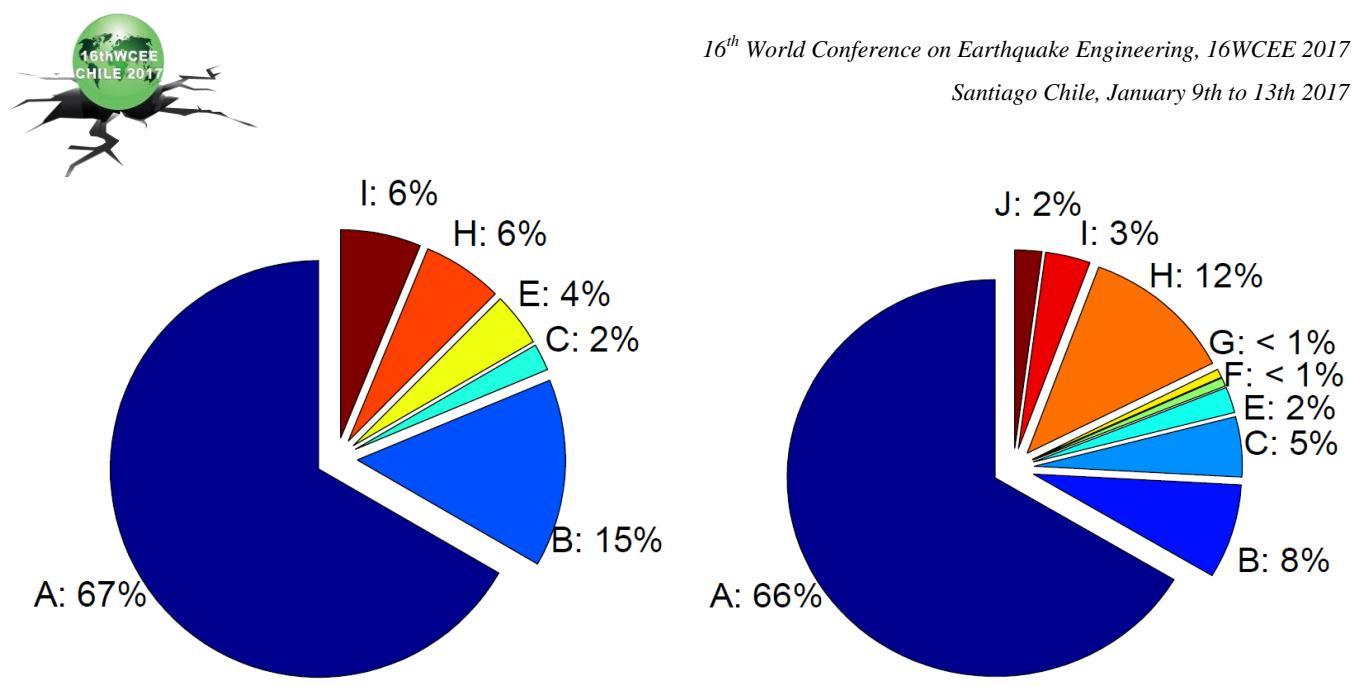
Fig. 5 – Damage distributions in the sewage (left) and drainage (right) pipes constructed in 2000 and later.

discontinuities, they are found to suffer much less damage than the drainage pipes. The relative number of damages related to the tees were found to be similar in drainage and sewage pipes. Around the year 2000, concrete pipe manufacturing in Iceland underwent several improvements in terms of materials, compaction methods, and the joints used. These improvements led to the reduction in damage rates by almost 50%.

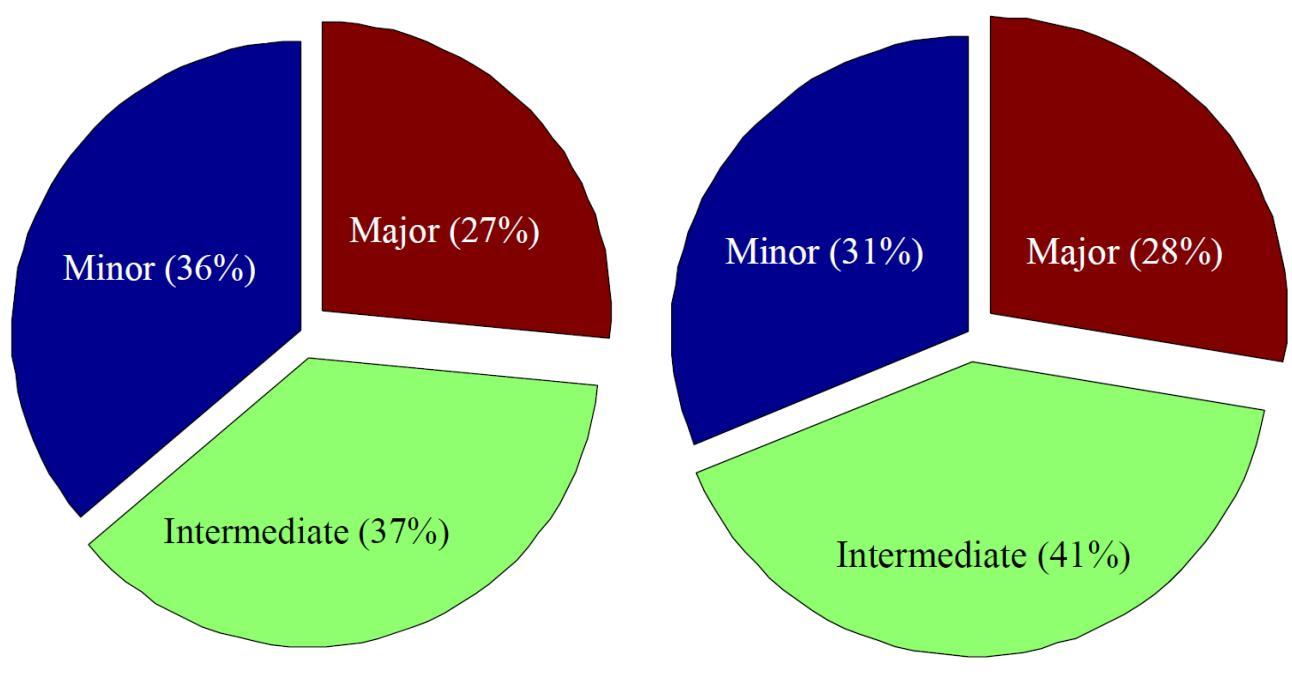
To facilitate repair/restoration time and cost, HAZUS classifies repairs into two categories: breaks and leaks. A break is assumed to be more severe and harder to repair than a leak, implying longer repair time. In HAZUS, the standard proportion of breaks and leaks caused by wave propagation effects are assumed to be 20% and 80%, respectively. These proportions are interchanged when damages are caused by permanent ground deformation. In this study, the observed damage was classified into three different states of severity: minor, intermediate, and major. Cracks narrower than or equal to 2mm were classified as minor damage, those between 2mm and 5mm as intermediate damage, and those wider than 5mm as major damage. Tension/compression failures at pipe joints and pipe collapses were also classified as a major damage. Figure 6 shows the damage state distributions in the sewage and drainage pipeline. Both systems have similar damage state distribution, or about 1/3 damages in each damage state. Major damages were further classified into two categories: breaks and leaks. Breaks are defined as breakage and/or collapse of the pipe, and cracks wider than 5mm are defined as leaks. The relative proportions of breaks and leaks, were found to be comparable to what is suggested in HAZUS.

Fig. 6 - Damage states in sewage (left) and drainage(right) lines.

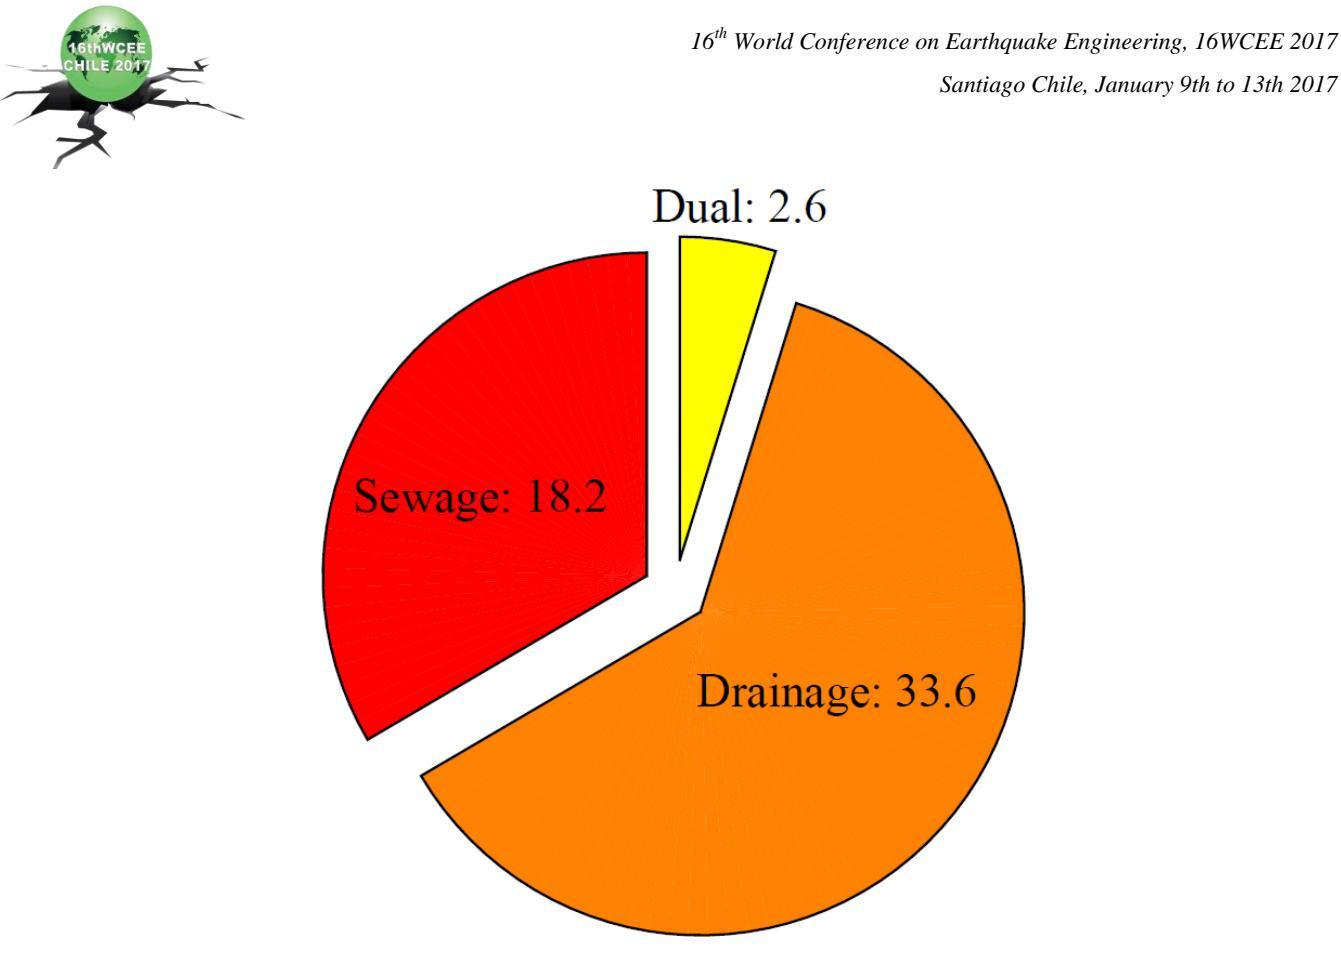
It was observed that the damage rates in the sewage and drainage pipes were significantly different. The total lengths of the pipes performing these two functions are approximately the same. Figure 7 shows the number of damages per unit length (km) of sewage, drainage, and dual function pipelines.

Fig. 7 – Comparison of damage ratios by pipe function; the numbers shown in the figure are number of damages per km of pipe.

A very interesting observation from the damage analysis is that the damage rate in sewage pipes is about 57% of that in the drainage pipes. The drainage pipes and sewage pipes are made of the same material and are of similar age. They are laid in the same trench, with drainage pipes lying only about 0.5m above the sewage pipeline, and therefore the significant differences in damage rates is not likely to be due to differences in ground motion experienced by these pipes. The sewage pipes lie almost on the engineering bedrock, while the drainage pipes are laid over backfill material. Some settlement of the backfill including potential interaction of the pipes with the surrounding soil may be the cause of higher damage rates in the drainage pipes. One notable difference between the drainage and the sewage pipes is that the sewage pipes are more restrained laterally than the drainage pipes. This restraint is provided by pipes and tees, at 10-20m intervals, connecting the main sewage pipes to the branches serving the houses. The extra stiffness provided by these lateral restraints might have caused lesser deformation (and damage) of the sewage pipes compared to the drainage pipes. Generally, damages tend to concentrate at or near connections and geometrical discontinuities (such as tees). However, this is not the case in the pipelines being studied here. Although the sewage pipes have much larger number of such
