INFLUENCE OF IRREGULAR CONFIGURATIONS IN THE DAMAGE OF RC BUILDINGS IN 2010 CHILEAN (MAULE) EARTHQUAKE

F. Yáñez⁽¹⁾, D. Silva⁽²⁾.

(1) Civil Engineer, PhD, C.E.O. IDIEM, fernando.yanez@idiem.cl
(2) Civil Engineer, Division Manager, IDIEM, david.silva@idiem.cl

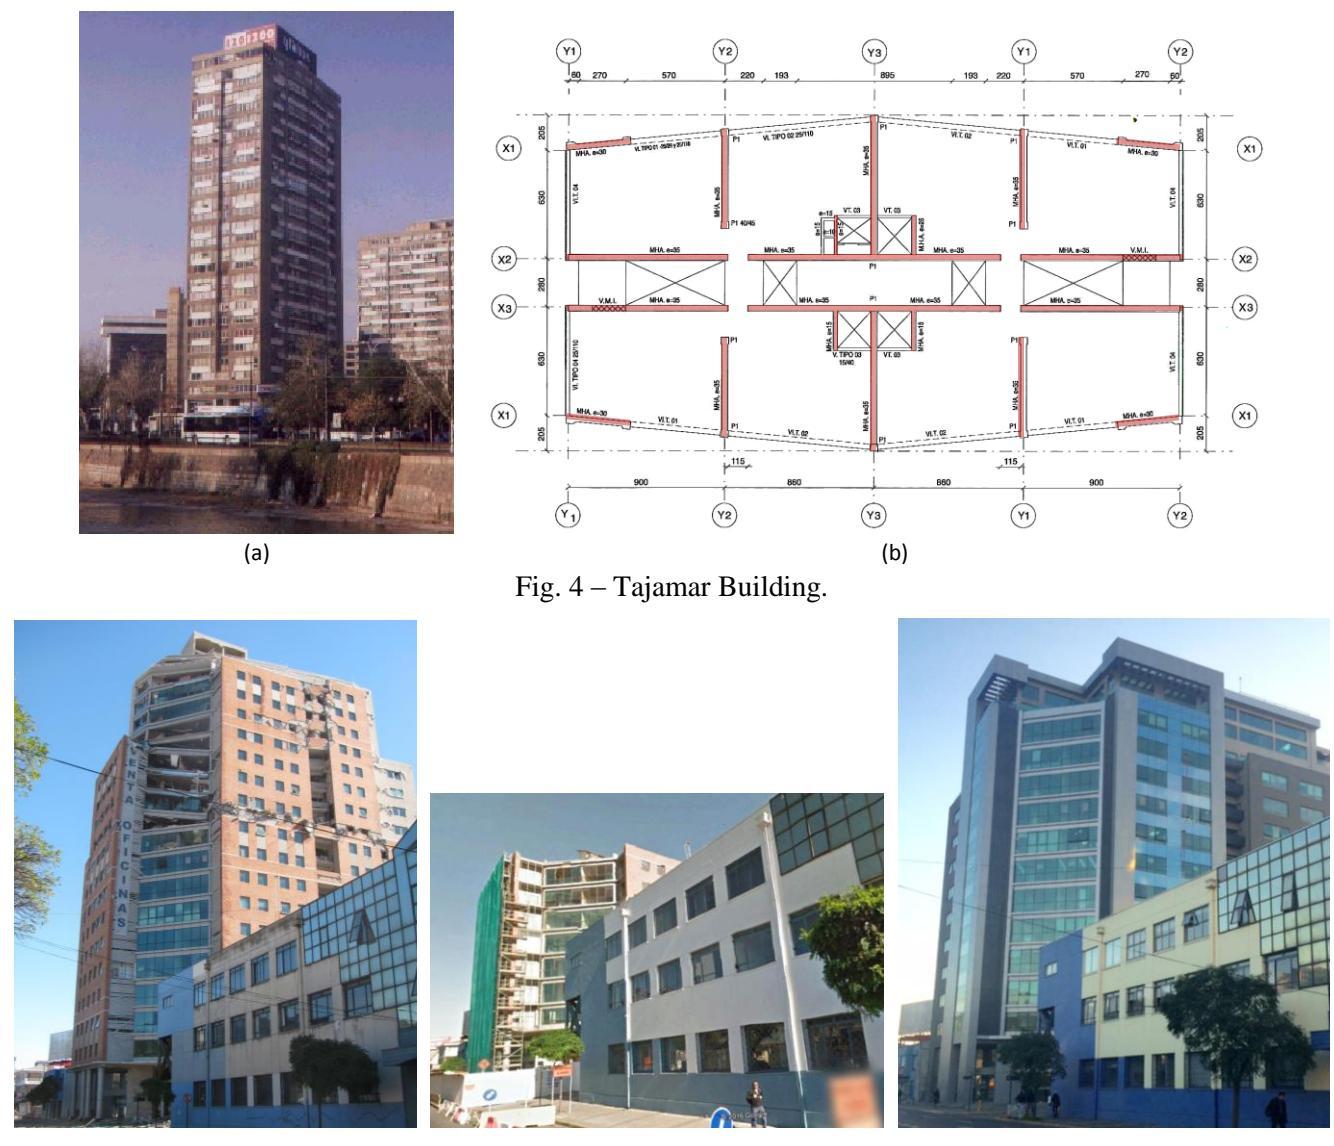
Fig. 5 – O'Higgins Building.

Four buildings are highlighted: Tajamar Building^[6] in Santiago (#1) Fig. 4; O'Higgins Building (#59) Fig. 5; Alto Río Building (#74); and Centro Mayor Building (#75). Alto Río Building collapsed, O'Higgins Building was severe damaged, the upper part was demolished and the lower part retrofitted. Centro Mayor had severe damage and was demolished.

(a) After 2010 earthquake

(b) Partial demolition in 2013 (c) Current retrofitted building in 2016

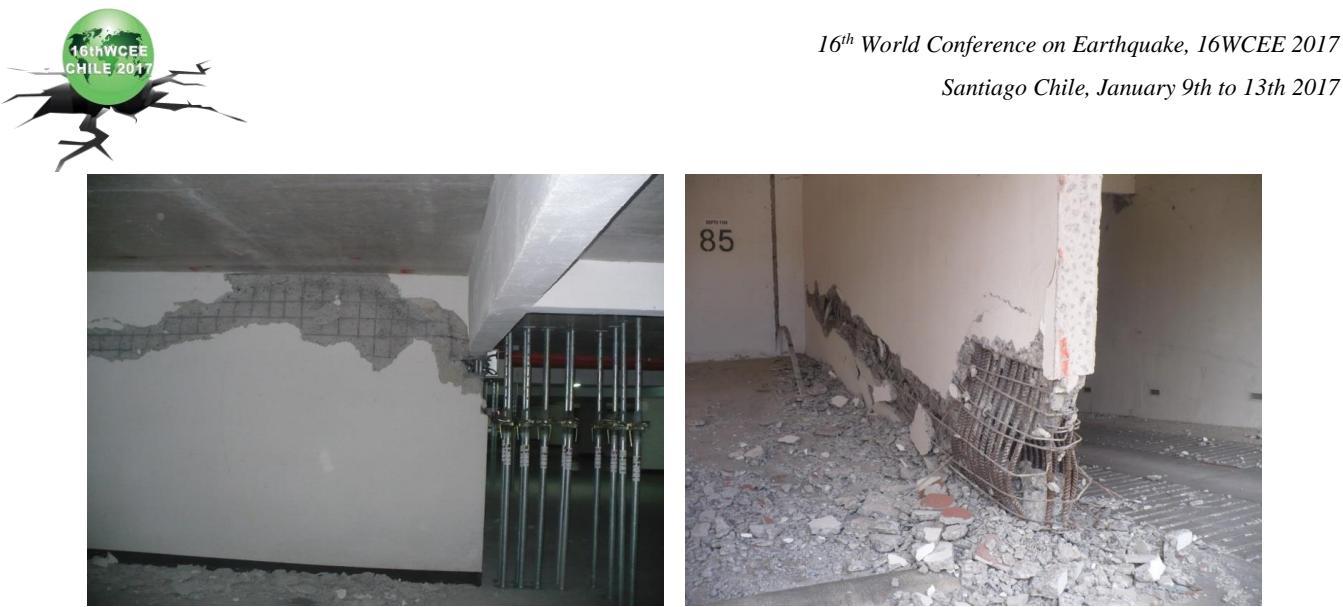
Fig. 6 – Damage pattern observed in RC "T" walls.

Notably, all building that were severely damaged (a) had the same structure configuration as Tajamar Building, but with many basement parking floors; (b) failed in flexural compression mode, as indicated in Fig. 6. Shear failures were not observed in the field inspections; (c) most walls had vertical irregularities; (d) the thickness of walls at the base was of the order of 250 mm.

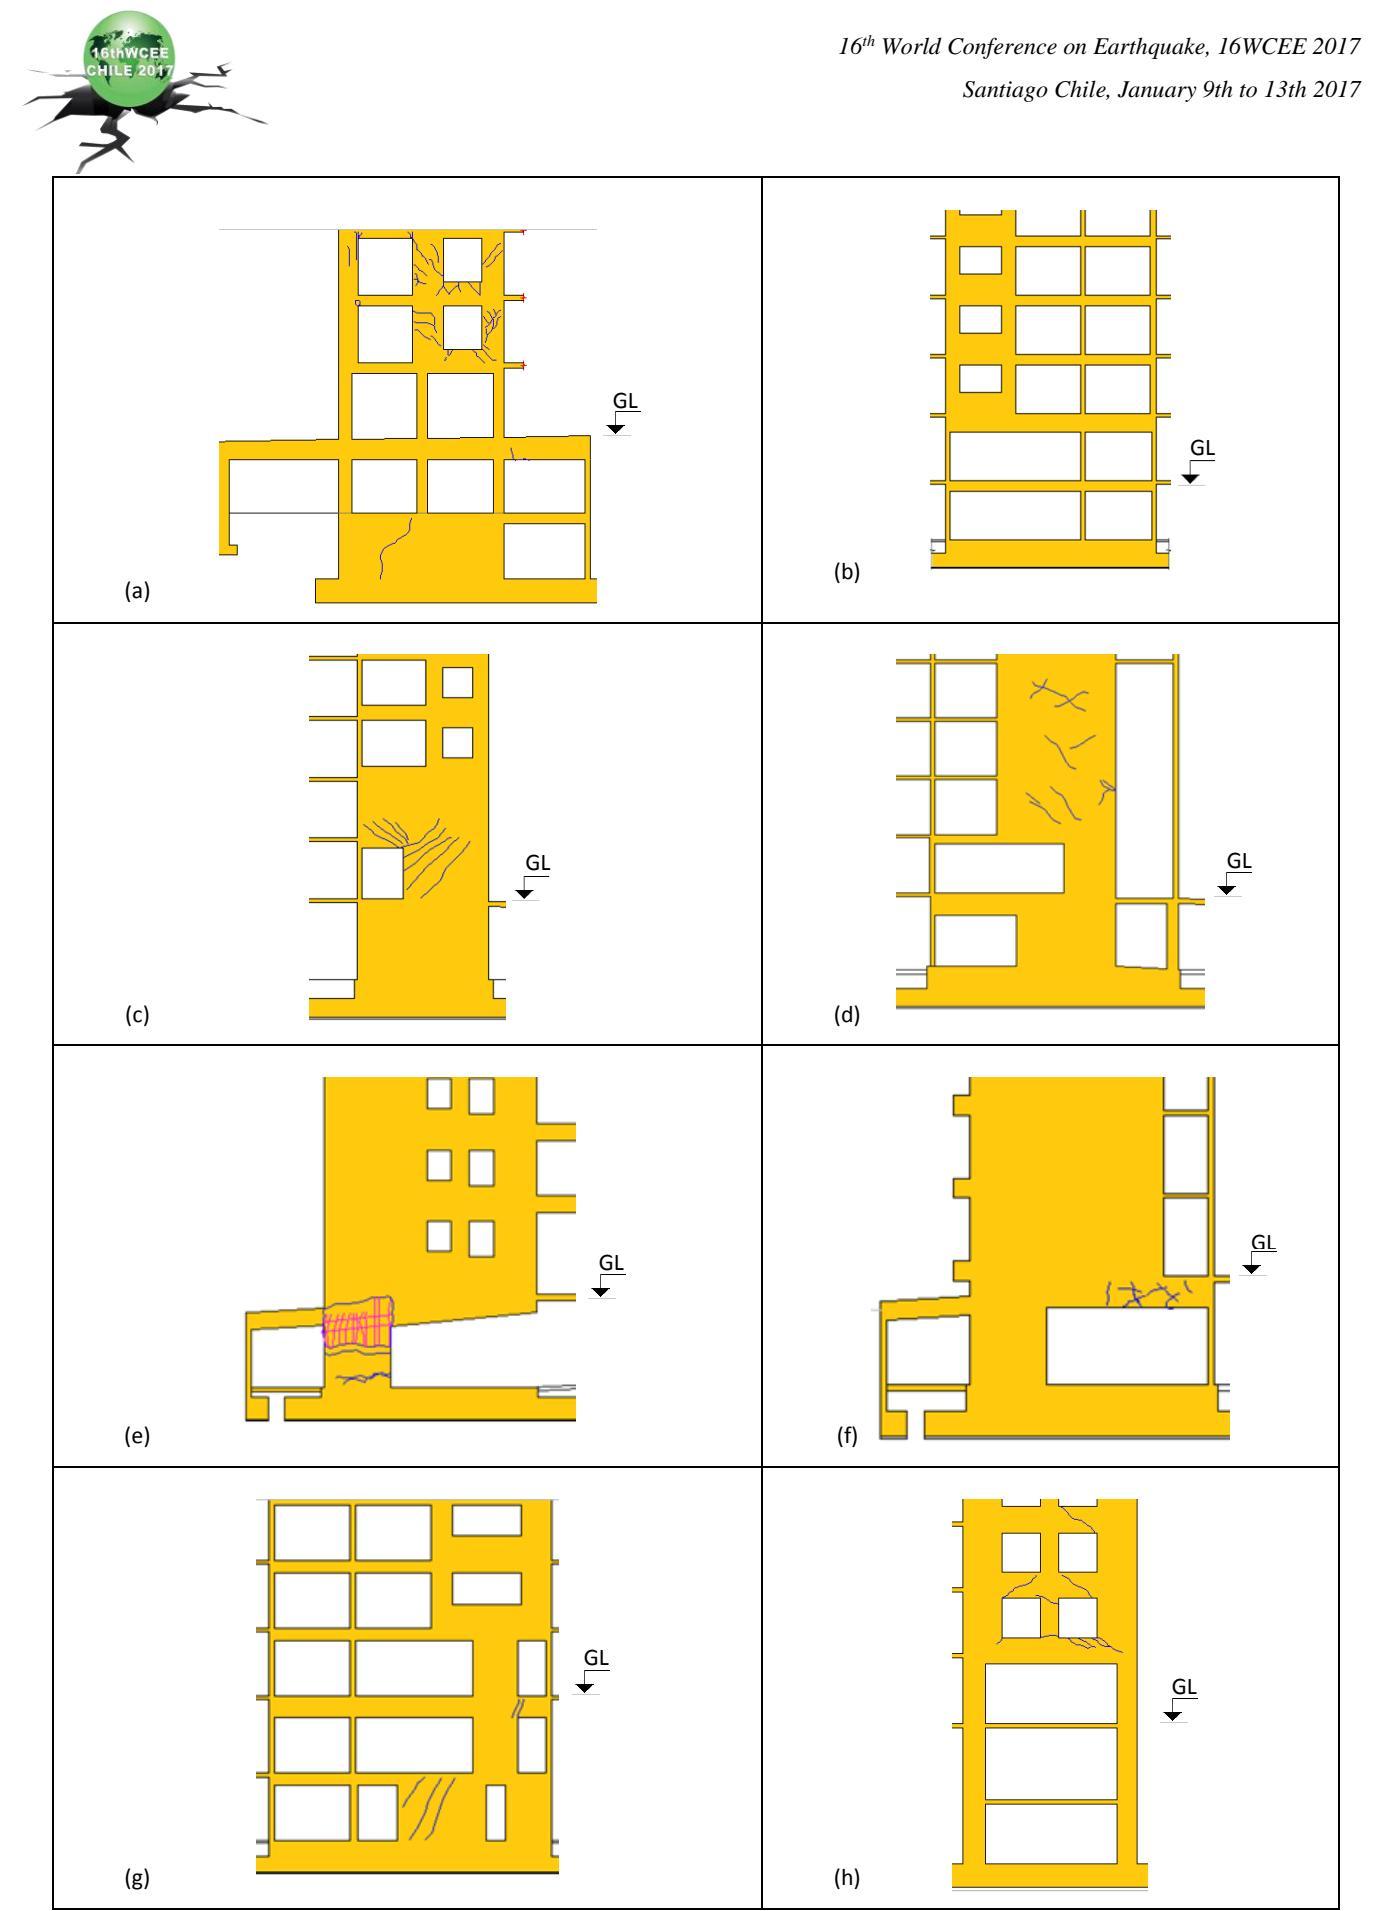
Fig. 10 – Selection of vertical irregularities in buildings that were damaged during the Maule 2010 earthquake.

A collection of typical irregularities in walls with their damage due to 2010 Maule Earthquake is exhibited in Fig. 10. In each case the ground level (GL) is indicated. The reinforcement detailing of these walls was very poor. These figures show the inability of many Chilean architects to deal with parking basement floor. It also indicates the inability of many structural engineers to fix these deficiencies. It seems that they are not designing the structure properly but just determining the amount of reinforcement for the structure actually designed by the architect. If these irregularities in the walls are not solved during the architectural design process, it is difficult for the engineer to fix them afterwards.

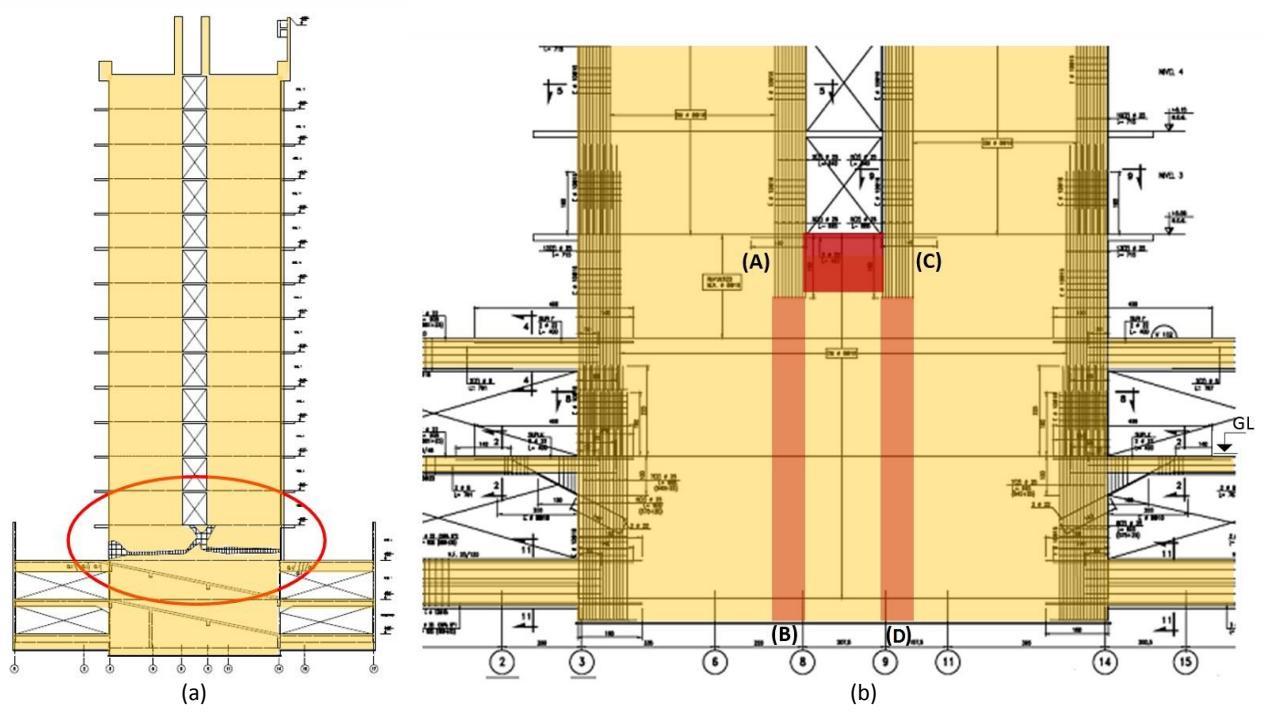
Fig. 11 – Failure of wall with mechanical irregularities.

Most irregularities, geometrical or mechanical, are not designed properly. As an example, Fig. 11 shows a wall of Centro Mayor Building (#75) in Concepción. The larger lower wall failed at the end of the central vertical reinforcement points A and C. The failure zone is shown in Fig. 12. The central vertical main reinforcement had enough development length into the larger wall; however this design does not comply with the requirement 4.4.4 of ACI 318-14^[7].

The only "final points of resistance" for this central vertical reinforcement are points B and D in the foundation mat, Fig. 11.

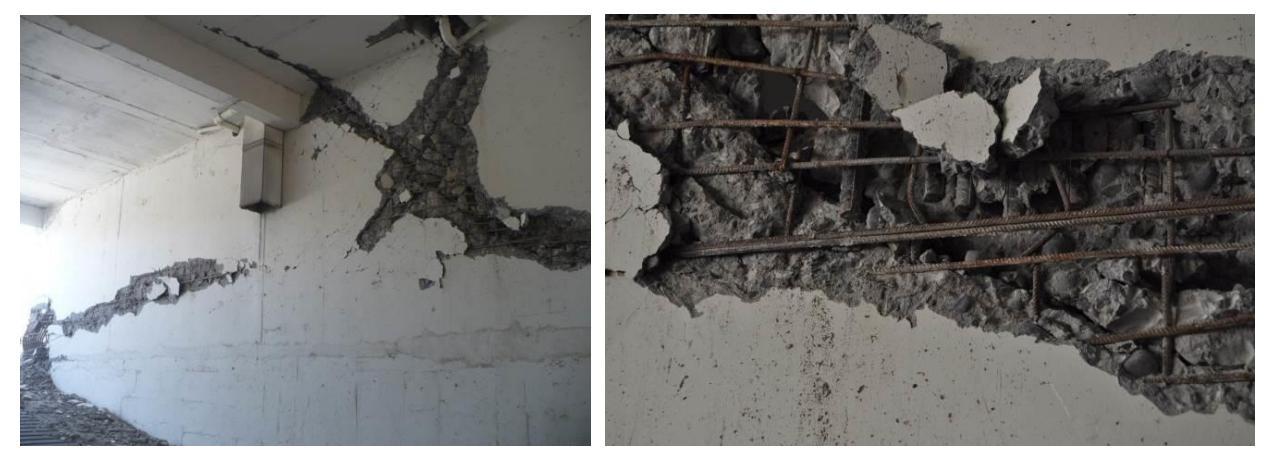
(a) (b) Fig. 12 – Pictures of the failure zone AC of the building of Fig. 11.

On the other hand, Fig. 12 shows that in the panel AC there is damage (disintegrated concrete) due to local shear force; however the horizontal reinforcement in the panel (ϕ 8 at 160 mm.) did not yield. This shear reinforcement was about 1.4 times V_c, the contribution of concrete to shear strength. This value indicates that the shear demand was not high; however the concrete in the panel disintegrated. To avoid disintegration, it is suggested to confine this panel with transverse ties at each intersection of the panel vertical and horizontal bars. The confinement zone should be of the same horizontal dimension of the opening and extend downwards 1.5 m but not larger than half the story high.

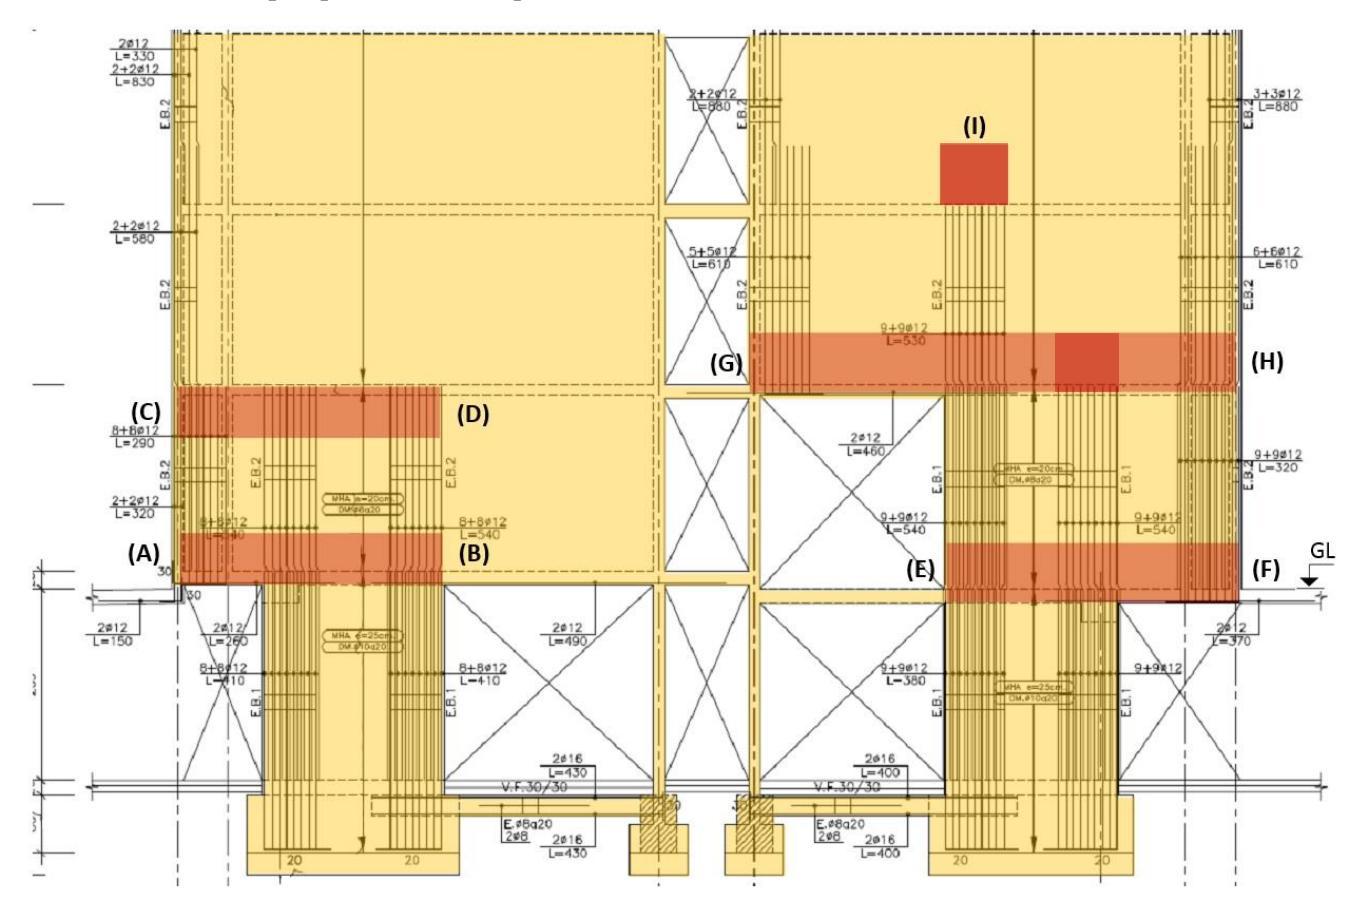
Fig. 13 – Geometrical irregularities in a wall with a set back in the first floor.

Another typical geometrical irregularity is shown in Fig. 13, corresponding to the design of a building before the peer review. Apart from the vertical main reinforcements, there is a light steel mesh in both faces. But there is not horizontal reinforcement in AB, CD, EF and GH, as a strut and tie model (Fig. 15) would suggest. If the strut are designed at 45°, then an horizontal reinforcement should be designed with the same amount of the vertical main reinforcement. An example of node design for node F in Fig. 13 is shown in Fig. 14 with bars with hairpin shape for the vertical and horizontal ϕ 12 mm diameter bars. Finally the vertical main bar at E (Fig. 13) should be extended up to point I to develop 45° struts GI.

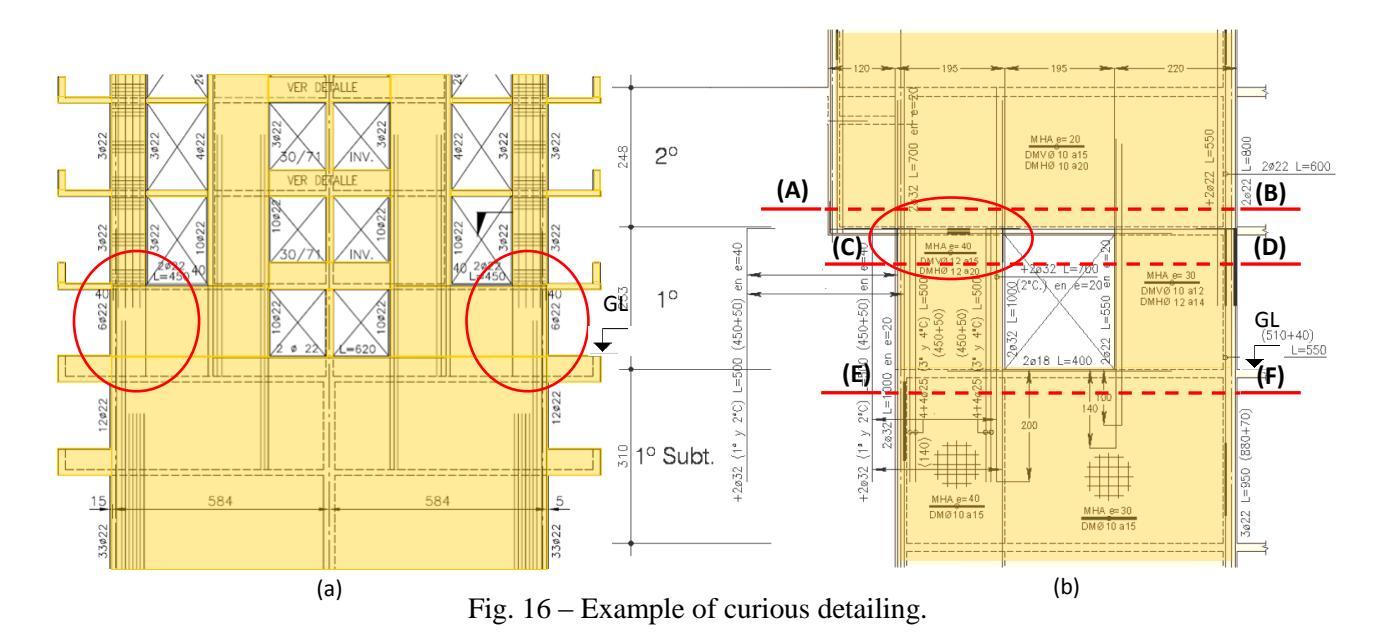
The design shown in Fig. 16, corresponding to drawings before the revision by the peer reviewer, demonstrates how some structural engineers use structural software that does not properly deal with irregularities. Fig. 16(a) shows discontinuities of the vertical main reinforcement. This is not understandable unless it is the outcome of some sort of automatic design software. This design obviously does not comply with ACI 318-14, 4.4.4 requirement.

Another typical example is shown in Fig. 16(b). In this case some vertical main bars at level CD are not properly developed upward. At level EF 4+4 ϕ 25 mm bars (i.e. 8 bars) in each side of the left wall do not exhibit a clear "final point of resistance". Finally at both sides of levels CD and EF there is not the symmetry of reinforcement one would expect.
