16th World Conference on Earthquake, 16WCEE 2017 Santiago Chile, January 9th to 13th 2017 Paper N° 2466 (Abstract ID) Registration Code: S-K1464748820

Assessment of Seismic Vulnerability of Historic Buildings Based on their Current Condition Captured by Laser Scans and Retrofit Strategies

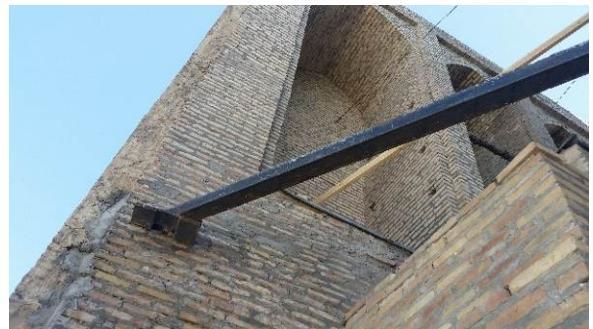
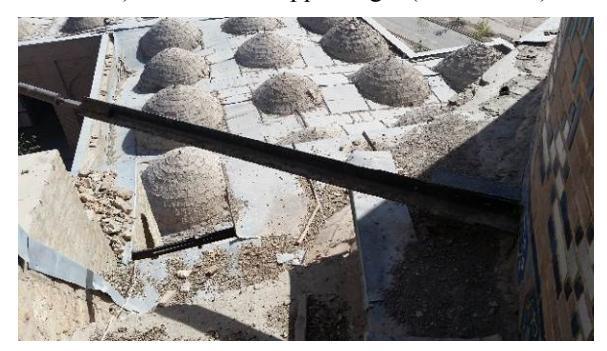
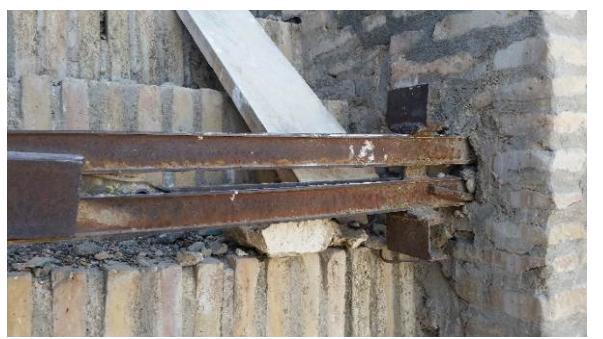
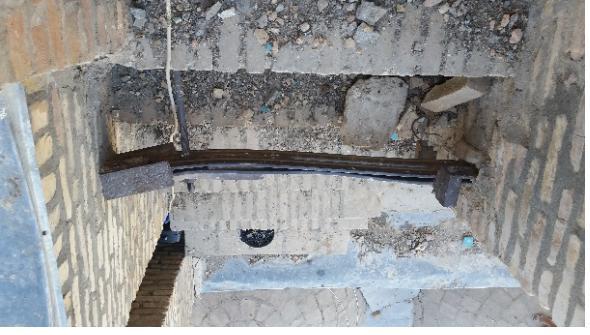
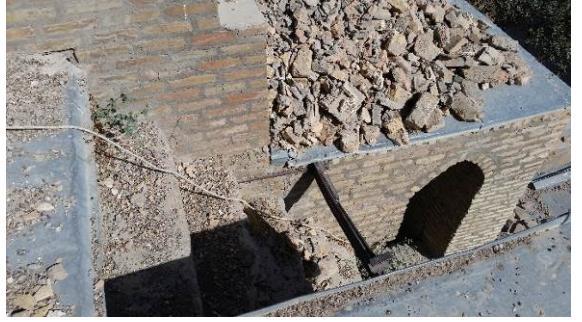
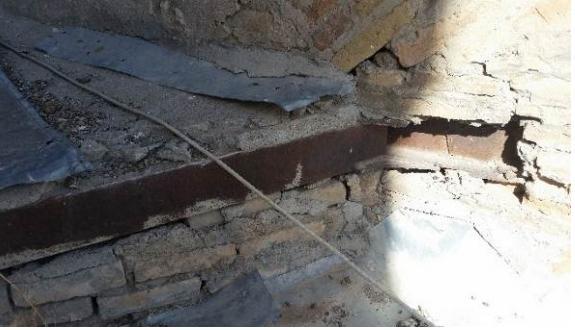
From analysis of the point cloud it was concluded that reinforcement rods did not reveal any sagging. This serves as evidence that the tension force was still present in the rods. One of the pretension rods applied force in weak direction of the reinforcement member (web of a double channel) that resulted in plastic deformations of the double channel. The latter was installed at Elevation 3 as shown in Fig. 4b. It was most likely related to a mistake in the engineering detailing of the way the reinforcement needed to be installed in the monument. Because this reinforcement could not serve its purpose, it was not included in the model.

It worthy to note that the engineering detailing of the existing reinforcement was not done in a proper way. The current reinforcement attracts the forces and creates stress concentration points. Localized failures of masonry around the attachment points were observed at several locations throughout the monument. Therefore, these connection details need to be redesigned to distribute forces where the brace comes in contact with the masonry.

f) South side's angles orthogonal to portal's face (Elevation 2) Fig. 4. Existing reinforments connecting portal to the main structure

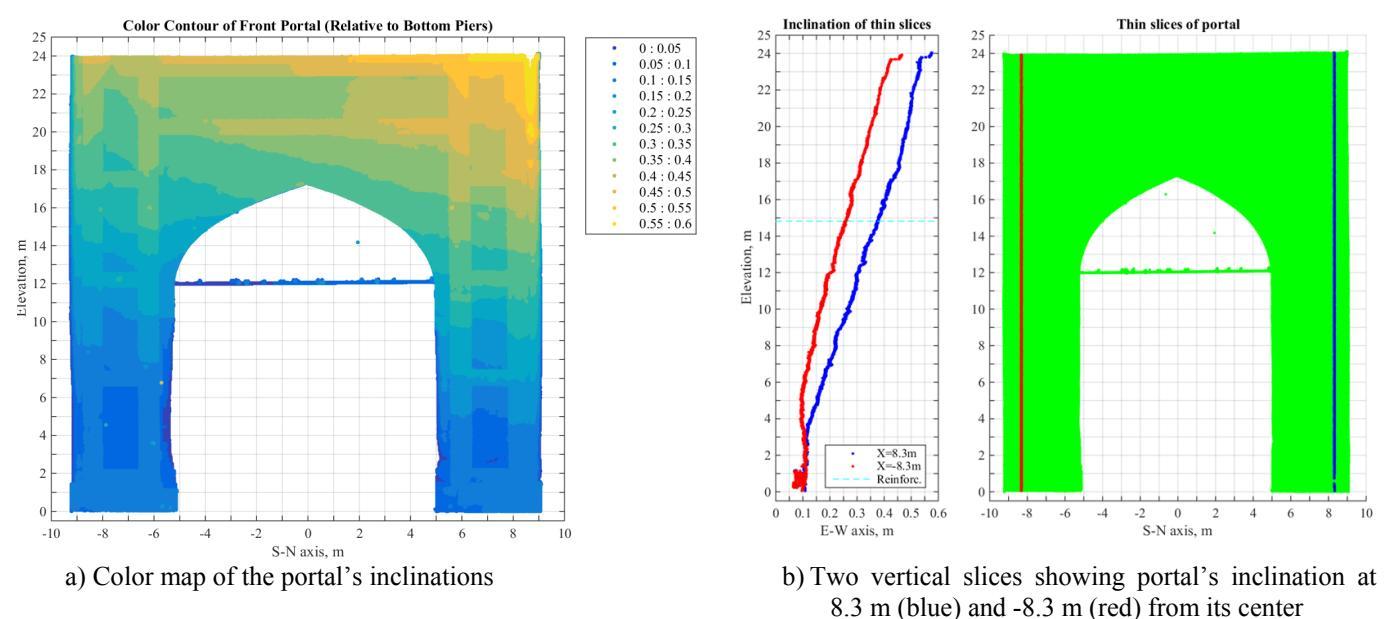
Fig. 6 – Major pre-existing reinforcements of mosque

The monument's point cloud was investigated for anomalies. The main portal was investigated for its inclination from a vertical plane passing through the bottom of both piers. A color map of the inclinations is presented in Fig. 6a. The color map shows that the portal's inclination increases from south to north with the maximum differential displacement of 0.6m at the top north corner. To ensure that this degree of inclination of the portal is not progressing, a periodic monitoring by laser scanning was recommended. It was also advised to proceed with the installation of laser targets to increase accuracy of monitoring.

The same inclination for two vertical slices of the portal is presented in Fig. 6b. The cyan line (at Z = 14.62 m) corresponds to Elevation 1 where one type of reinforcement was installed. Since the slope of the slice (plots on the left side) does not change after this elevation, most likely the reinforcement is not effective and does not provide enough support to prevent continuous leaning of the portal. Another major conclusion was drawn from the Fig. 6b, that the residual drift of the structure remains the same from about 4 m to the top of the portal and this elevation coincides with the starting elevation of the crack that essentially separated the portal from the main structure.

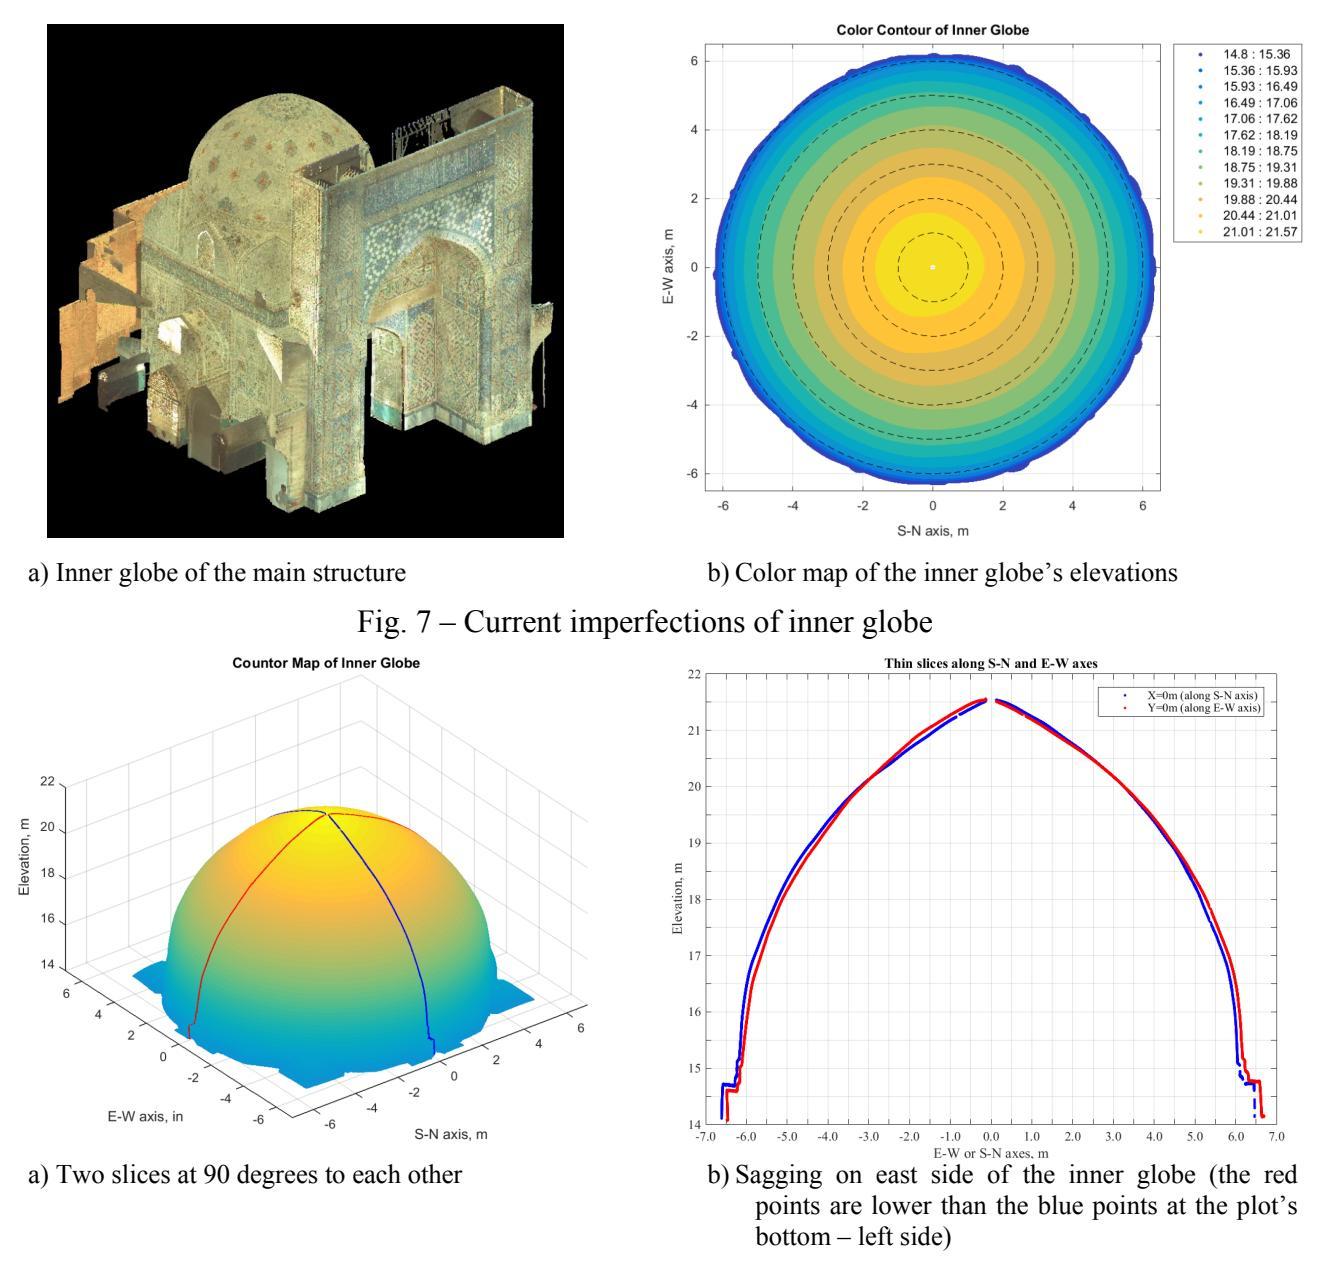
Structural anomalies of the inner globe in the main structure shown in Fig. 7a were also studied. The color map of the inner globe's elevations is presented in Fig. 7b. The dashed lines show elevations with 1-meter increments and in many cases the color map for each elevation range have some deviations from the dashed lines. This shows imperfections of the globe. To ensure that the imperfections are not changing over time, a periodic monitoring by laser scanning was recommended. Two slices in S-N and E-W axes were cut from the inner globe as presented in Fig. 8a. These slices are plotted in Fig. 8b which shows that a slice at Y=0 m is lower on the left (south side) at elevation close to 14.8 m.

Fig. 8 - Sagging on east side of inner globe estimated from two vertical slices

The inner globe has some imperfections with the north half at a higher elevation than that on the south side. The latter can be a result of soil settlement on the south side of the building. Periodic monitoring by laser scanning is planned for future investigations.

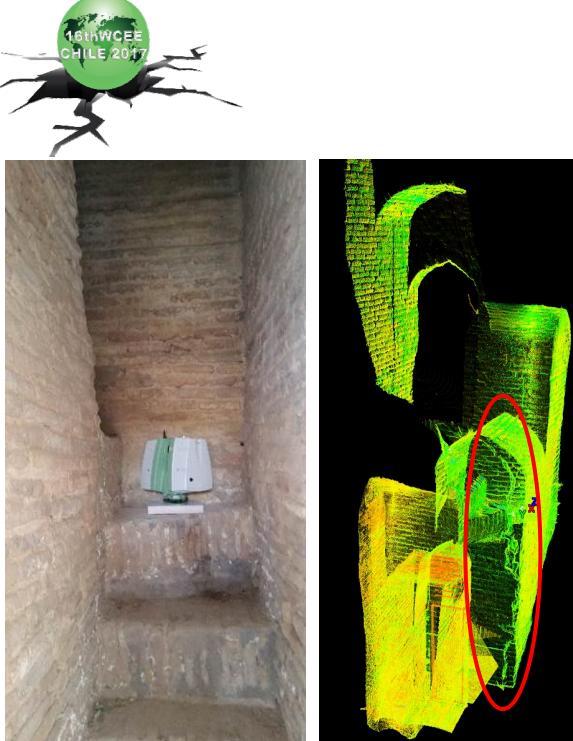
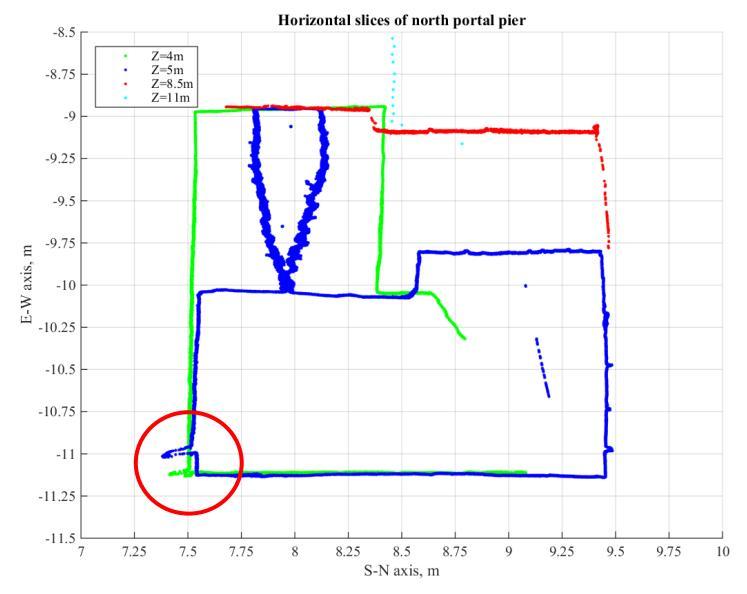
The horizontal slices of the north pier and the stairway with a long crack between the portal and the main structures are shown in Fig. 9. The scanner was installed at several elevations of the stairway with one of them shown in Fig. 9a. These scans were also stitched with the main registration. The view of the stairway's point cloud is shown in Fig. 9b. The horizontal slices at several elevations of the stairway are presented in Fig. 9c. A similar, but smaller crack, was observed inside of the south pier of the portal.

b) Point cloud of the crack (inside of red oval)

c) Slices showing that the crack in the red circle propogates from elevation Z=4 m in a 2 m by 2 m stairway

Fig. 9 – Continuous crack in a narrow stairway (north pier of portal)

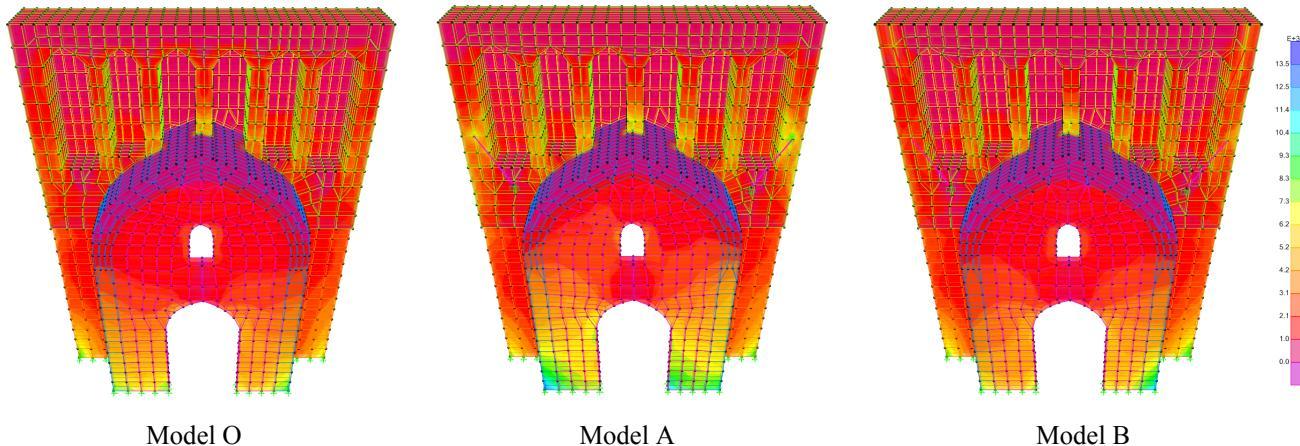
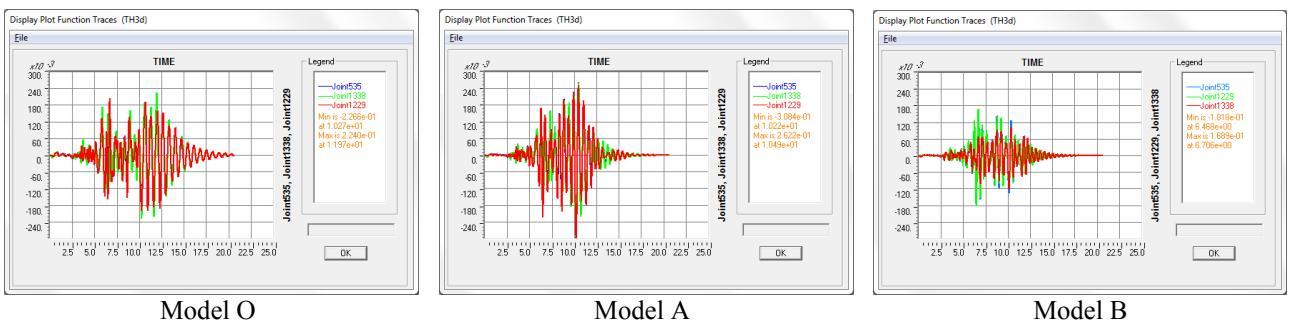
An analysis of the numerical results leads to the following conclusions. The current reinforcement is not as effective as it was intended to be. As presented in left and middle images of Fig. 14, the stress concentration at the bottom of the reinforced model is even greater than that in a model without any reinforcement. The same conclusion can be drawn from the displacements on top of the portal shown in Fig. 15. The current reinforcement failed to reduce the displacements on top of the portal. Moreover, the peak displacement of Model A is greater than that of Model O. Adding two more braces to Model A results in Model B that has much better performance as presented in the right image of Fig. 14. These braces also helped to reduce peak displacement on top of the portal, as presented in the right image of Fig. 15.

More analysis aiming at better reinforcement strategies are planned for future studies. These studies will include tests of the masonry wall, ambient vibration studies to estimate resonant frequencies at low excitations, and more detailed numerical models analyzed in a nonlinear time history simulation. The old reinforcement and any new reinforcement attracts the forces and creates stress concentration points. Therefore, these forces need to be properly distributed at the point where they come into contact with the masonry.
