# SEISMIC STRENGTHENING OF A 19TH CENTURY BANKING TEMPLE

O.A. Rosenboom<sup>(1)</sup>, T.F. Paret<sup>(2)</sup>, Kelly Cobeen<sup>(3)</sup>

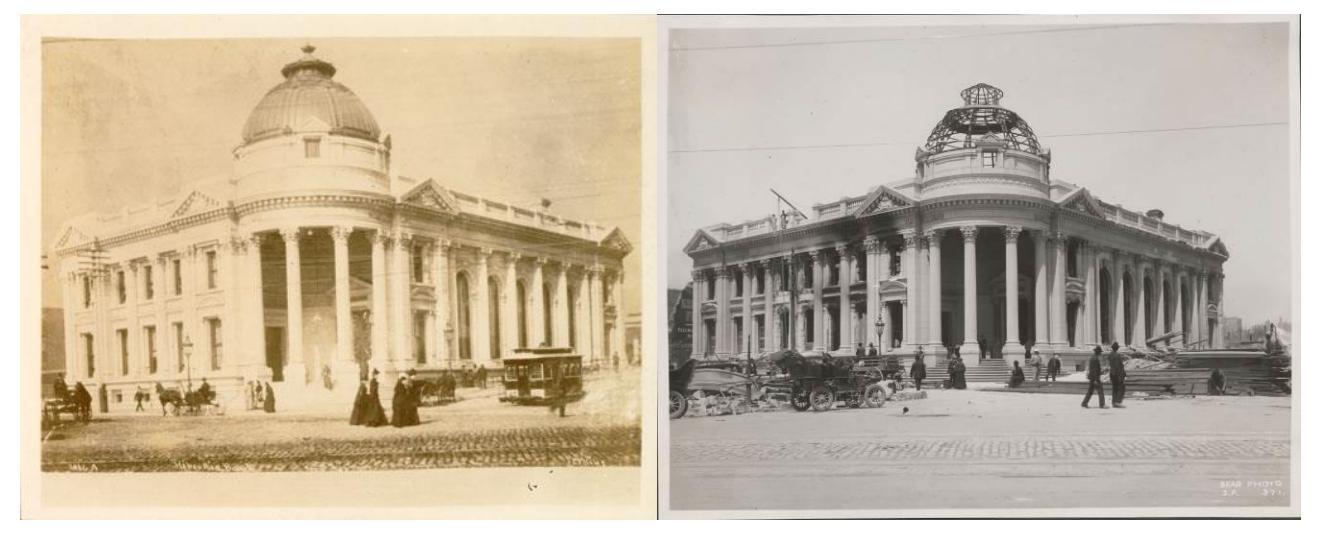
Fig. 2 – Hibernia Bank Building in 1894 (left) and after the 1906 earthquake (right)

...the granite fronts, especially around the doors and windows, were badly spalled by fire; other damage to the structure was confined almost entirely to the roof [3].

In 1904-1905, a seamless addition to the building that extended the building along McAllister Street enlarged the banking hall and added offices was also designed by Albert Pissis (Fig. 2). The final interior touches to the addition were being completed in January 1906, just three months prior to the April 18, 1906 earthquake. The structure survived the shaking from the earthquake structurally intact, or so it seems, but sustained significant fire damage to the interior and some of the granite exterior during the subsequent conflagration that consumed much of the city. From 1906-1908, the building was repaired to its former glory with new skylights designed by Pissis and executed in San Francisco [2] along with some new features including the construction of "fire proof" hollow clay tile (HCT) partitions throughout and the installation of roll-up steel security shutters at each window.

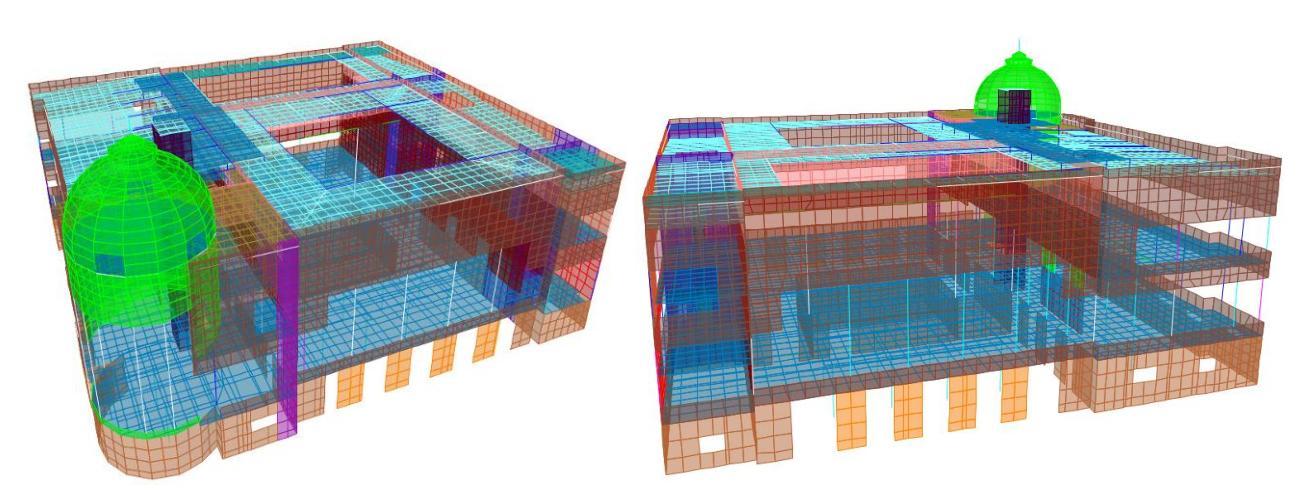
Damage to the concrete roof diaphragm in the 1906 earthquake was confirmed by benchmarking studies conducted using a SAP2000 v. 15 analysis model of the building as it appeared in 1906; an overall view of the model is shown in Fig. 5. The model was constructed after an extensive round of masonry shear testing that demonstrated the very competent state of the masonry. The model incorporates primarily linear-elastic material properties and elements, but includes nonlinear behavior associated with rocking of the masonry piers in both the in-plane and out-of-plane directions. The rocking capacities were incorporated into the model using nonlinear, elastic-plastic hinges at the bases and, where applicable, at the tops of existing masonry piers expected to undergo rocking during a strong ground shaking event. In cases in which there was a semi-circular full-height fluted granite column shafts, as is typically the case along the Jones St. and McAllister St. elevations, the cross-sectional area of that element was neglected for stiffness purposes but was included for mass and weight calculations.

Fig. 5 – Hibernia model looking at Jones Street elevation (left) and west alley elevation (right)

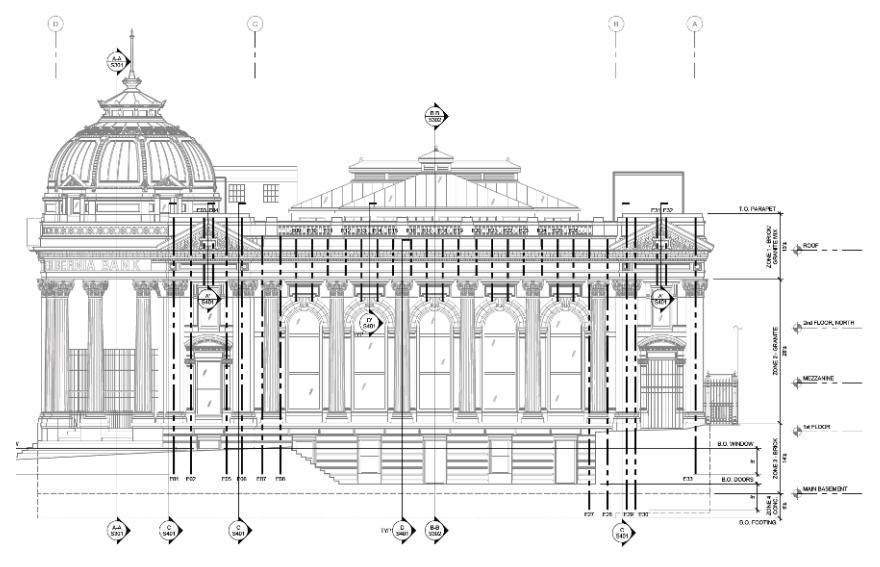
Fig. 7 – Center coring at Jones Street elevation

Pioneered in the 1980s [9], center coring of unreinforced masonry walls improves the integrity of unreinforced masonry walls. The increased strength that may also result from center-coring however is not permitted to be relied on in the San Francisco Building Code. At Hibernia, this reinforcement involved the coring of holes, installation of 25 mm diameter high-strength Dywidag rods as reinforcing, and grouting with a high-strength, low modulus polyester resin-based grout that was custom designed to reduced shrinkage and heat build-up during curing. The hybrid walls at Hibernia made center coring more difficult than usual, as coring through granite is substantially more difficult than coring through clay-brick masonry. Center coring was provided in every unreinforced masonry wall at the building, even though calculations show that most masonry piers will rock before shear cracking can occur, and only the very long masonry walls in the structure are shear critical. All of the rods were anchored into bond beams at the roof level, where their ends were fitted with a nut and encased in reinforced concrete, with many rods extending into the original concrete foundation. The spacing of the rods was approximately 1.3 meters on center, with rods also extending down to improve integrity of the masonry above doorways and window openings (Fig. 7). The full height center coring of the pediment piers, located on both street elevations, provides resistance against pier walking, which can be one drawback to pier rocking that otherwise is an effective earthquake survival mechanism.

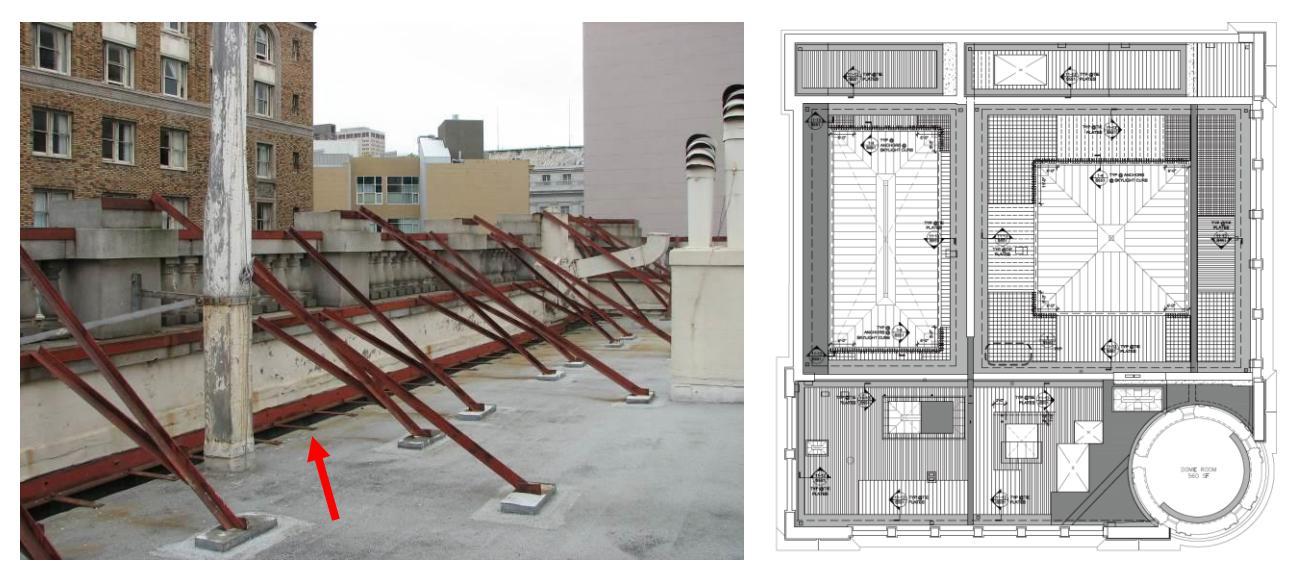
Around the perimeter of most of the discrete diaphragm segments on the roof, and allowing significant movement between the roof diaphragm and the perimeter and interior masonry walls, was a deep gutter (Fig. 8). To provide a connection between the bond beams and the existing concrete roof diaphragm, and to create continuity between adjacent roof segments, a pre-tensioned "tie plate," essentially a 150-mm thick reinforced concrete element cast monolithically with the bond beam, was cast over each roof diaphragm segment along its perimeter and the interface was pre-compressed with regularly spaced 19-mm diameter bolts and square plates. This provided a connection using shear-friction between the roof diaphragm and the bond beams that required no slip to engage.

Fig. 8 – View of roof including gutter (red arrow) and 1980s parapet bracing (left). Surface-mounted, topside FRP roof-strengthening plan (right).

To complete the roof strengthening, a unique FRP strengthening system was devised that allowed the project to save the original roof diaphragm, preventing the exposure of the interior finishes in the main banking hall to weather and dust during retrofit. The FRP effort involved installation of surface-mounted Carbon FRP (CFRP) sheets (Fig. 8) at the top of the slab, and near-surface-mounted CFRP rods around the perimeter and at openings in the diaphragm to provide chord strengthening and crack control. Additional CFRP surface-mounted sheets were provided at the soffit of the roof diaphragm in areas of higher demands. To provide a "basketing" backup system to help prevent chunks of the roof diaphragm from becoming dislodged and falling below, the topside and soffit surface-mounted FRP strengthening system were tied together with a network of FRP splayed anchors, with spacing determined from the level of stress in the analytical model.

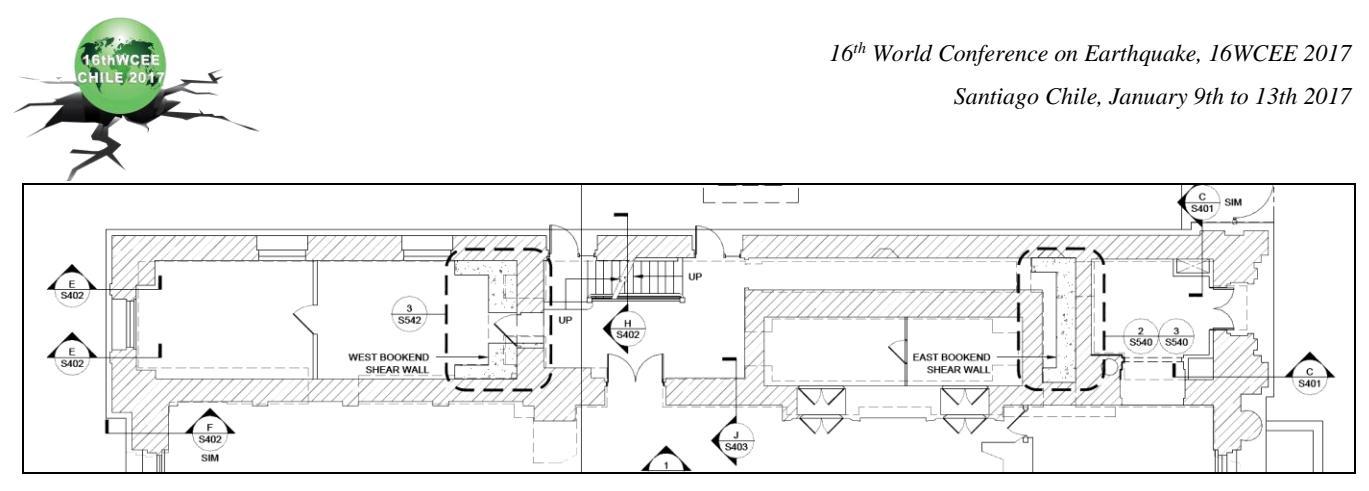
Fig. 10 - Closeup of bookend showing "box girder"

Another location where the historic structures report did not identify historically significant finishes was in the "bookend" located on the north side of the building where massive parallel masonry walls only twelve feet apart add significantly to the north-south seismic mass which was detrimental to the predicted building performance (Fig. 4). To turn this negative attribute into beneficial behavior, the walls were interconnected with reinforced concrete "web" members such that the entire system resists loads analogous to how a cantilevered box girder resists shear and bending moment in the north-south direction, with the existing massive masonry walls acting as flanges and the assembly acting as a vertical box girder that cantilevers for the basement (Fig. 10). Shear transfer between the new reinforced concrete wall and the existing masonry was accomplished using C-shaped wall sections that expanded the area available for the 45 degree inclined epoxy doweling between the concrete and the masonry. Force is delivered to the new walls via concrete collectors on the roof, while overturning is resisted in the basement by long reinforced concrete outrigger beams that help mobilize weight from the heavy first floor slab. This vertical box girder resists a substantial proportion of the total north-south seismic loading, hence the "bookend" terminology that was adopted for the element.
