# CRITICAL STRUCTURAL WEAKNESSES EXPOSED IN OLDER RC WALL-FRAME STRUCTURES DURING THE CHRISTCHURCH EARTHQUAKES

#### Abstract

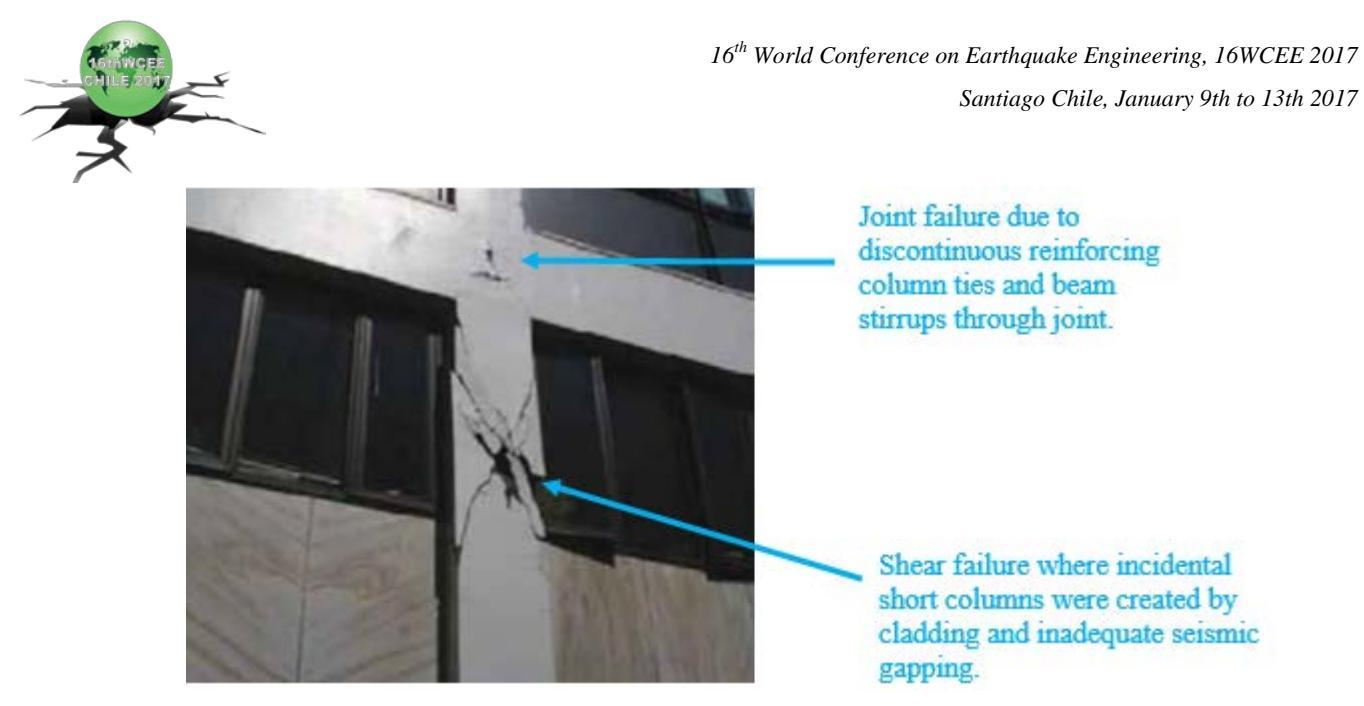
The perimeter frames sustained heavy damage, particularly at the beam column joints. In addition, there was significant cracking and spalling to columns on the northern perimeter (see Fig. 4) [10]. The engineer that assessed the damages suggested that the structure appeared to have "twisted vigorously" around the shear core, leading to perimeter frame damage; the engineer believed the building to be near collapse. In addition, the building had developed a lean towards the south-west, which would suggest differential settlement of the foundation, and made salvaging the structure impractical [10].

Fig. 4 shows an image of typical column shear failure on the north side of the structure. The shear failure happened as a result of the contact between the column and the cladding when extreme torsion caused excessive displacements at the perimeter farthest from the center of rigidity [2]. Shear failure in the columns suggests that there was inadequate detailing at the point where the column made contact with the cladding panels. Along with the column shear failure, the image also shows joint failure above the column. Joint failure suggests inadequate detailing through the beam-column connection.

Fig. 4 - Column and joint damage on north side of Securities House. Source: [2], and annotated by authors.

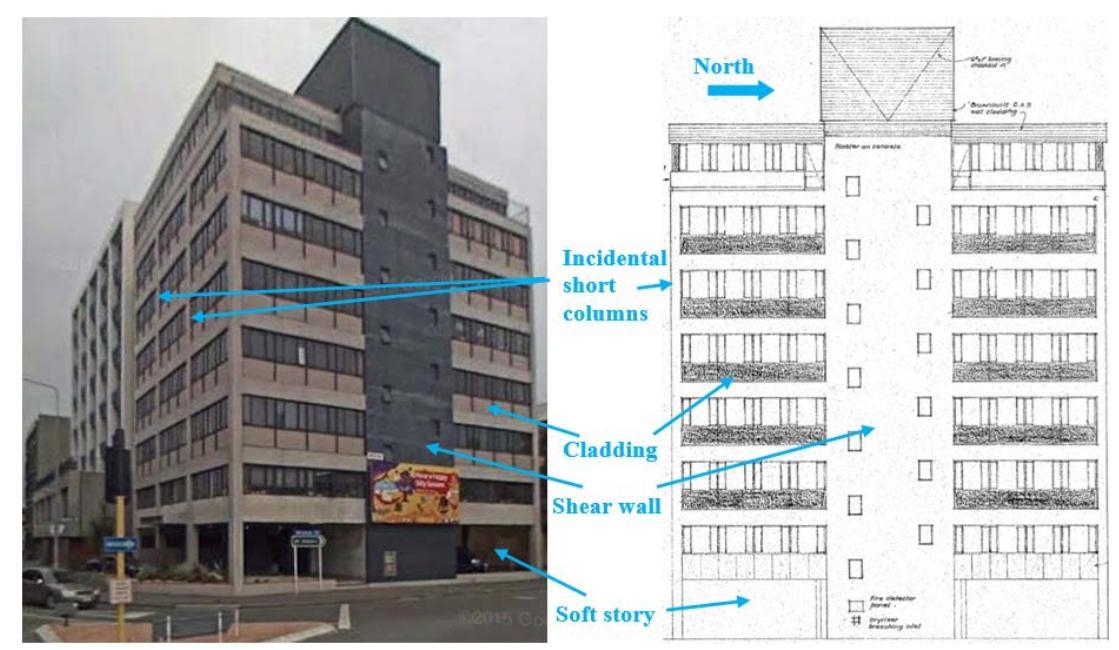
Securities House has an apparent soft-story vertical stiffness irregularity (G6, following the CSW numbering scheme in Table 2) at the first level, which is evident in Fig. 5. The columns at the 1<sup>st</sup> story are taller than the upper level columns and in addition the entire ground level is open, which makes this a CSW because of the vertical discontinuity in stiffness and, likely, strength. It would take detailed strength calculations based on the member detailing in the plans to confirm this, but qualitative engineering judgment can easily identify this weakness.

Fig. 5 - Elevation of the Securities House. Sources: left image google maps, right image building plans [15], annotated by the authors.

It is important to examine the load paths through shear wall. The elevation view in Fig. 5 shows that there are not major discontinuities along the height. Had there been a discontinuity it would create a vertical stiffness irregularity or a weak story G5 CSW. Likewise, the loading path through the wall goes directly into the piers below. Some of the case study buildings had loads from the walls above transfer into foundation beams which then had to divert the load to piers. These foundation beams failed and, as a result, the loading path from the wall to the foundation is an important (G4) CSW to check.

The damage evidence suggests that short columns were incidentally created at the perimeter, due to contact with cladding due to inadequate seismic gap between the cladding and the column [2]. Referring back to Fig. 5, it can be ascertained from both the physical building and the building plans that cladding is prevalent throughout the height of the structure. Furthermore, the cladding is inset flush with the exterior, essentially sandwiched between the columns. The consequence of this configuration is that when the displacements of the building are large enough, contact between cladding and column is possible, changing the moment and shear demand on the columns [2]. In addition, Fig. 8 has a typical perimeter column reinforcing plan detail which shows that there was not additional reinforcement detailing specified which would allow for this contact. In short, Securities House has a (G7) CSW because there is cladding between the columns.

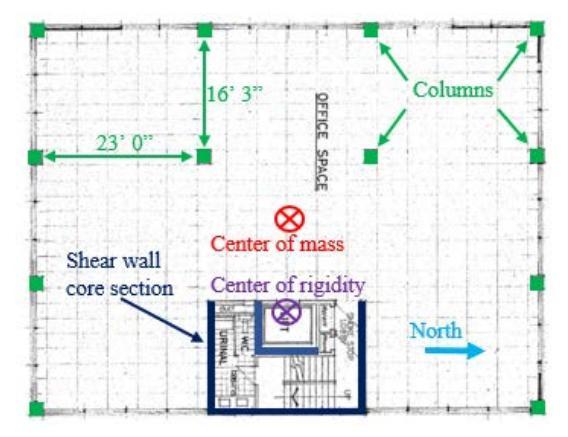
A common (G1) CSW exhibited by many of the most severely damaged Christchurch buildings is torsional eccentricity caused by nonsymmetrical wall layout. The shear wall core of Securities House is located to the far east of the building as indicated in Fig. 6. Reasonable engineering judgment locates the center of stiffness offset from the center of mass, because of nonsymmetrical wall layout in one direction. During a

seismic event, rotation of mass around the center of rigidity will lead to the largest displacements at the north and west walls [13]. This conclusion comes as no surprise and is supported by the Level 2 damage report which states that the building appeared to have "twisted vigorously" around the shear core and that most of the column damage was on the north and west side [10].

The core section is not quite square, but does not qualify for a G2 CSW (narrow core). Since the configuration of the core section is a C then there is only a single wall in the North-South direction to resolve the lateral force. Furthermore, despite the inherent ability for the beam-columns connections to resist moment forces, the single shear wall is the primary lateral force resisting system for the entire structure in one direction. This is the definition of a non-redundant system and leads to the identification of a non-redundant G3 CSW for this structure.

Fig. 6 - Plan view of Securities House. Source: Building plans [15], annotated by the authors.

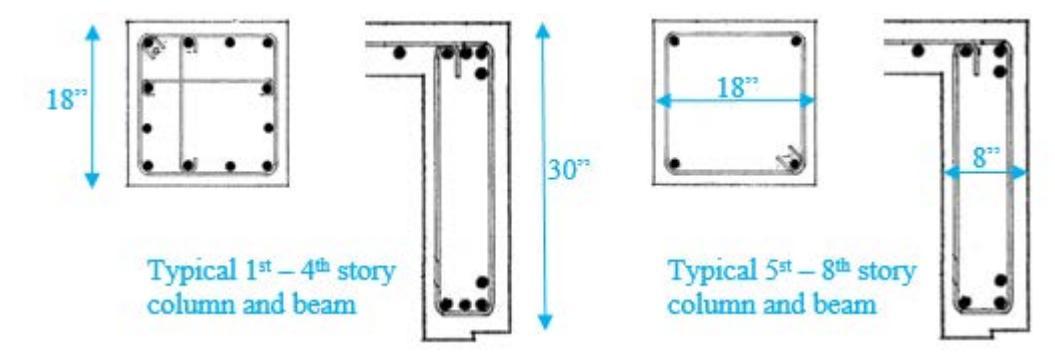
Evidence supporting the claim that the deformation capacity of the columns is not sufficient to resist large lateral displacements is prevalent in many of the specific details of the columns, beams, and beam-column connections. By comparing typical beam column size throughout the structure, as provided in Fig. 7, the beams are clearly very deep compared to the height of the column. Also, comparing the quantity of rebar in the beams and columns suggests that columns are likely the weakest link without more detailed calculation (L3 CSW).

Fig. 7 - Typical beam and column configuration at lower and upper levels, showing likely failure of columns preceding beams. Source: Building plans [15], annotated by authors.

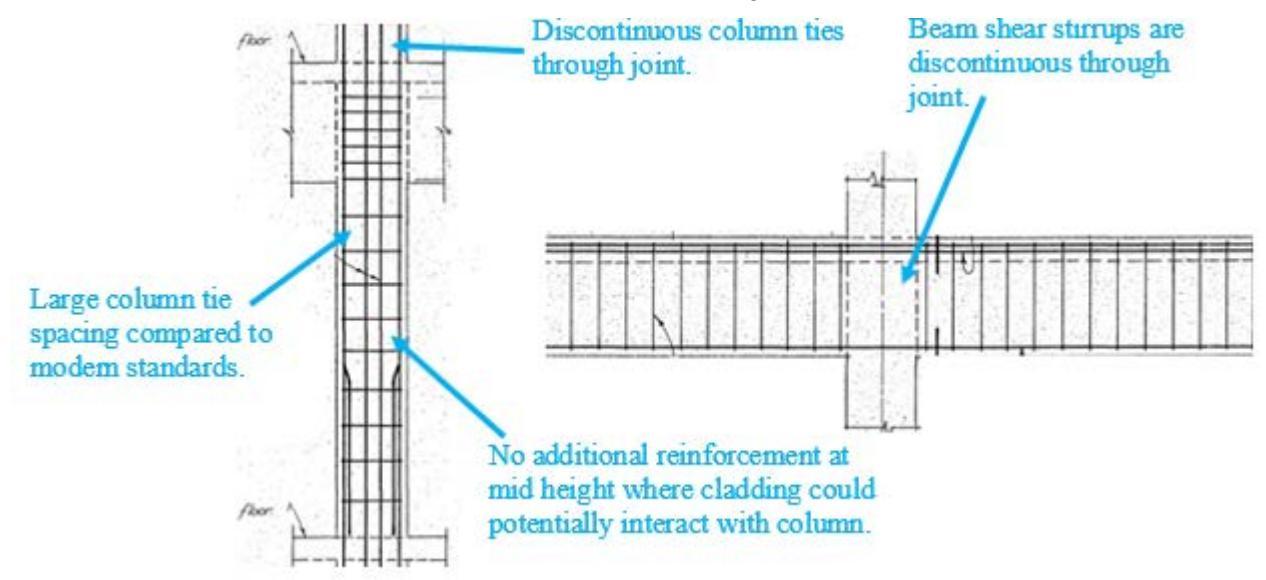
Fig. 8 - Inadequate tie and stirrup spacing in columns and at joints. Source: Building plans [15], annotated by the authors.

Fig. 8 also shows us that the column tie detailing is inadequate because of large spacing compared to modern detailing standards. This is typical of older concrete structures, but also a dangerous L4 CSW because it allows the possibility of shear failure in the columns. In addition, Fig. 8 also shows that both the beam stirrups and column ties are discontinuous through the joints. Modern detailing requires joints to be much stronger than the beams or columns, and also requires confinement of the joints [14]. Confinement would be difficult to achieve without sufficient reinforcing, and the lack of confinement/continuous reinforcing through the joints is considered a (L5) CSW.

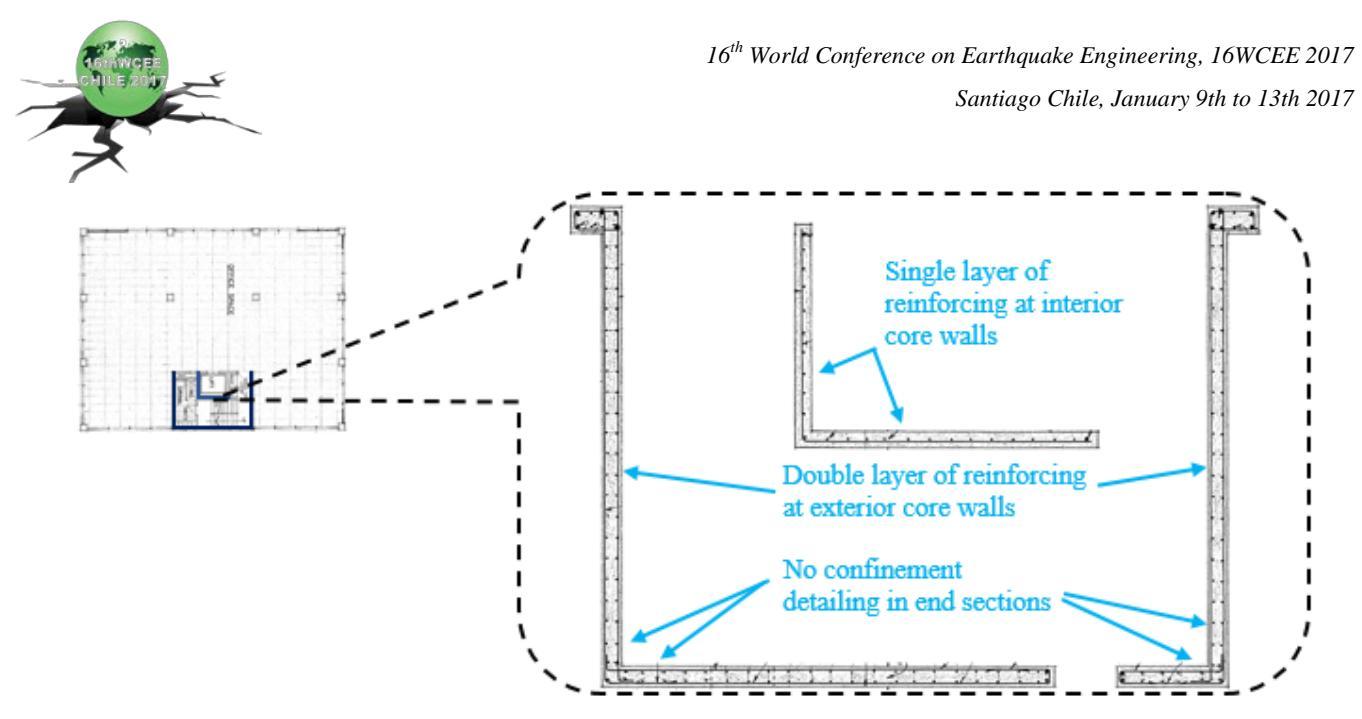
Modern shear walls would generally have additional confinement rebar specified for end "boundary" sections. The Fig. 9 detail is the core section for Securities House. This image and the elevation detailing images which are not included in this paper all show that there is no special detailing for boundary confinement. The lack of detailing is a L2 CSW because lightly reinforced walls have been shown to buckle. Fig. 9 also emphasizes that there is a bit of subjectivity required in the decision making about CSWs. In this case, the external core section has a double layer of reinforcement, while the inner core section has a single layer of reinforcement. The single layer would be considered a L1 CSW and the double layer would not. Since we neglected the inner core in our assessment of a redundant system then it seems appropriate to neglect it here as well, assuming it is not a critical part of the lateral force resisting system.

Fig. 9 - Reinforcement detailing in wall core section, shown with respect to location on the building plan view. Source: Building plans [15], annotated by the authors.
