VERTICAL MOTION EFFECTS ON SUSPENDED CEILINGS

G.C. Yao⁽¹⁾, W.C. Chen⁽²⁾

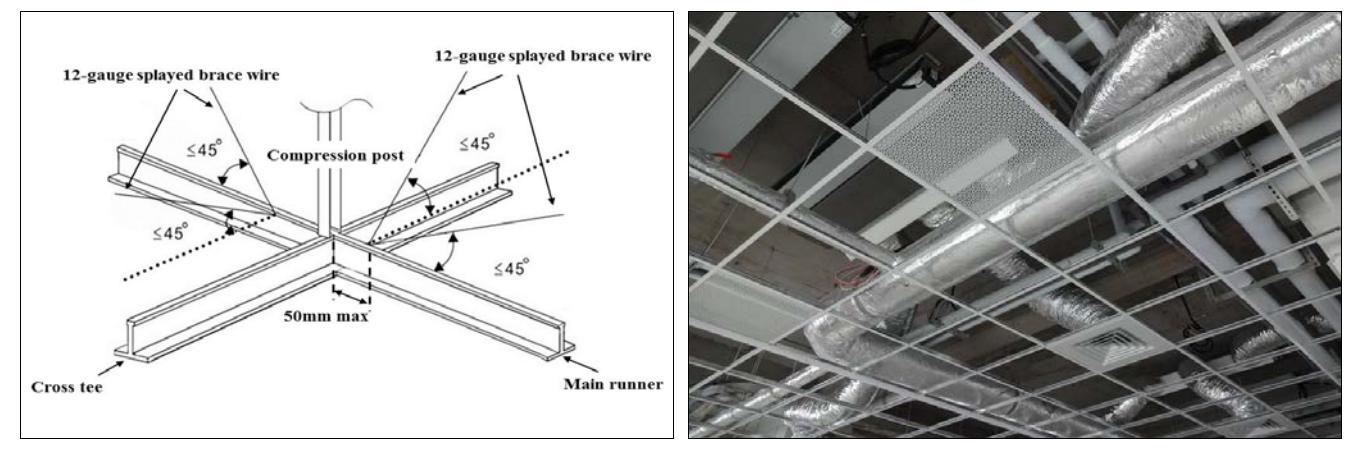
Fig. 2 – Unfavorable installation condition
