# Implementation of a seismic retrofitting solution for the San Pedro de Atacama church in Chile

J. Vargas<sup>(1)</sup>, C. Sosa<sup>(2)</sup>, R. Aguilar<sup>(3)</sup>, B. Yuste<sup>(4)</sup>, C. Heisen<sup>(5)</sup>

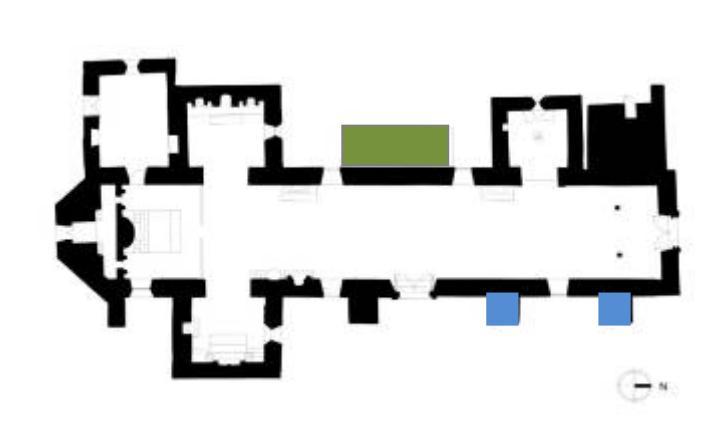
Fig. 3. Floor plan of the church with two new buttresses included (light blue). Green buttress is a widening of the west central wall (1.2 m height aprox.).

Two new buttresses are reintegrated into the 22 m long and 1.20 m thick east wall of the temple. The buttresses have a stepped typology and rise on a foundation of 0.80 m deep, built with stone boulders and lime mortar. Masonry rises with  $0.60 \ge 0.40 \ge 0.10$  m adobe bricks which are hooked to the wall of the temple every 3 rows at a depth of 0.30 m.

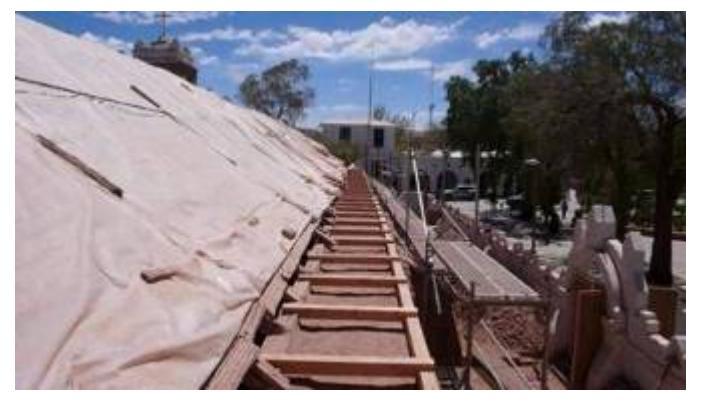
Fig. 8. Wood collar beam in the top of the walls.

Only the coronation of the walls of the central nave had a support beam for roof structure. The measure of this piece is variable between 63 mm and 152 mm. In the case of the side chapels and sacristy this beam does not exist and the beams rest directly on the adobe walls. The new design considered a wood ring beam that was installed in the top of the walls (see Fig. 8). This double wooden bond beam, reinforced with crossbars, was installed around the perimeter of the temple during the consolidation of the roof, including side chapels and sacristy. Timber was 100 by 100 mm and crossbars were spaced 1 m. This solution was implemented in order to provide a better distribution of loads of the roof to the walls and act as an anchor for the eaves of the church. Fig. 9 shows the process of intervention.

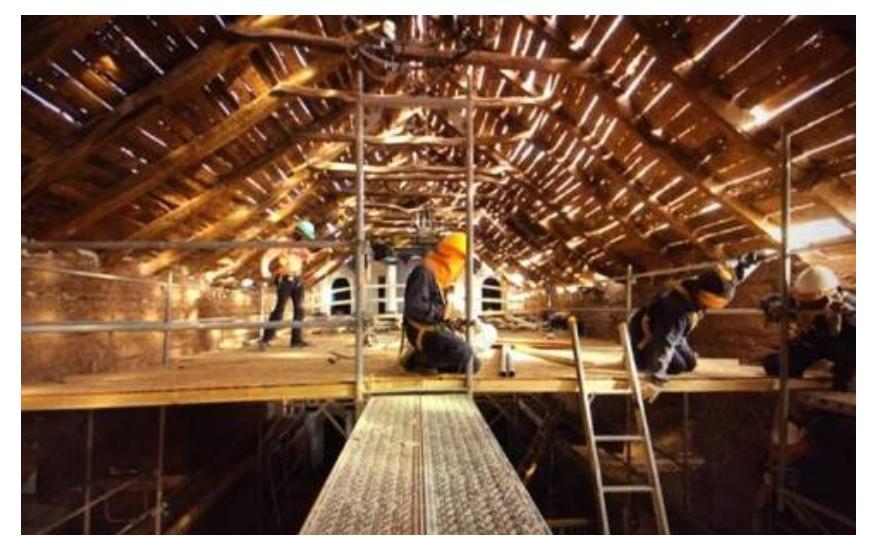
Fig. 9. Support platform to work the wooden roof.

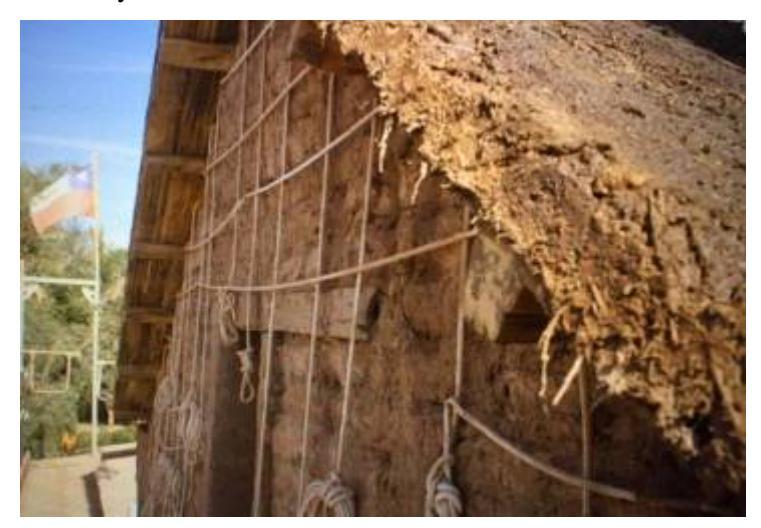
Fig. 10. Beginning of the installation process of vertical and horizontal ropes.

Structural reinforcement of the walls is made using synthetic netting ropes. The reinforcement includes the walls of the main nave, new and existing buttresses, bell tower and side chapels. The basis of this method is to confine the adobe walls by tensioning ropes and improve their behavior in case of any seismic loads. Part of this system consists of connecting the bond beam with the mesh to the walls, thus allowing an overall behavior of the structure as shown in Fig. 10, Fig. 11 and Fig. 12.

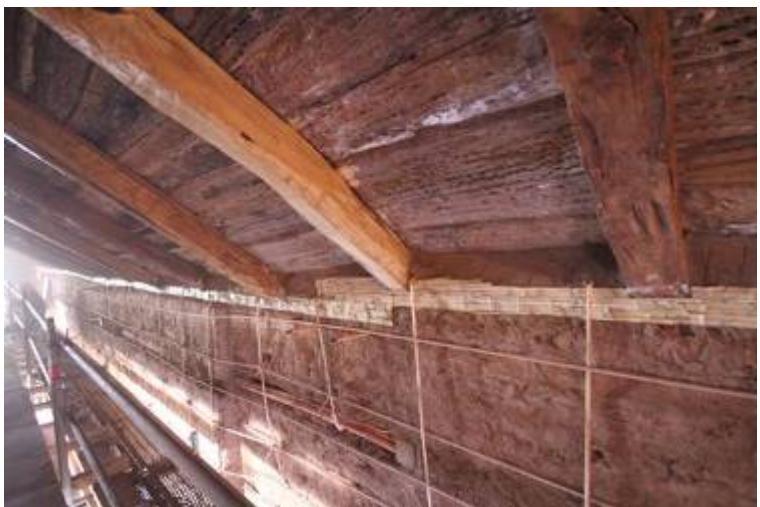
Fig. 11. Ropes are connecting roof and walls through the collar beam.

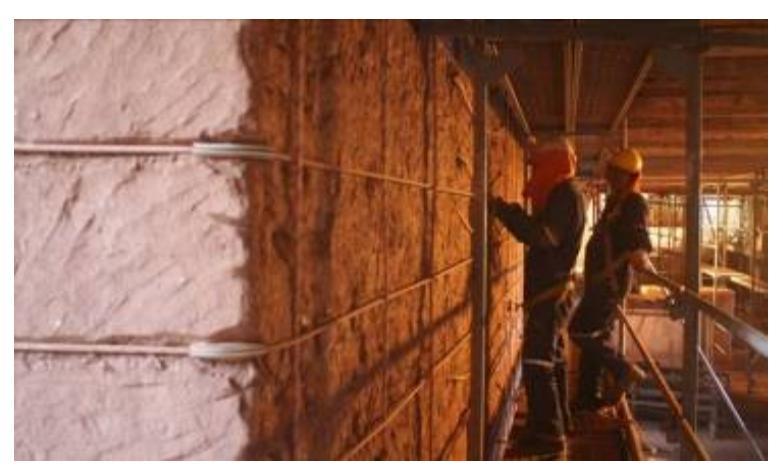
Fig. 12. Structural reinforcement by tensioning synthetic ropes.

Synthetic polypropylene ropes have a diameter of 12 mm and have a maximum tensile strength of 12.89 kN (1315 kgf) and an elongation of 35%. Ropes are distanced 0.60 m vertically and 0.30 m horizontally in the upper third of the wall and 0.40 m in the lower 2/3 of the wall (Fig. 12). Structural reinforcement of the bell tower is done by netting synthetic ropes in the second body of the construction. In this case polypropylene ropes have a diameter of 6 mm, are distanced 0.15 m vertically and horizontally and a have maximum tensile strength of 3.9 kN (398 kgf) and an elongation of 36%.

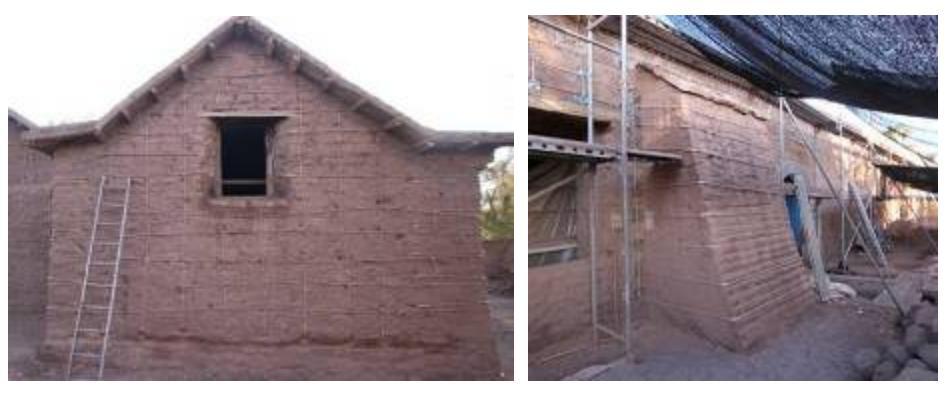
Fig. 13. Vertical and horizontal layout of the ropes.

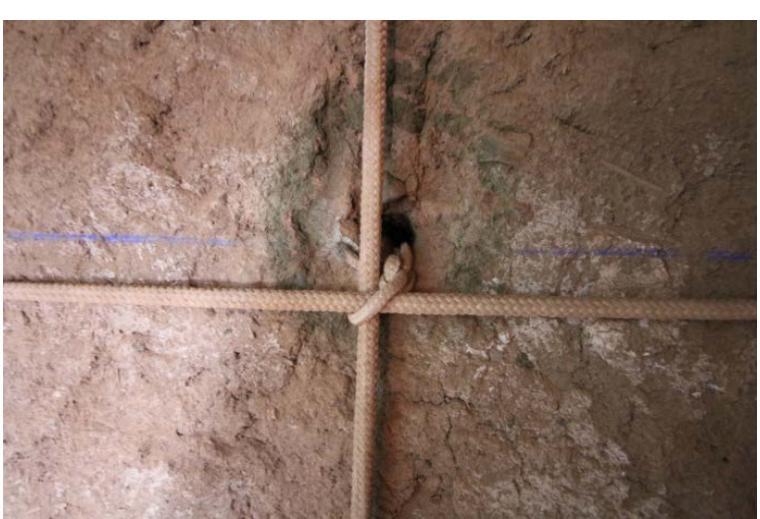
Fig. 14. Crosstie ties the ropes at the intersection

The adobe walls are perforated in section to fix the mesh on both sides of the wall with 6 mm diameter crossties, while in the bell tower crossties are 4 mm diameter. The crossties tie side by side the ropes of the mesh, the upper half of the wall is tied on every intersection of the ropes while the bottom half of the wall is just alternately tied (Fig. 13 and Fig. 14). The ropes are not at the level of the mud mortar joints, but in the middle of adobe bricks as a precaution. Ropes are knotted by double eight knots. Knots get an approximate initial tension of 392 N (40 kgf); two days after the knot suffers a loss of strength up to approximately 275 N (28 kgf), and the string tension is stabilized within two days.
