EVALUATION OF EARTHQUAKE PERFORMANCE OF HISTORIC MULTI-STOREY MASONRY STRUCTURES: BEYOĞLU CASE

E. T. Alhan Simsek⁽¹⁾, N. Torunbalci⁽²⁾

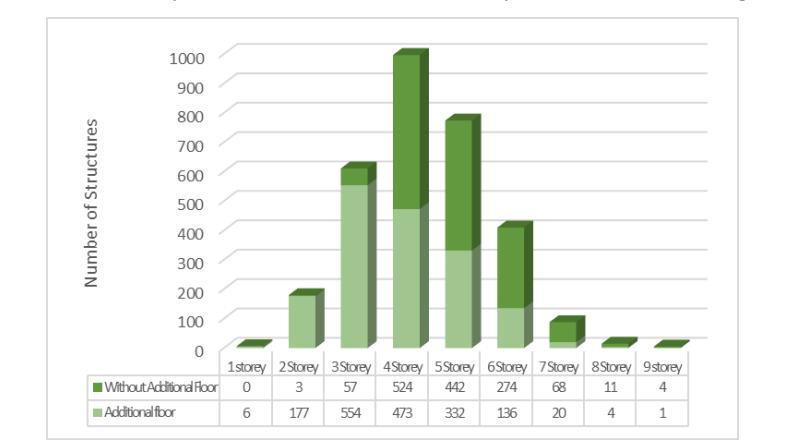
Table 3 - Additional storey status and number of storey of historic buildings located in Beyoğlu

Average number of stories is expected to be 3 because Beyoğlu district is located the 2^{nd} degree earthquake zone[4]. However, when the number of stories in these areas is examined, it is seen that the 3, 4, 5, and 6-storey buildings are high in number as can be seen in the Table 3. Also, there are a lot of buildings that have an additional storey as can be seen in Table 3.

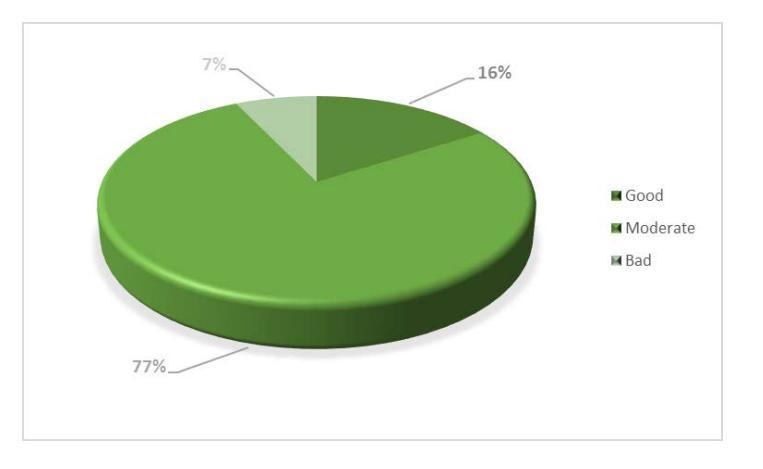
Table 4 - The protection status of the masonry structure in the Beyoğlu District

When the protection status of masonry structures located in Beyoğlu is examined, it is seen that only 16% is in good condition as can be seen in Table 4. Also, 77% of them are moderately protected. The moderately protected buildings have a probability of getting damaged after the probable earthquakes. Therefore, these structures need to be protected, repaired, maintenance and reinforced in order to pass on to the future generations. 7% of the structures has been observed to be in very poor condition and is about to collapse.

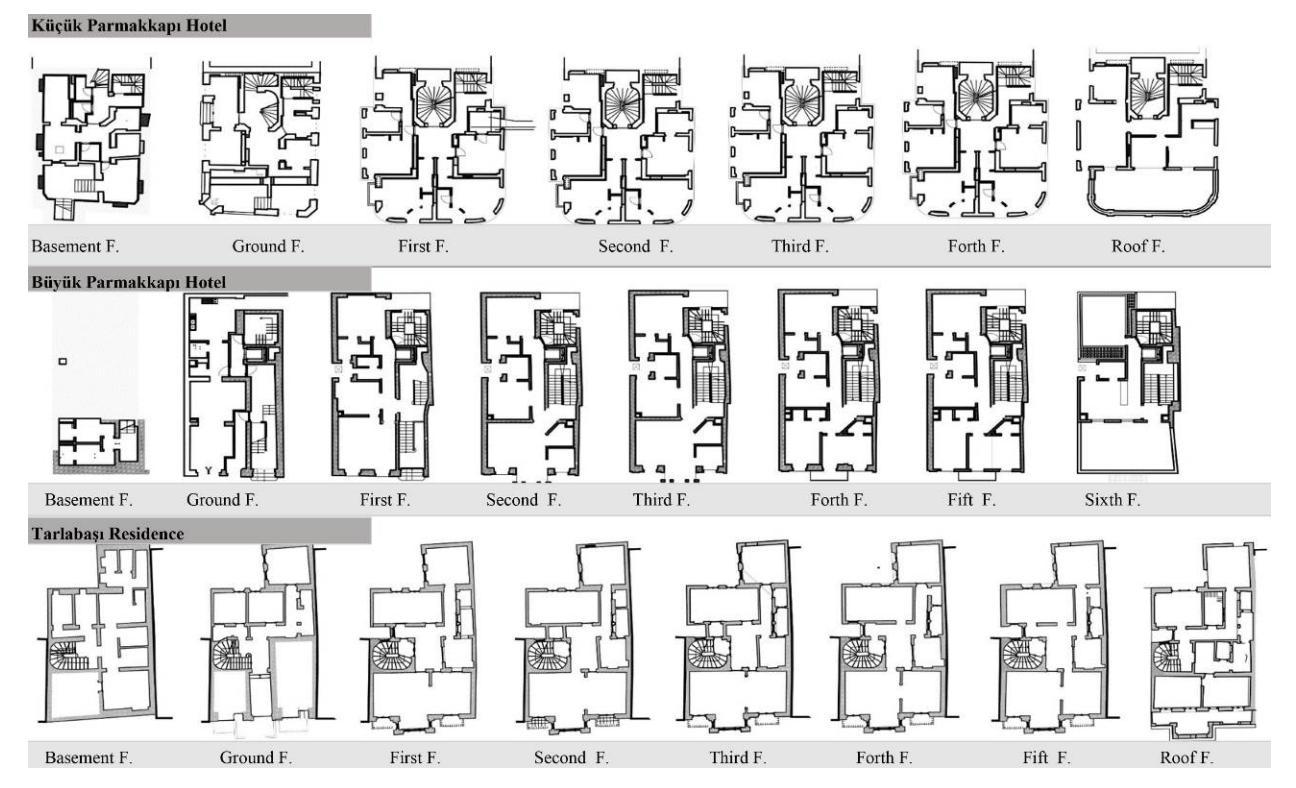
Figure 2 – The floor plans of three strengthened masonry structures of registered civil architecture in Beyoğlu District

Vertical structural system should be continuous and the main structural system of the building should be approximately symmetric with respect to the orthogonal axis on plan according to the Turkish Earthquake Code. When the intervention plans of these structures are examined, it can be seen that the layout of load-bearing walls of the residential structure is largely preserved and most of the walls are continuous in vertical direction. Two additional stories were added in the scope of the repair and strengthening project of this building. High number of interventions on the structural system was done for creating necessary spaces due to the change in function of the from-hotel-to-residential converted structures. Some of the walls were removed, some new walls were constructed, and some space for elevator, stairs, ventilation, and installation were opened on the floor. Therefore, in these structures, vertical-wall continuity is not sufficient.

These three structures are located in a second-degree earthquake zone. Maximum number of storey except basement is 3 stories according to the regulation for the masonry structures located in 2^{nd} degree earthquake zone. Storey height can be at most 2.40m in basement, and 3.00m in other stories [4]. The related structures cannot satisfy the requirements as can be seen in the figure 2. Also, partial basement construction is not suggested. As can be seen in the figure 2, there is a partial basement in Büyük Parmakkapı Hotel, but the two others.

The required condition of being 7.5m of the largest unsupported length for load-bearing walls in 2^{nd} degree earthquake zone is satisfied in the walls (L_{max} =4.30m) in each direction in Tarlabaşı Residents and Küçük Parmakkapı Hotel structures. However, there are some walls in Büyük Parmakkapı Hotel that do not satisfy the conditions in Y direction. On the other hand, along with any of the unsupported length of a wall in the regulation, total length of door and window installation space on the plan should not exceed 40 % of the unsupported length. This condition is not satisfied in all three buildings on facade and some internal walls. The largest door or window space length on plan should not be exceeding 3.0 m according to the regulation for masonry structures. There is no wall and window space exceeding this condition in all three buildings.

In the 1st and 2nd degree earthquake zone, full part of the wall between the closest window or door to the corner of the building and the corner of the building should be larger than 1.5m on plan. Also, apart from the corner of the building, the full part of the wall between window and door space should be larger than 1.0m on plan[4]. These two conditions cannot be satisfied in all 3 buildings more than once. On the other hand, the full part of the wall between the closest window or door space to the intersection of two perpendicular walls except than the corner of the buildings and the intersection of the walls cannot be smaller than 0.50 on plan for all earthquake zones[4]. This condition is satisfied with none of the buildings.
