SEISMIC PERFORMANCE OF REINFORCED CONCRETE CORNER BEAM-COLUMN JOINT SUBJECTED TO BI-DIRECTIONAL LATERAL CYCLIC LOADING

K. Kitayama⁽¹⁾, H. Katae⁽²⁾

Abstract

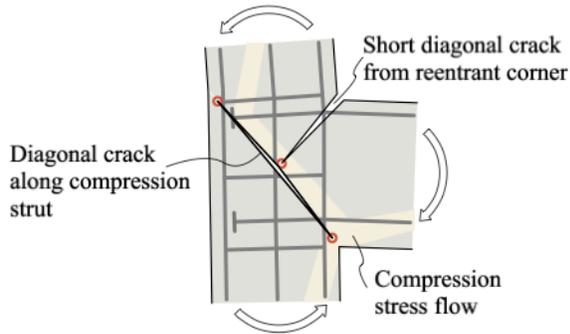
Fig. 1 – Joint hinging model at exterior joint [2]

A new mechanism of joint hinging was proposed by Shiohara [1], a professor at the University of Tokyo, Japan, for a beam-column joint in reinforced concrete (R/C) moment-resisting frames. The joint hinging mechanism is observed in laboratory tests when an ultimate flexural capacity of a column section is close to that of a beam section in a R/C unit frame. A joint hinging model proposed by Kusuhara and Shiohara [2] is shown in Fig.1 for a plane exterior beam-column joint. An exterior beam-column subassembly is divided into three elements; an upper column, a lower column and a beam. Each element rotates like a rigid body as shown in Fig.1, forming a principal diagonal crack along a diagonal compression strut in a joint and a short diagonal crack developing from a reentrant corner in a tension side.

Crack patterns and damage conditions on the south surface are shown in Photo.2 at a story drift angle of 1 % and 2 %. Flexural cracks occurred at beam critical sections for two specimens at a story drift angle of 0.2 %. Principal diagonal cracks occurred in a beam-column joint and beam longitudinal bars and joint lateral hoops yielded during a loading cycle with a story drift angle of 1 % for two specimens. Column longitudinal bars yielded at a story drift angle of 0.9 % for Specimen K2 with a column axial stress ratio of 0.04 and 1.5 % for Specimen K3 with a column axial stress ratio of 0.12 respectively. Almost all longitudinal bars in beams and a column yielded at both the vertical or horizontal critical section and a point crossing a short diagonal crack which developed from a reentrant corner shown in Fig.1.

The story shear force - story drift relations are shown in Fig.5 in the east-west and north-south directions. The story shear force was computed from moment equilibrium between measured beam shear force and the horizontal force at the loading point on a top of the column. Peak story shear forces and story drift angles when reaching the peak story shear force obtained by the tests are summarized in Table 3 with predicted ultimate capacities of a beam and a joint. The ultimate beam flexural capacity was computed by a section analysis assuming that a plane section remains plane, indicated by a horizontal solid line in Fig.5. The joint hinging capacity was evaluated according to a proposed method by Kushihara and Shiohara [2] based on the failure mechanics in a beam-column joint shown in Fig.1, indicated by a horizontal dotted line in Fig.5.

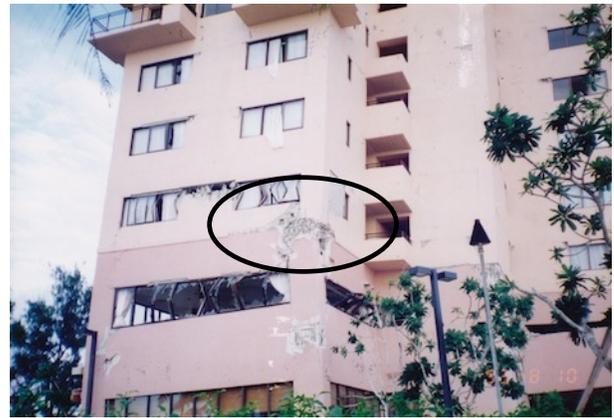
Photo. 1 – Failure of corner beam-column joint by Guam Island Earthquake in 1993

Recent experimental studies to verify the joint hinging mechanism have been conducted using 2D plane interior and exterior beam-column subassembly specimens. There are, however, few tests which use 3D beam-column-joint subassemblies with orthogonal beams to each other which frame into a column such as a corner beam-column joint. For corner columns in actual R/C buildings, a loss of capacity to sustain column axial load resulting from severe damage to a corner joint led to partial story collapse of the building by past earthquakes, for example, Guam Island Earthquake in 1993 as shown in Photo.1. An ultimate flexural capacity of a corner column frequently decreases during an earthquake because an axial load to a corner column cyclically increases and decreases by change of direction of lateral loads induced by earthquake excitations. Therefore, it is of great importance to investigate earthquake resistant performance of a corner beam-column joint subjected to tri-directional earthquake loading.

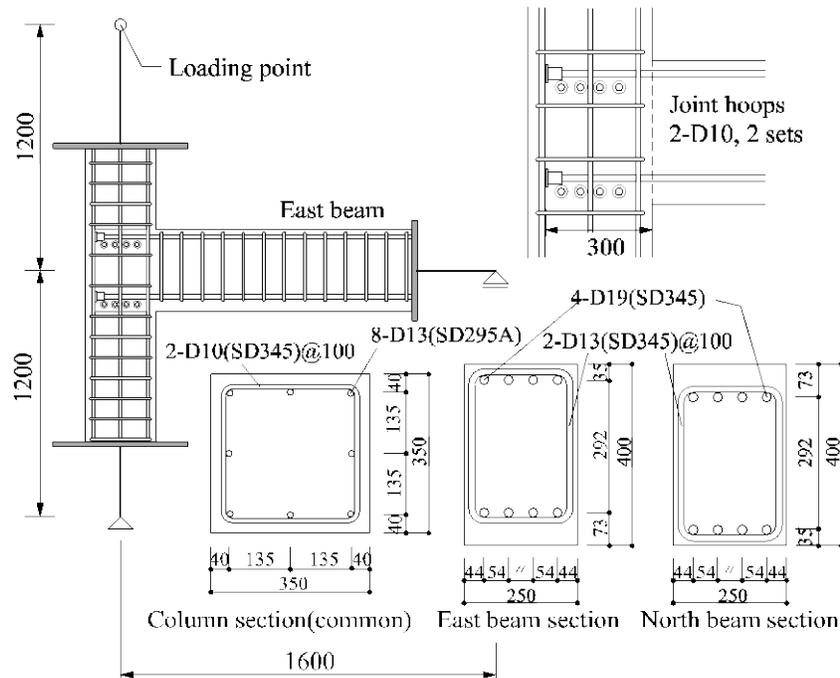
Fig. 2 – Details of specimens

Two half-scale 3D corner beam-column subassemblage specimens without slabs, removed from a 3D frame by cutting off the beams and columns at arbitrarily assumed inflection points, were tested. A configuration of specimens, section dimensions and reinforcement details are shown in Fig.2. Properties of specimens and material properties of concrete and steel are listed in Table 1 and 2 respectively. The length from a center of the column to a support of the beam end was 1600 mm. The height from a center of the beam to the loading point at the top of the column or to the bottom support was 1200 mm respectively.

Section dimensions and reinforcement arrangement for beams and columns were common for two specimens. The column with a square cross section of 350 mm width had longitudinal bars of 8-D13(SD295A) and hoops of 2-D10(SD345) at center-to-center spacing of 100 mm. The beam had width of 250 mm and depth of 400 mm with longitudinal bars of 4-D19(SD345) at a top and a bottom respectively of the section and stirrups of 2-D13(SD345) at center-to-center spacing of 100 mm. A ratio of the total amount of column longitudinal bars to a column gross sectional area was 0.83 % and a joint-hoop-ratio was 0.28 %, which almost correspond to the lower bound required by Japanese Building Standard Law or seismic provisions. Beam longitudinal reinforcement was mechanically anchored by an end plate within joint core concrete with a horizontally projected length of 300 mm corresponding to 0.86 times the column depth. Concrete compressive strength was

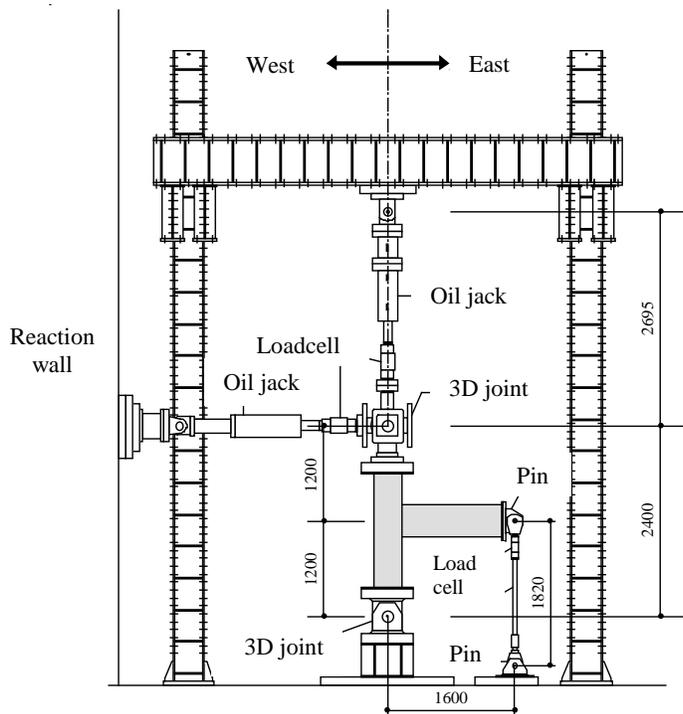
Fig. 3 – Loading apparatus

A loading apparatus is shown in Fig.3. Beam ends were supported by horizontal rollers, while a bottom of the column was supported by a universal joint. The reversed cyclic horizontal load and the constant axial load were applied at a top of the column through a tri-directional joint by three oil jacks. Rotation around a vertical axis in the column was prevented by a steel pantagraph placed in a horizontal plane. Specimens were controlled by a story drift angle for a loading cycle of 0.25 %, 0.5 %, 1 %, 1.5 %, 2 %, 3 % and 4 %. The story drift angle was defined as a story drift divided by a height of the column; 2400 mm.

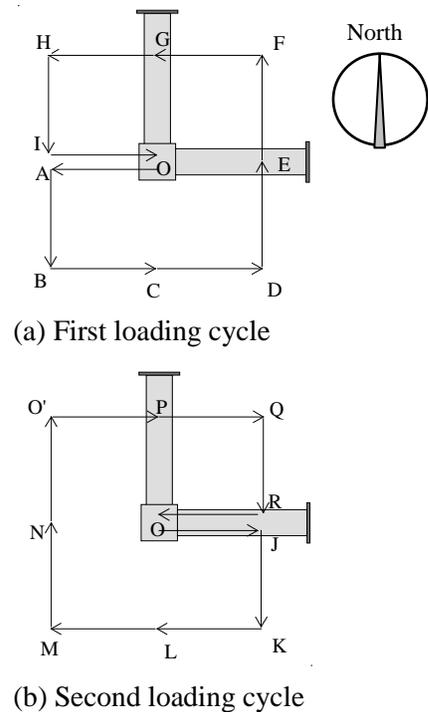
Fig. 4 – Loading Paths at top of column

Loading paths at a top of the column under bi-directional lateral load reversals are shown in Fig.4. The column top moves on a square in the horizontal plane. For a first loading cycle, after a prescribed drift was given to the top of the column from the origin point O to the point A in Fig.4 (a) to the west direction, a loading path depicts a counterclockwise square from points A to I, and then the column top goes back to the origin point O. For a second loading cycle, a loading path depicts a clockwise square from points J to R in Fig.4 (b). For all bi-directional lateral loading cycles, at first the lateral force in one direction was applied and then that in the other direction was applied while keeping the story drift in one direction constant.

Widths of a principal diagonal crack along a main compression strut in a joint are shown in Fig.6. Those were measured by a crack-gauge under bi-directional loading at a story drift angle of 2 % located at both loading point F and point G at a EW directional story drift of zero as shown in Fig.4 (a). Note that a NS directional story drift was kept constant during loading point F to G, sustaining some story shear force in the north-south direction. Points where crack widths were measured are shown in Fig.7; a principal diagonal crack crosses a center axis of the column at point “a” and crosses another diagonal crack generated by a reversed loading at point “b”.

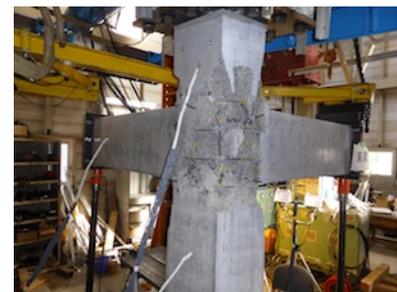
(a) Outer surface

(a) Crack patterns at story drift angle of 1 %

Damage in a joint panel for Specimen K3 with a column axial stress ratio of 0.12 was mitigated up to a story drift angle of 1.5 % comparing with Specimen K2 with a column axial stress ratio of 0.04, but progressed abruptly during a loading cycle with a story drift angle of 2 %. Core concrete in a joint region spalled off and column longitudinal bars buckled within a joint at a story drift angle of 3 % for Specimen K2 and 2 % for Specimen K3 respectively. Column bar buckling was caused by concrete crushing in beam-column joint core and inferior confining action due to a little amount of joint lateral hoops and column longitudinal bars.

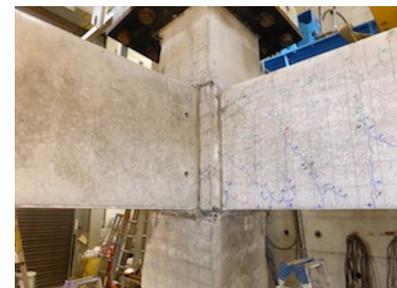
(b) Inner surface

Damage in a beam-column joint surface without framing beams was heavier than that with framing beams as shown in Photo.3. This indicates that beams framing into a joint panel contributed to mitigating damage to the joint due to its confining action.

(b) Crack patterns at story drift angle of 2 %

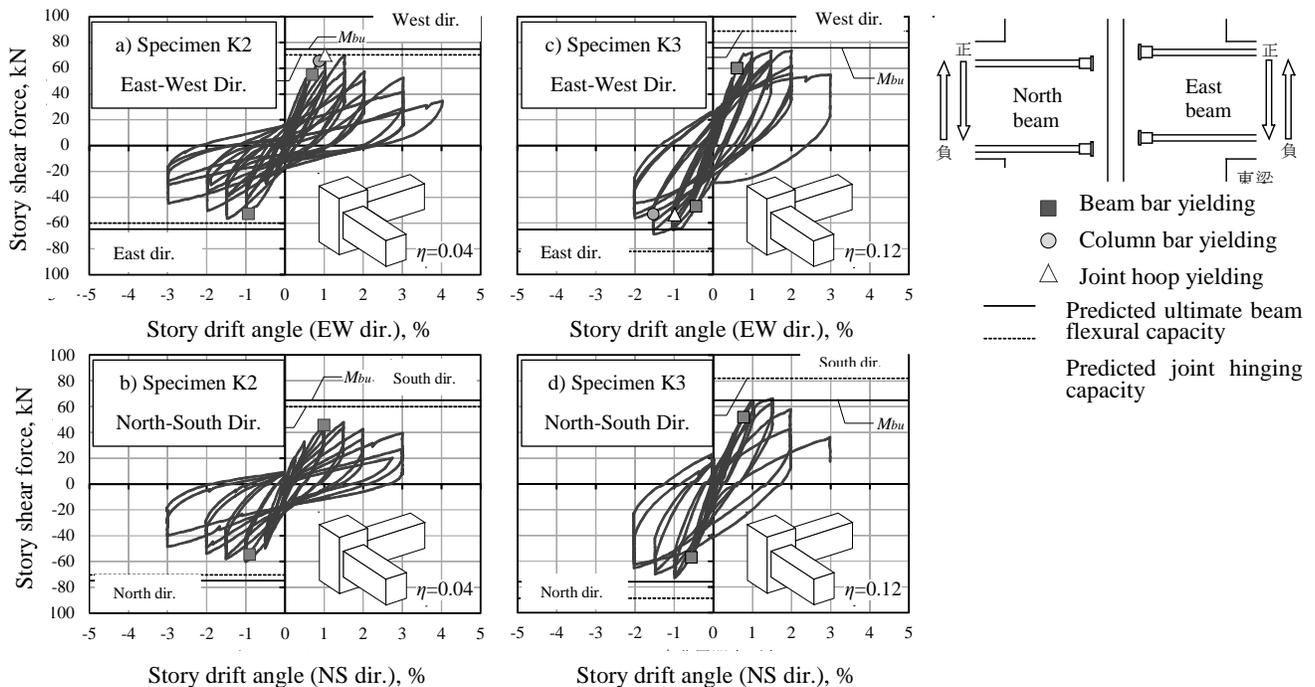
Fig. 5 – Story shear force - story drift angle relations

Hysteresis loops exhibited a little pinching shape for Specimen K2 with a column axial stress ratio of 0.04 (a column-to-beam flexural strength ratio of 1.4). In contrast, those showed a fat spindle shape for Specimen K3 with a column axial stress ratio of 0.12 (a column-to-beam strength ratio of 2.3), showing a more amount of energy dissipation. This was caused by restraint of diagonal crack opening in a joint due to large column axial load in Specimen K3.

Peak story shear capacity in uni-directional loading toward the west direction was 6 % lower than the predicted ultimate beam flexural capacity, but reached the joint hinging capacity for Specimen K2. Peak story shear capacity during bi-directional loading in the north-south direction, however, did not reach even the joint hinging capacity, being 20 % or 26 % lower than the joint hinging capacity or the ultimate beam flexural capacity respectively. This resulted from joint hinging failure under bi-directional loading, where the orbit of a story shear resistance depicted a part of an ellipse on a coordinate surface of the EW-NS direction story shear forces as mentioned later. The story shear capacity for Specimen K2 decreased by 25 % at a story drift angle of 3 % due to concrete crushing and column bar buckling within a joint region.

Peak story shear capacity during uni- or bi-directional loading for Specimen K3 attained to 0.96 to 1.05 times the predicted ultimate beam flexural capacity. This indicates that beams developed almost fully its flexural capacity even during bi-directional loading. Damage concentrated on a joint region after loading point B shown in Fig.4 at a story drift angle of 2 %, resulting in severe crushing of joint core concrete and column bar buckling. Vertical axial deformation in a joint begun to shorten during a loading cycle with a story drift angle of 3 %. This shows symptom of a loss of axial load capacity. Thus the test for Specimen K3 was terminated.

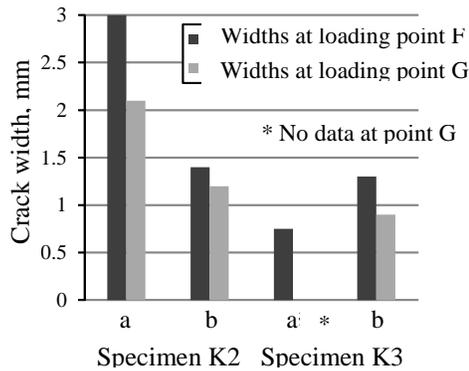
Maximum crack width for Specimen K3 was 1.3 mm at a loading point F subjected to peak story shear force in the east-west direction and 0.9 mm at loading point G at a EW directional story drift of zero, both at the measurement point “b”, which were less than half those at the point “a” for Specimen K2. The tendency that crack widths for Specimen K3 were smaller than that for Specimen K2 was observed in other loading points. This confinement of crack opening is attributed to compressive axial load to the column in Specimen K3 which was three times as large as that in Specimen K2.

Fig. 6 – Principal diagonal crack widths in joint Fig. 7 – Measuring points of diagonal crack width

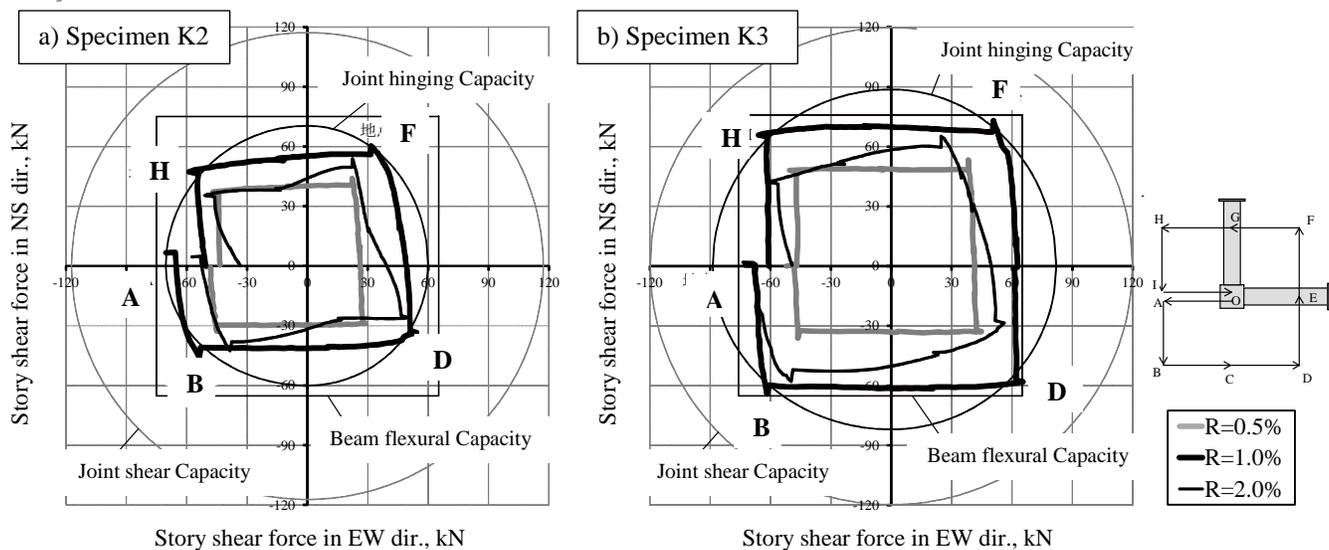
Fig. 8 – Orbit of story shear resistance under bi-directional loading

The orbit of a story shear resistance under bi-directional lateral loading in the first loading cycle is shown in Fig.8 at a story drift angle of 0.5 % before the occurrence of diagonal cracks in a joint, 1 % at diagonal cracking in a joint and 2 % at concrete crushing in a joint. The ultimate beam flexural capacity, the joint shear capacity and the joint hinging capacity each predicted by an aforementioned manner are shown in Fig.8. The ultimate flexural capacity surface of a beam shows two orthogonal lines and the biaxial interaction surface of the joint shear capacity or the joint hinging capacity does a circle or an ellipse respectively in Fig.8.

All the orbits of a story shear resistance under bi-directional loading remained inside a circle of the predicted joint shear capacity for two specimens. This indicates that a beam-column joint did not fail in shear.

The orbit of a story shear resistance for Specimen K2 depicted a rectangle under bi-directional loading at a story drift angle of 0.5 % since little damage occurred in a beam-column joint. The orbit, however, changed to a curved line at a story drift angle of 1 % because of joint damage. Then four peak points under bi-directional loading, i.e., points B, D, F and H in Fig.8 (a), were located on the ellipse line of the predicted joint hinging capacity.

The orbit of a story shear resistance for Specimen K3 with column axial load three times as large as Specimen K2 depicted a rectangle under bi-directional loading up to a story drift angle of 1 % since joint concrete suffered only slight damage. Peak story shear capacities especially at loading points B and D in Fig.8 (b) almost reached both the ultimate beam flexural capacity and the joint hinging capacity. Specimen K3 behaved dominantly in beam flexure and then reached the peak capacity because damage was slight in a beam-column joint at a story drift angle of 1 %. Just before loading point F at a story drift angle of 1 %, however, the story shear capacity in the east-west direction decreased due to the onset of joint hinging failure, which was attributed to reduction of axial load in the lower column at loading point F induced by vertical shear forces in both beams. After loading point F, damage to a joint grew remarkable with the increase in a story drift and a story shear resistance descended. Thus the orbit of a story shear resistance at a story drift angle of 2 % depicted curved lines and was located within the orbit at a story drift angle of 1 % for Specimen K3.

A story shear force at loading point A reached the peak value of 70.6 kN at a story drift angle of 1 % for Specimen K2. During bi-directional loading from loading point A to B, a story shear resultant force remained to be almost constant; 70.6 kN at loading point B in Fig.9 (a). This was caused by a phenomenon that a beam-column joint started to fail in joint hinging at loading point A and the orbit of a story shear resistance under bi-directional loading depicted a part of an ellipse as shown in Fig.8 (a).

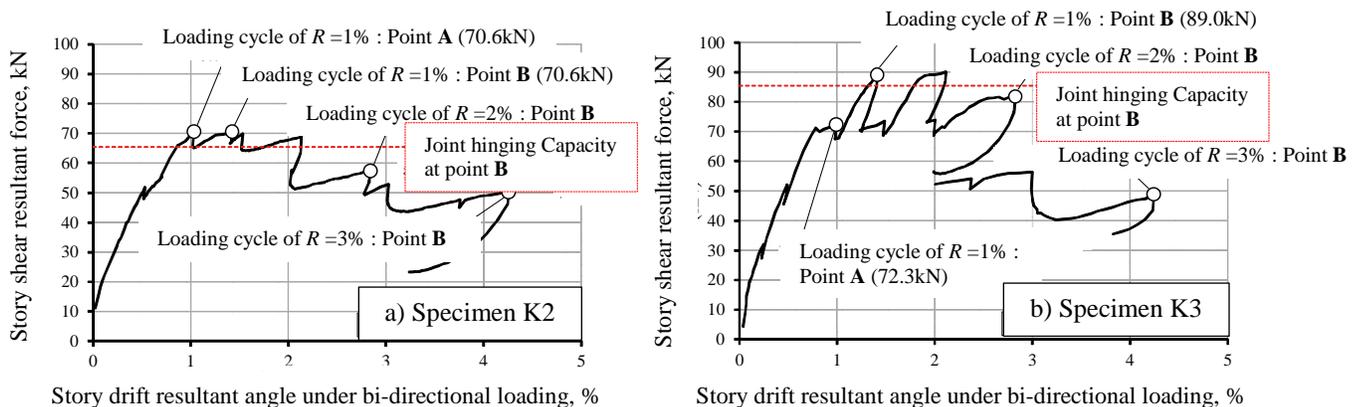
Fig. 9 – Story shear resultant force under bi-directional loading

Envelope curves of relationship between a story shear resultant force and a story drift resultant angle under bi-directional loading from the origin point O to loading point C in a loading paths are shown in Fig.9. A story shear resultant force or a story drift resultant angle was obtained by the square root of sum of squares of story shear forces or story drift angles respectively in EW and NS directions.

In contrast, flexural yielding for Specimen K3 occurred in an east beam at a story drift angle of 0.8 % and stiffness was degraded shown in Fig.9 (b). Under bi-directional loading from loading point A to B, a north beam yielded in flexure and a story shear resultant force increased to 89.0 kN at loading point B, which was 23 % larger than that at loading point A; 72.3 kN.

A peak story shear resultant force obtained at loading point B exceeded the predicted joint hinging capacity, shown by horizontal dashed lines in Fig.9, for two specimens; the former was 8 % or 4 % larger than the latter for Specimen K2 or K3 respectively. A story shear resultant force for Specimen K3 declined heavily due to progressive failure in a beam-column joint after a story drift resultant angle of 2.8 %, leading to axial collapse of the subassembly. This should be noted for seismic design to R/C buildings when a little amount of column longitudinal bars and joint lateral hoops is provided according to the lower bound required by Japanese law or seismic provisions.
