## FLEXURAL PROPERTIES OF BOLTED WIDE FLANGE COLUMN SPLICES

F. Tork Ladani<sup>(1)</sup>, G. MacRae<sup>(2)</sup>, G. Chase<sup>(3)</sup>, G. C. Clifton<sup>(4)</sup>

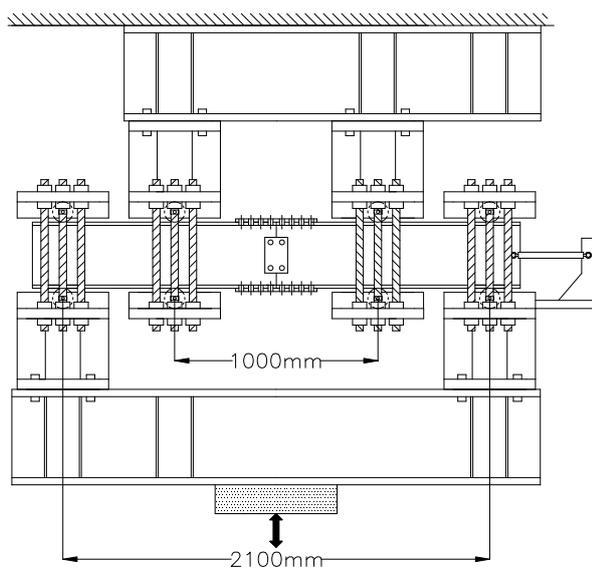
Figure 1 – Test setup

Fig.1 shows the moment configuration under the Dartec 10MN universal testing machine. The Dartec upper portion is supported by four columns (not shown in the figure). It may be fixed at any height and a hydraulic actuator at the bottom applies cyclic loading.

The top and bottom setup beams are attached to the Dartec by four 2" bolts of high strength steel Grade 4140. While the bottom beam moves with the actuator, the top beam is stationary. Special connections were designed to facilitate the cyclic loading. Each connection consists of a block accommodating a roller and threaded rods connecting a thick plate accommodating another roller on the other side of specimen. The rollers are restrained by edge plates which allow them to move horizontally but not vertically. The threaded rods are pulled enough to let the rollers rest on the specimen while avoiding pre-tensioning. Eight M24 bolts were used to connect the bottom of the blocks to the support beams.

When the actuator moves up, the end bottom rollers push up the specimen ends and the middle top rollers apply downward force on the specimen. When the actuator moves down, the forces are applied in the opposite direction through the opposite rollers. In this state, the threaded rods are activated in tension to transfer the forces.

The setup provides constant moment between the loading points without significant shear force. The displacement of the specimen was measured at four bearing points as well as the center to provide the deformation profile of the specimen.

Although the right end rollers were prevented from rolling, the specimen could slide on them under heavy loads. As such, a link was fabricated to stop the horizontal movement of the specimen while allowing the rotation.

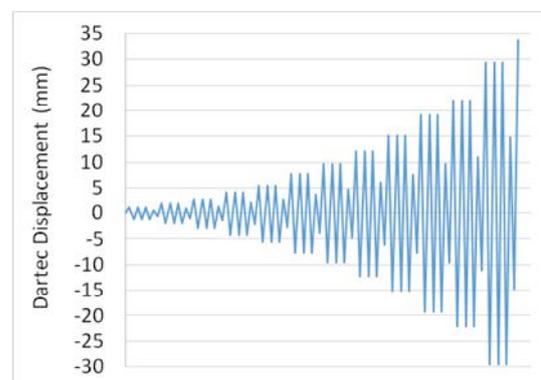
Figure 2 – Loading regime

The loading in this study is controlled by the displacement of the Dartec actuator. Since the bolts attaching the setup to the Dartec could not be post-tensioned due to the large diameter, they experienced slackness in tension. This was observed as high as 0.8mm at the bottom connection for about 2000kN force of the Dartec. Therefore, the input displacement on the specimen is less in tension than in compression. The loading regime applied in the experiments is shown in Figure 2.

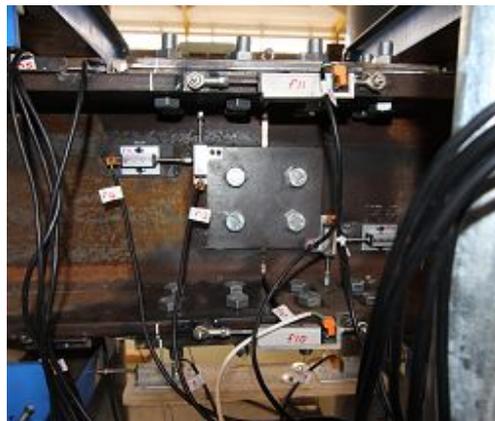
Figure 3 – Instrumentation of the connection

String potentiometers were used to measure the absolute displacement of the beam at the ends and in the middle of the specimen. The two mid-loading points in this setup are constrained between the top and bottom rollers which are both fixed. Two linear potentiometers were attached to the top and bottom flanges to measure the gap between the spliced sections. The data provides the displacement profile of the beam and the splice rotation at each load step. Fig. 3 shows a typical example of using linear potentiometers installed on the specimen. Other instrumentation devices seen in the photo are not the subject of this study.

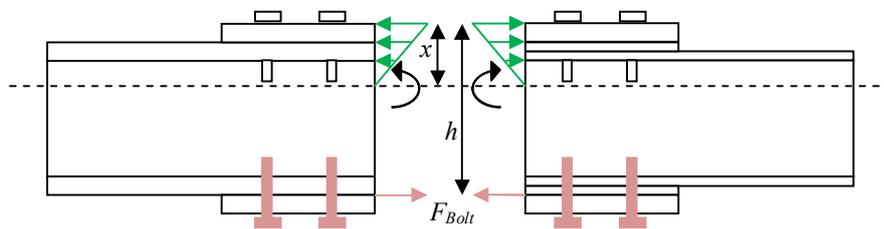
Figure 4 – Schematic forces acting on the bearing splice sections

Numerical analyses of the splice connections were carried out to predict their moment-deformation behavior. Three equations were developed of which one is the compatibility of deformations at the section and two others are the equilibrium of the section axial forces and their moment about the neutral axis. Fig. 4 shows the schematic forces acting on the sections before compressive stresses reach their yield. These two halves shown separated for clarity are actually in contact. The stresses are shown to increase linearly with distance from the neutral axis. At large rotations, the yield strength of some components will be reached and the stress distribution will become trapezoidal. Since the moment over the central region of the beam, where the connection is placed is constant, the deformation at the exterior of the flange on the compressive side of the connection,  $\Delta_c$ , can be expressed by Eq. (1) where  $L_{connection}$  is the distance between the farthest bolt to the centre of the connection. The deformation at the level of the outside of the flange on the tensile side of the connection is given by  $\Delta_t$ , which consists the axial deformation of the splice plate, shear deformation of the bolts and ovalization of the bolt holes. The compatibility of compressive and tensile deformations is expressed in Eq. (2). The force displacement model used to characterize the behavior of the splice plate in tension is as Eq. (3). The form of the equation was initially developed by Fisher, while the values of the coefficients were later determined by Crawford and Kulak based on six single bolt shear tests [9]. This equation is very general and does not consider parameters such as bolt diameter and length, failure mode, packer plates and the thicknesses of the plates [9]. The maximum predicted displacement is based on the ultimate shear capacity of the bolts.

In this study, it was assumed that the compressive stresses are transferred through the splice plate in compression and the contact area of the section. The tensile force is considered to be the sum of bolt shear forces. Bolt shear in the compression side of the splice was ignored in the equations, but the splice plate and flange on the compression side were assumed to behave compositely here. Also, prying actions, in particular due to splice plates, were not modeled here.

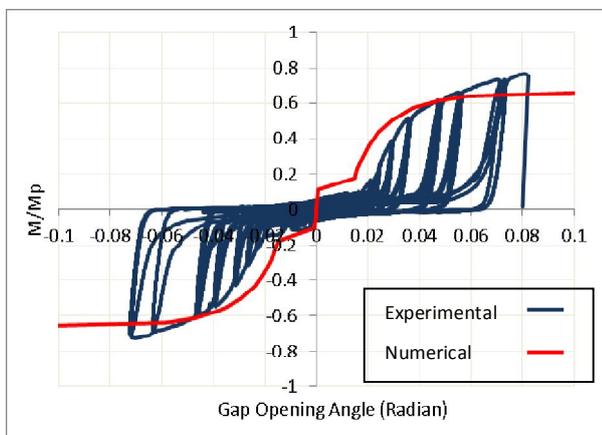
Figure 5 – Hysteresis behavior of Specimen #1

Figure 5 shows that the actual slope before load increased significantly was about 0.02 radians or 2%. This is likely to be as a result of the bolts rotating and possibly not being perfectly centered as well as a small fabrication gap (0.5 mm) between the spliced members. The actual strength before the bolts started increasing strength due to bearing was less than 0.1 $M_p$ . This is consistent with the low predicted strength of 4.5% $M_p$ .

above was  $0.65M_p$ . The peak strength measured was about  $0.75M_p$  as shown in Figure 5. This is about 50% greater than the  $50%M_p$  considered in the design for the plates, and 70% greater than the  $44%M_p$  considered in the design for the bolts. The model based on Equations 1-3 seemed to represent the overall behavior envelope well.

It can also be seen that the loops corresponding to the second and third cycles after the slippage show slackness and gapping due to hole elongation. The maximum elongation in the splice plates and the shear deformation in the bolts were approximately 4mm and 5mm, which allows a  $2 \times 9\text{mm}/327\text{mm} = 0.055\%$  displacement after slippage. This is consistent with the post-slippage displacement of about 6% seen in Figure 5.

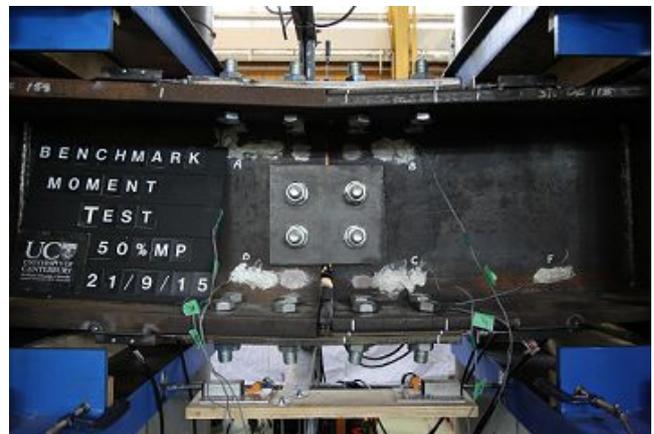
Figure 6 – Rotation of Specimen#1 close to failure

The bolts on the bottom splice plate of the smaller member failed in shear and the bolts were projected out with very high speed as an explosion. This occurred as the elastic flexural energy in the splice plates was released as the bolts failed. While the bending/prying of the splice plates on the tension side puts tension on the bolts, this did not seem to adversely affect the splice flexural strength.

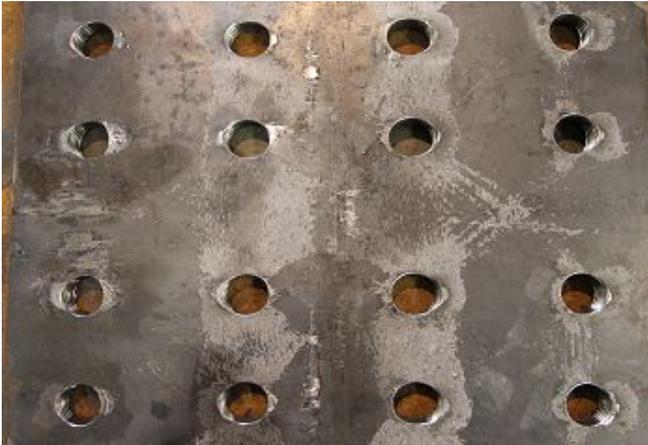
Fig. 7 – Damage in flange splice plate

Fig. 7 shows the damage in the splice plate. It is seen that all the holes yielded in bearing and the plate yielded along the inner row of the bolt holes. Also, it is clear that hole ovalization is larger for the inner rows compared to the edge rows. The average elongation was observed to be 3.9 mm and 1.3 mm for inner and edge rows, respectively. Fig. 8 shows the damage in the web holes. Although it is assumed that web splices do not contribute in transferring bending moment, they could damage in large rotations which could potentially affect their shear performance.

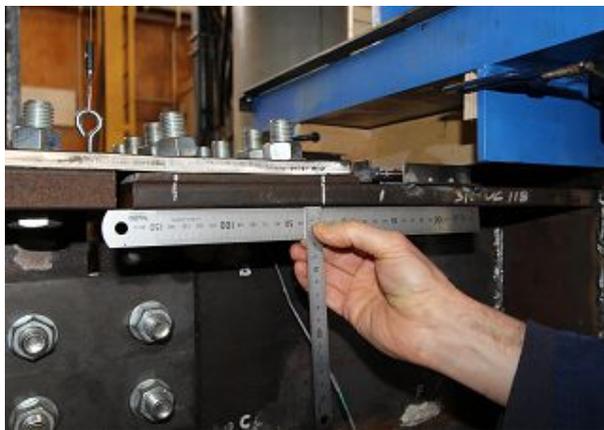
Fig. 9 – Damage in the flange of the smaller section

Fig. 9 shows the distortion of the flange at the location of splice is approximately 1 mm. Fig. 10 shows the separation of the splice plate and the packer close to the connection failure. The damage could be attributed to prying actions and piled up material behind the bolts.

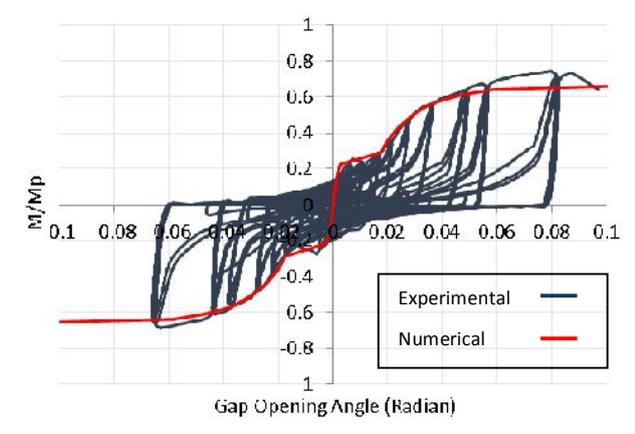
Fig. 11 – Hysteresis behavior of Specimen #2

Fig. 11 shows the hysteresis behavior of the connection. Initially, the friction force in this case is about  $0.2M_p$  which is very close to the estimated value calculated as follows. The friction force, assuming a coefficient of 0.35, is  $0.35 \times 145\text{kN} \times 8 \text{ bolts} = 406\text{kN}$ . The associated moment from the flange bolts is  $406\text{kN} \times 0.327\text{m} = 133 \text{ kNm}$ , which is equal to  $24\%M_p$ .

The slip force is greater than that of Specimen #1 due to the different construction. However, it can be observed that the friction force reduced in the larger displacement cycles. The connection rotational capacity is 0.084 radians which is 5% more than that of Specimen #1. The ultimate strength is approximately  $0.75M_p$  which is similar to that of Specimen #1. Also, Specimen #2 is more flexible at larger rotations than Specimen #1 which is likely to be as a result of the absence of web splice. The failure mode was the same as Specimen #1 with sudden explosion.

The numerical model shown with the red line in Fig. 11 is identical to that of Specimen #1 as the web plate effect was ignored in the model.

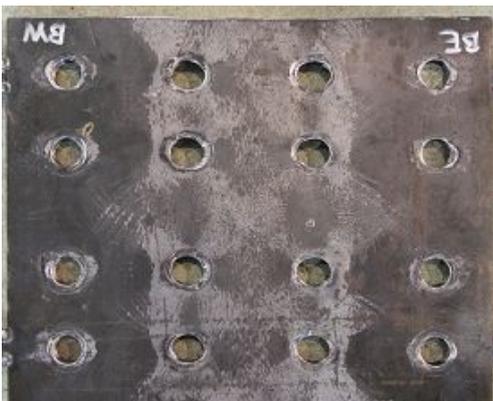
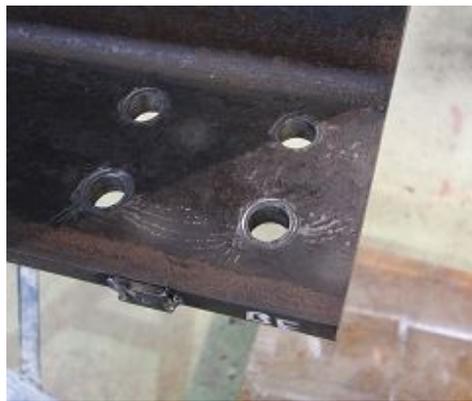
Fig. 13 and 14 show the damage in the splice plate and the flange of the smaller member. The inner rows of the holes in the splice plate elongated 2.7mm on average, but no elongation was observed for the edge rows. Fig. 15 shows the extent of deformation in a bolt at its failure.

Fig. 13 – Damage in flange splice plate

Fig. 14 – Damage of the flange in 310UC118 section

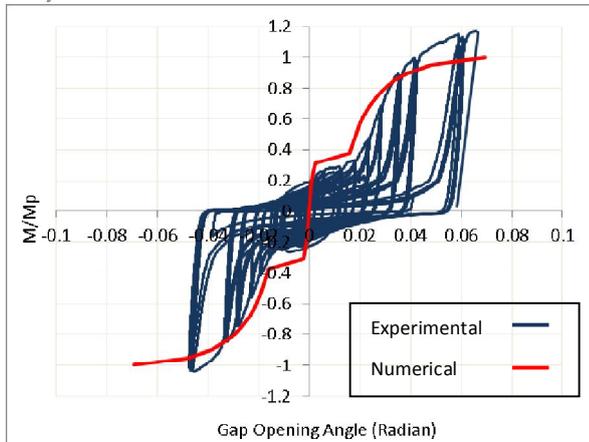
Fig. 16 – Hysteresis behavior of Specimen #3

The cyclic performance of the connection is illustrated in Fig. 16. The predicted slippage strength of about  $0.32M_p$  is larger than  $0.22-0.28M_p$  observed. The connection ultimate strength capacity is greater than  $M_p$  even though holes were present in the flange and beam. This could be attributed to flange strain hardening as well as to the splice plate. Also, the connection exhibits larger stiffness compared to the other two specimens. The connection has smaller rotational capacity compared to the other two specimens possibly because the thicker (20mm) flange splice plate was stronger and had less bolt hole deformation under the forces imposed by the bolts.

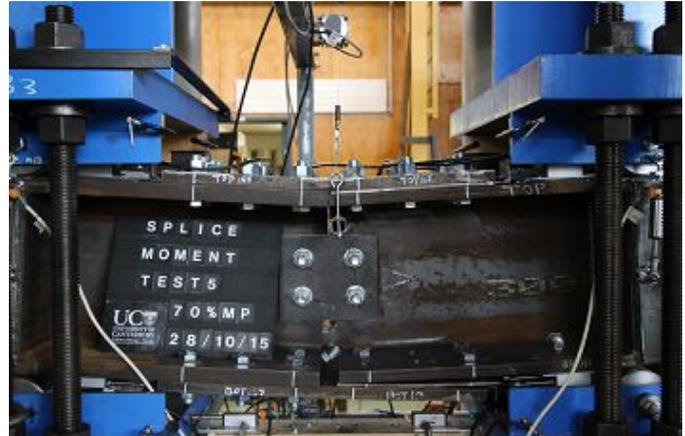
Fig. 17– Specimen #3

Beam flange and web damage was larger than in Specimens #1 and #2. The 6mm web plate material is of Grade 350 rather than the Grade 300 11.9mm thick beam web. Interestingly, the web plates were damaged less than the web itself. Figs. 18 and 19 show the damage in the smaller member. No significant elongation was observed in the splice plate holes. The same failure mode was observed in the test as in the other two tests.

The contact surfaces were cleaned as in Specimen #2 preparation. The bolts were tightened to 1/3 of a turn from the snug-tight condition.

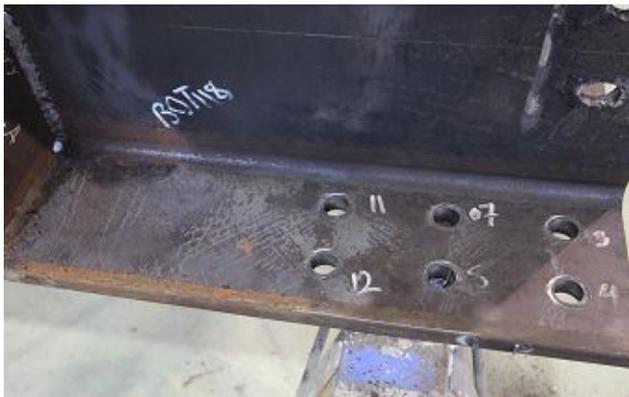
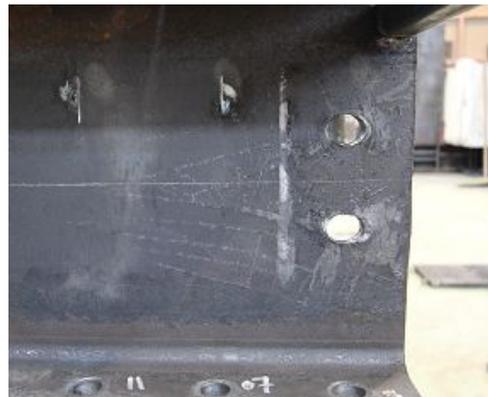
Fig. 18 –Damage of the flange in 310UC118 section

Fig. 19 –Damage of the web in 310UC118 section
