New Zealand Research Applications of, and Developments in, Low Damage Technology for Steel Structures

G.A. MacRae⁽¹⁾ and G.C. Clifton⁽²⁾

Abstract

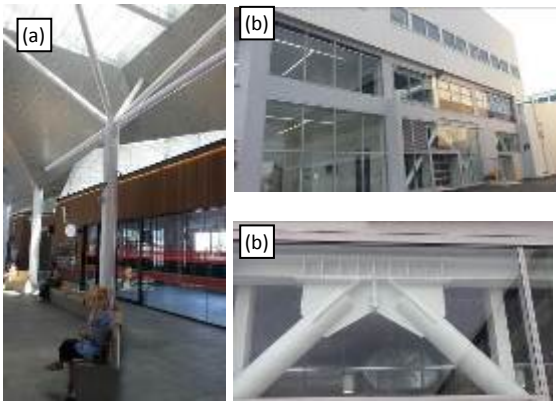
Figure 1. Nominally Ductile Systems (MacRae)

b) Nominally elastic systems

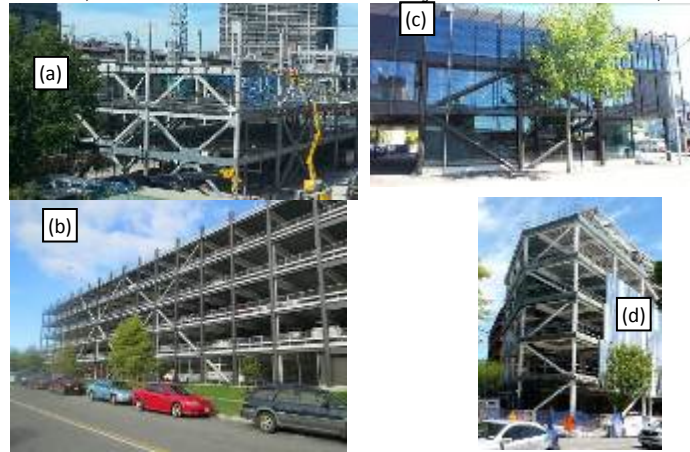
Figure 2. BRB Systems (MacRae)

While BRB systems are used widely around the world, no specific regulations exist in NZ and prior to 2011 there was only one home-designed and untested BRB retrofit on the psychology building at the University of Canterbury in Christchurch; built in 1990. Since the earthquakes, these have become very popular, being incorporated into approximately one half of the new steel buildings and often replacing traditional EBFs, which was the principal seismic-resisting system used prior to 2010. BRBs are used in diagonal, or super X, as well as in the Chevron configurations as shown in Figure 2. Some examples here include: (a) UoC Science Annex, (b) 14 Hazeldean Rd, Addington, Christchurch 8024, (c) 254 Montreal Street, (d) PwC Centre, Cambridge Terrace. In order of decreasing popularity are braces from StarSeismic, Taiwan, and CoREBrace then “in-house” designs. Both StarSeismic and the Taiwanese braces are being fabricated under licence in Auckland. One frame on the location of the old police station site on Cambridge Terrace was constructed with temporary angles at the location of the BRBs until the braces arrived.

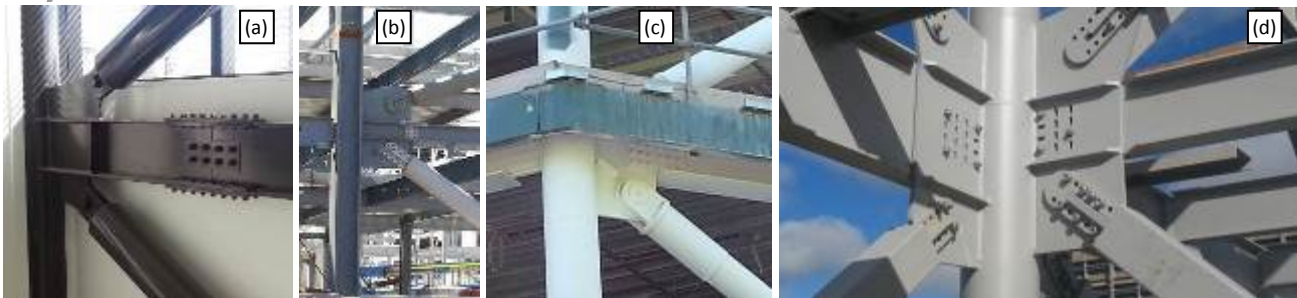
Figure 3. Gusset Plate Details (MacRae)

Details of the brace end connections are shown in Figure 3 from (a) 254 Montreal Street, (b) NE corner Lichfield and Colombo Street, (c) PwC centre, (d) UoC Science Annex. It may be seen that (i) columns are a mix of bare steel and CFT, (ii) connections to the gusset plates are a mix of bolted and pinned, and (iii) in general the gusset plates have no stiffeners. The advantage of the pin-end connection is that no moment is induced due to in-plane action, however there are likely to be more issues with fit, and possibly with gusset plate stability. Many NZ designers follow AISC specifications for gusset plate design, where an effective length of the gusset plate used is $k = 0.65$, even though the mode of failure is sway, implying that this effective length factor should be greater than unity. SCNZ is developing a design guide that is expected to be available during 2016.

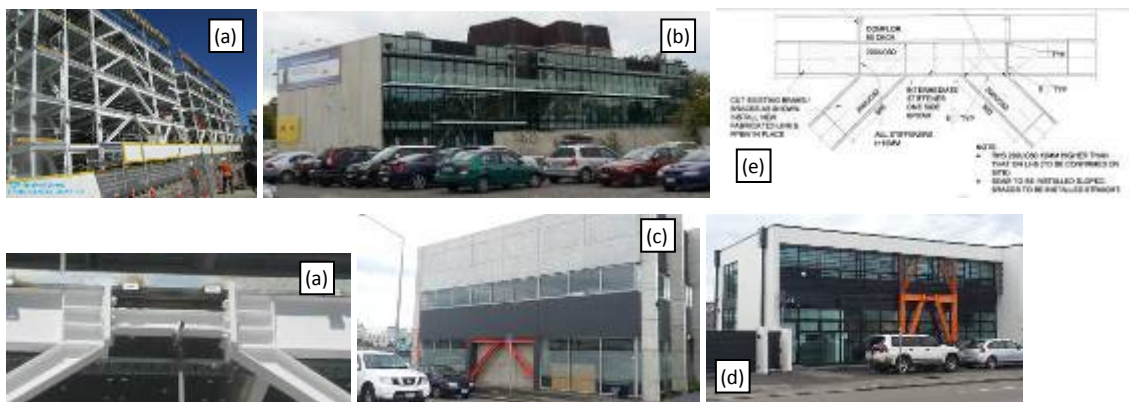
Figure 4. Examples of EBF structures in Christchurch (MacRae)

EBFs, with and without replaceable links, are being designed according to a guidance document from HERA (2013). The replaceable link is required to be smaller than the main beam to allow it to be bolted in place. It generally has about 50% of the traditional link shear force resistance. Relative advantages of the replaceable link EBFs and traditional EBFs are given in Table 1. Examples of EBF structures in Christchurch are given in Figure 4 including (a) 120 Hereford Street, (b) 329 Durham St, (c) NW Corner of Lichfield and Barbadoes St, (d) 208 Barbadoes St. The EBF like replacement used in Pacific Tower is shown in Figure 4e (Gardiner et al., 2013).

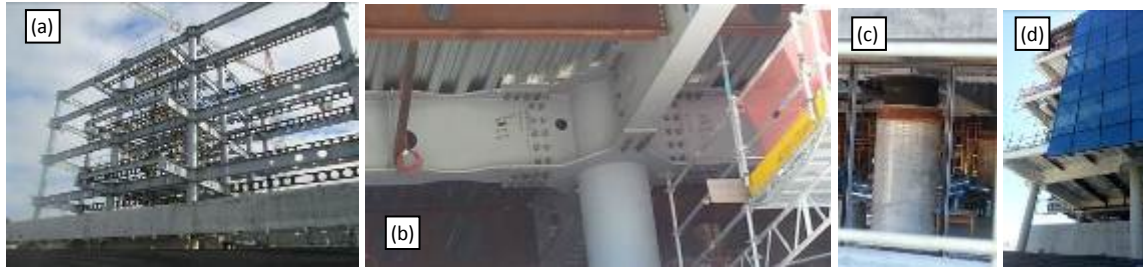
Figure 5. Some details from the Justice Precinct (MacRae)

A number of steel structures are using base isolation. This includes (a) 151 Cambridge Terrace, (b) the Justice Precinct at 121 Tuam Street shown in Figure 5a, and others. The Justice Precinct is required to perform very well and composite circular CFT columns connected to beams with external diaphragm connections using bolted connections. The beams have reduced beam sections (RBS) as shown in Figure 5b. A bearing above the column

is shown in Figure 5c, and low friction supports in Figure 5d. Similar framing is also used on the north side Kilmore street west of Durham Street. In addition to new design, the existing mainly concrete Art Gallery has been retrofit with base isolation. Lead-rubber as well as sliding friction systems have been used. A guideline for the design of base-isolated systems is due to be released soon by NZSEE.

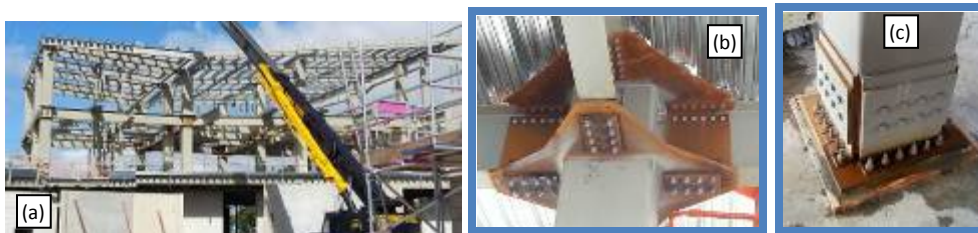
Figure 6. Details of the Friction Connections on the Terrace Project (MacRae)

These were developed in NZ and used initially in the Te Puni Apartment building at Victoria University in Wellington in 2007. In this building, sliding occurred at the columns at the base of the structure and in the beam to column connections of the perimeter frame in the 2013 Grassmere earthquake. Friction dissipation has been recently used in (a) Forte Health Building on Kilmore Street, and (b) as the main energy dissipation system in the Terraces Project on Oxford Terrace. Oxford Terrace was unique in that Friction connection were used in two directions using external diaphragm connections on a RCFT column as shown in Figure 6b. The base connection was a two way connection with the column sitting on a central pin and oversized holes placed in the baseplate to allow flexural movement in both directions as shown in Figure 6c. No codified design guidelines currently exist for the design of friction connections.

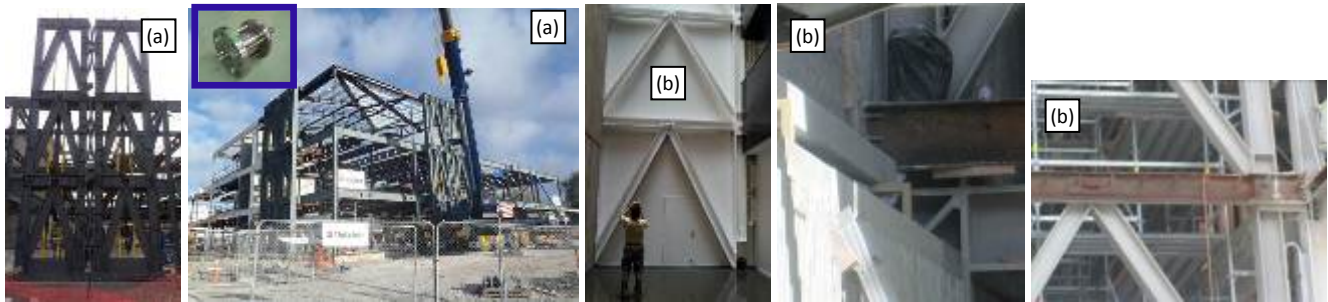
Figure 7. Rocking system implementations (MacRae)

Rocking steel concentrically braced frames with ring spring base hold down systems were also used in the Te Puni Apartment building at Victoria University in Wellington in 2007 and exhibited uplift of some 4 to 6mm in the 2013 Grassmere earthquake. A number of other rocking frames have been constructed since then around the country. One rocking concrete wall was in Christchurch at the time of the Canterbury earthquake. While it exhibited some movement, it was on the north side of Christchurch where excitations were considerably less than in the central city. The first new rocking steel frame buildings in Christchurch after the earthquakes was the Forte Health building, 132 Peterborough Street, which used many interesting systems including friction dissipaters. The rocking walls were coupled and energy is dissipated during relative movement between the walls by lead extrusion dissipaters as shown in Figure 7a. Here, the rocking frames are held down by tendons extending over their height. Vertical deformations of the rocking frame are also decoupled from the slab of the building while allowing horizontal force transfer. An alternative means to hold down the building is used in 141 Cambridge Terrace. Here, the large springs at the base of the structure limit the onset of rocking as shown in Figure 7b, flexural yielding U-shape dissipaters are placed up the side of the frame. The advantage of this system is that the frame members over the height do not need to be sized for the post-tensioning forces, and the spring size can be selected for the appropriate deformations. However, the cost of the springs must be considered.

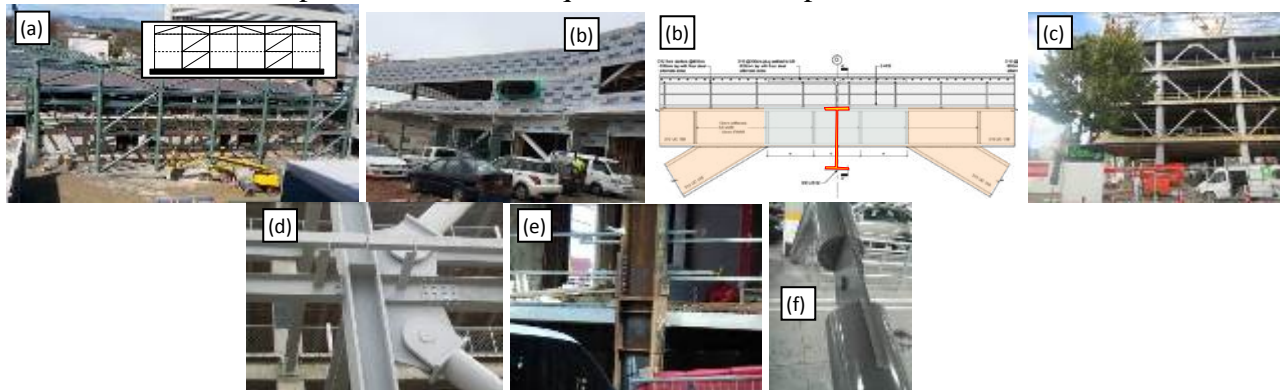
Figure 9. Some Interesting Structural Systems

- i) CBFs being placed over 3 stories in an unbalanced manner at the Univ. of Canterbury engineering hub as shown in Figure 9a. The frame design ductility demand here is low.

- ii) Beams carrying gravity force which go through the centre of, and are supported by the active link on a EBF building (136 Moorehouse Avenue) are shown in Figure 9b. Again, the ductility demand is stated as being low. There is nothing specific in current NZ standards to prevent this, it was not envisaged such an application would be used and according to SCNZ it will be prevented in the next version of the standard.

- iii) An IL3 (moderately important) building, located at the corner of Cambridge Terrace and Armagh Street, has CBF braces on the 2nd, 3rd, 4th and 5th stories, but no braces in the ground (first) storey as shown in Figure 9c. This building is base isolated.

- iv) A BRB extension to 32 Oxford Terrace (shown in Figure 9d from Tuam Street) has gravity beams framing into the BRB bay with small (perhaps 2 M16) bolts. Here, it is assumed that the slab will transfer all the force into the BRB bay so that drag struts are not needed. This is quite a different philosophy than that used in the UoC Science Annex (Figure 3d), for example, where drag struts were used to carry beam axial forces. It was not clear whether web doubler plates were needed, or provided, in the beam and column to carry the brace forces from the thick gusset plate into these members from the views obtained.

- v) A friction connection seems to be placed in columns of a building in Boulcott St, between St Mary of the Angels Church/O'Reilly Ave and Willis Street, Wellington, as shown in Figure 9e (provided by John Scarry). If it is indeed a friction connection, it is not clear how it would work considering the column must carry axial force, and flexure in two directions.

CBFs may be designed according to NZS3404. An example at 124 Kilmore Street is given in Figure 9.

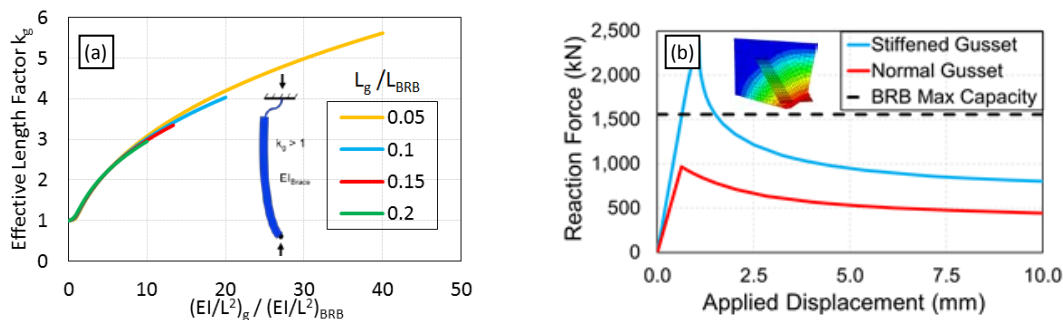
Figure 10. Gusset Plate Performance (Westeneng et al., 2015)

Most gusset plate design procedures (E.g. AISC) consider that the gusset plate has a buckling effective length factor of 0.65-0.70 even though sway is the predominant failure mode. This issues is similar to issues with axial cleat connections which sway and for which mitigation methods have been developed (E.g. MBIE, 2010). Westeneng et al. (2015) used stability functions to obtain the actual gusset plate effective length factor corresponding to overall buckling failure of an elastic gusset plate connected to an elastic BRB brace member as shown in Figure 10a. The upper line on this graph can be approximated by the equation $k_{gusset} = 1 + 0.55\alpha^{0.58}$, where $\alpha = (EI/L)_g^2 / (EI/L)_{BRB}^2$. They showed that the effective length factor is (i) dependent of the stiffness of the brace, (ii) greater than unity as would be expected for a sway element, and (iii) may be greater than 3.0 for high gusset plate stiffnesses.

An implication of this is that gusset plates designed according to standard methods, with small effective length factors, may fail under compressive load alone at strengths lower than that specified in the standards. This has been shown and replicated by Westeneng et al. (2015) as shown in Figure 10b. Westeneng et al. (2016) also demonstrated by calibrated FEM analysis that current recommendations are not conservative. Furthermore Sitler et al. (2017) have shown that a number of failures of BRB systems have occurred in the past and Takeuchi et al. (2016) have proposed a general method to consider these things. Simple guidance from this method is not yet available in English. There is also the concern that if gusset plates are too slender, they may buckle. However, if they are too stocky, they may yield during out-of-plane deformation compromising their performance in subsequent cycles.

To prevent failure of the gusset plate, the weld may be sized for the capacity of the plate using capacity design principles. While many engineers do size the welds this way, some use weaker welds, or simply consider the capacity of the brace and to determine a uniform weld size. This may be problematic if there are non-uniform distributions of force in the gusset plate due to element flexibility, frame (beam-column) opening effects, brace in-plane moments, brace force eccentricity, out-of-plane bending of the plate from member out-of-plane deformation etc. A weld distribution factor which may account for some of these actions, but it is not clear how robust it is in general. In addition to the weld, the elements in to which the gusset plate is connected, i.e. the beam and columns, should have sufficient strength the carry the demands as described by Palmer et al. (2016).

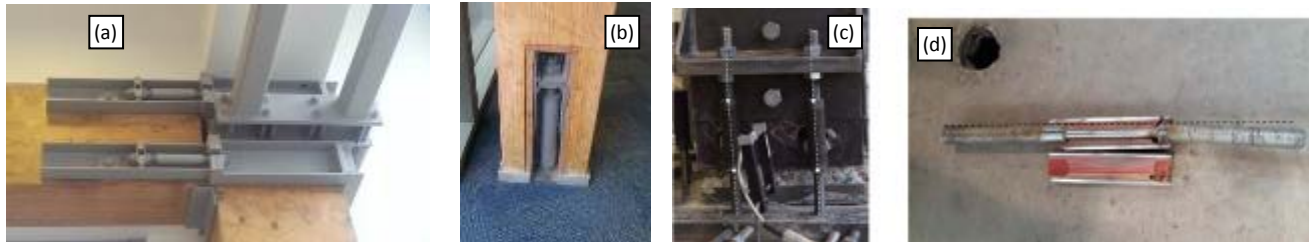
Figure 11. Tests of Externally Mounted Tension-Compression Yielding Devices (MacRae, Gultom and Ma)

These are mini BRBs used by Marriott (2009) in tests with concrete rocking systems. They have been implemented mainly in concrete and timber structures around NZ as a means to dissipate energy. Implementation in a timber structure in 11 Birmingham Drive is shown in Figure 11a and b (MacRae). The majority of the testing of these devices in their development was conducted under unidirectional loading. However, in recent bi-directional testing by Gultom and Ma (2015), it was shown that they buckled and lost strength. The test setup and buckled dissipater are shown in Figure 11c and d (Gultom and Ma, 2015). The comment was also made that if the design had been different they may have worked.

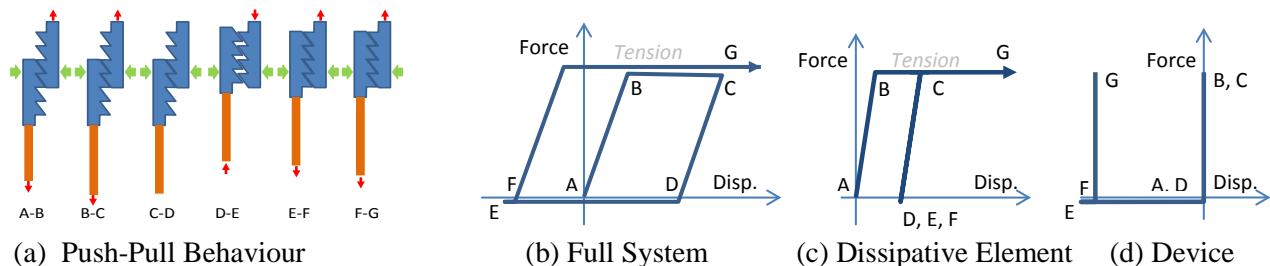
Figure 12. Tension-Only System (GripNGrab) Behaviour

A device to prevent buckling of tension dissipative devices in compression was inspired by plastic cable ties which can carry tension force, but carry little force in compression as they are pushed through the hole. It has similar, but opposite, characteristics to a car axle jack which is a compression only device. The tension only device has the behaviour described in Figure 12. The device itself is shown with the teeth in blue. A small lateral compressive force is required to encourage the two parts not to fall away from each other, so that the teeth engage. The dissipate element is shown in brown. Dissipation may occur due to yielding, frictional sliding or other means. Initially the device is loaded elastically in tension (A-B) then yielding/frictional sliding occurs in the dissipative element increasing its length (B-C). When the force is taken off (C-D) there is some elastic shortening of the dissipative element. When compression force is applied, the device carries very little compression but slides (D-E). When tension force is applied again (E-F), the device slips until the teeth are engaged but the dissipative element does not change in length since the axial force in this stage is very small. The maximum possible E-F distance is the tooth pitch. For greater tensions (F-G), displacement increases in the elastic range and then causes dissipation in the dissipative element as before. Preliminary tests of small scale devices indicate excellent behaviour with monotonic dissipation only of the yielding element (Cook et al. 2016). Such a device has the potential to be used on the outside of rocking walls, in brace, and in other applications requiring energy dissipation. The dissipative element would need to be replaced, and the device reset, after every major event.
