## Seismic Performance of Actual Members Retrofitted with Epoxy Resin Injection

### Abstract

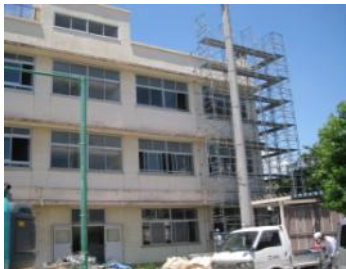
Fig. 1 – School building

The target building was a three story reinforced concrete building constructed in 1961, and used as an elementary school as shown in Fig.1. This building was judged to have low seismic performance in the seismic evaluation. Because this building was designed based on the old structural code of Japan, the main reason for the low seismic performance was the small amount of shear reinforcement. The other reason was the low strength concrete being less than the specified concrete strength of the construction year, estimated  $13.2\text{N/mm}^2 \sim 17.6\text{N/mm}^2$  ( $135\text{kg/cm}^2 \sim 180\text{kg/cm}^2$ ).

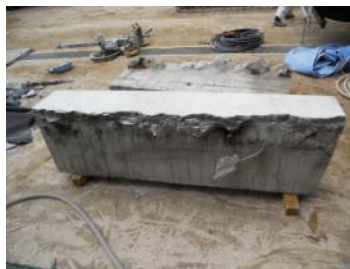
Fig. 2 – Obtained beam

The concrete strength in the report of the seismic evaluation was  $10\text{N/mm}^2$  under the lower limit of  $13.5\text{N/mm}^2$ , as recommended in the applicable standards [1]. Two beams and one column were obtained when the part constructed in 1961 was demolished as shown in Fig. 2. The eleven concrete cylinders were obtained by boring from the structural members for material tests as shown in Fig.3.

Two beams in the second floor and one column in the third floor were taken without any damage using a wire saw. The reinforced concrete stubs were manufactured at both ends of each member to fix to the testing machine. Steel plates  $t=12\text{mm}$  were welded at both ends of the main reinforcement for anchorage before casting concrete for stubs. In order to ensure the connection between the original concrete to the stub concrete, shear keys of 12-D16 were installed to the member sides with epoxy mortar. The process of manufacturing the test column is shown in Fig. 4. According to the structural drawing, the main reinforcements and shear reinforcements were plain round bar. The sectional area of the beam and the column were  $300\text{mm} \times 600\text{mm}$  and  $300\text{mm} \times 750\text{mm}$  respectively. All test members were designed to have a common shear span length of 1200mm in order to evaluate the validity of the current equation for the shear capacity.

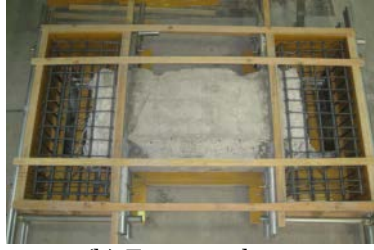
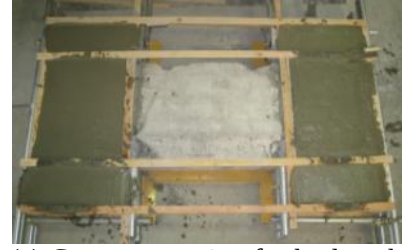
Fig. 4 – Process of manufacturing test member

(b) Form work

(c) Concrete casting for both stubs

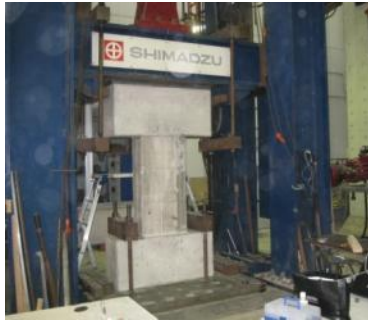
Fig. 6 – Test apparatus

The test setup was designed to subject the test members to shear force reversals. The test beam was set vertical to the testing machine as shown in Fig.6. The top stub was fixed to the L shaped steel beam and the bottom stub was fixed to the reaction floor with high tension bolts. Shear force was applied by a horizontal jack under displacement control, attempting one cycle for each of the peak displacement levels of drift angle  $R=1/800$ radian,  $1/400$ rad,  $1/200$ rad,  $1/133$ rad,  $1/100$ rad,  $1/67$ rad and  $1/50$ . The applied axial load for the test column was constant at  $N=304$ kN ( $N/F_c \cdot b \cdot D=0.1$ ) during lateral loading considering that the column was taken from the third floor. To ensure that the top and bottom stubs remained parallel during reversal loadings, a pantograph system was used.

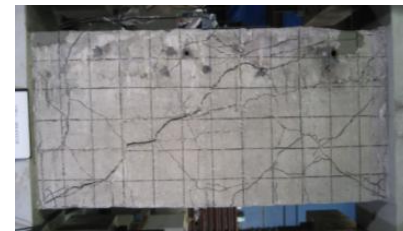
Fig. 9 (a) – Crack patterns of test beams

Crack patterns of the test beams at the maximum strength are shown in Fig.9 (a). In both test beams, slight flexural cracks occurred at the ends of the beams in the first cycle at drift angle  $R=1/800$  radians. In the same cycle, shear cracks occurred at the mid spans of the beams. As the controlled displacement increased, the shear cracks occurred in the entire beam. The width of the specific shear cracks were enlarged while the flexural cracks did not progress. In the original test beam AB-1, the width of the shear cracks near the cold joint rapidly expanded at drift angle  $R=1/200$  radians. After this event, a new crack did not occur. The retrofitted test beam AB-1RE showed almost the same crack propagation as AB-1. No significant difference in crack patterns between the two beams was observed, and the collapse mechanism was apparently the shear failure mode. Loading was discontinued when shear force decreased to less than half of the maximum strength.

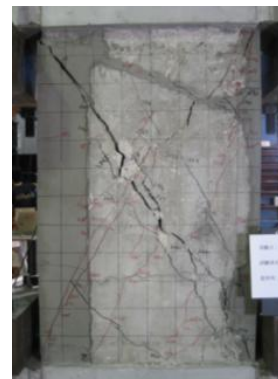
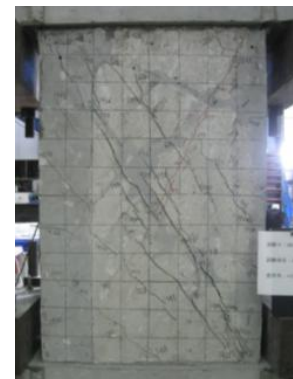
Fig. 9 (b) – Crack patterns of test columns

The test columns showed almost the same crack propagation as the test beams shown in Fig.9 (b). While the angles of the shear cracks of the test beams were approximately 45 degree, the shear cracks of the test columns occurred diagonally due to the axial force. The shear cracks of original test

column AC-1 occurred intensively in the diagonal direction although the cracks of the retrofitted test column AC-1RE occurred in the entire column. The locations of the main shear cracks were different to those of the original test columns AC-1. It is estimated that the large amount of epoxy resin injected in to the damaged column united the cracked concrete blocks. At the same time, the bond strength of the plain round bars in the concrete increased.

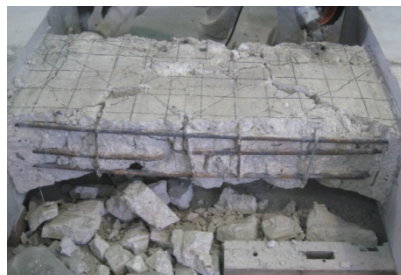
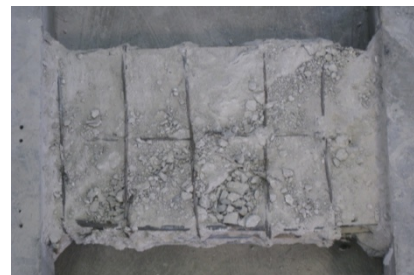
Fig.11 – Inspections for members after loadings

Bar arrangements in the members were inspected by removing the concrete cover. In the beam, the 9 $\phi$  stirrup was arranged with 200mm~300mm space as shown in the structural drawing. The stirrups consisted of a cap tie and U shaped tie as shown in Fig 11 (a). It was confirmed that two 19 $\phi$  main bars were arranged at the top and bottom through the beam length and a cutoff bar was arranged at the bottom of the beam. Two or three cutoff bars were found at the top of the beam. Those cutoff bars were anchored with a 180 degree hook as shown in Fig 11 (b). The locations of the cutoff were considered to have an influence on the occurrence of the main shear cracks. There was no significant difference in the bar arrangements between the structural drawing and the obtained members. Material tests were performed using reinforcing bars that were taken out after the loading tests. Averages of the yield strengths of 19 $\phi$  and 9 $\phi$  were 320N/mm<sup>2</sup> and 270N/mm<sup>2</sup> respectively from the tensile tests.
