## INITIAL GEOLOGICAL AND ENGINEERING ASSESSMENT OF THE 2015 NEPAL, GORKHA M7.8 EARTHQUAKE AND ITS SOCIETAL AFTERMATH

**Keywords:** Himalaya; Nepal; Kathmandu Basin; Building Damage; Earthquake Environmental Effects

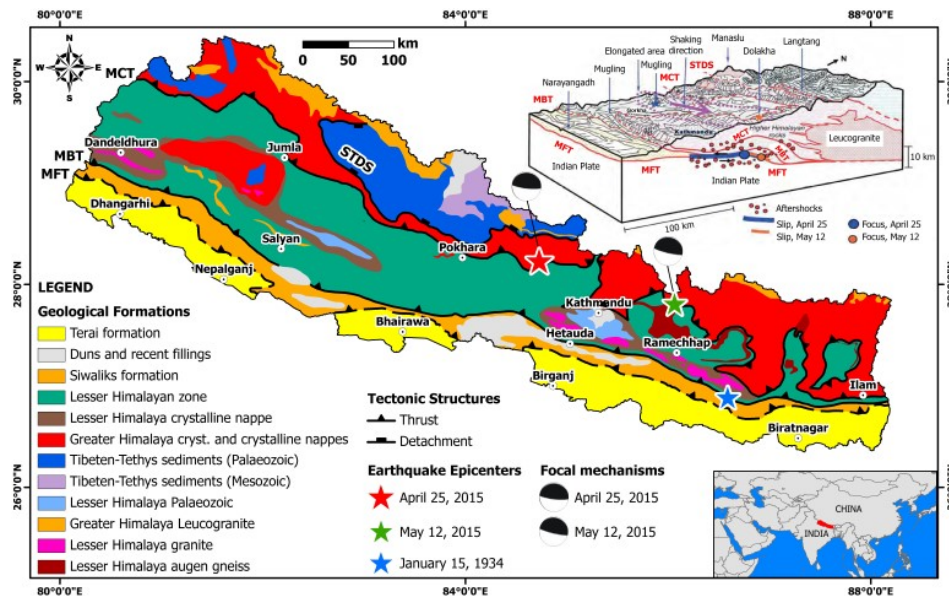
Fig. 1 – Geological map of Nepal after [8] with the epicenters of the April 25, 2015 Nepal, Gorkha earthquake and its largest aftershock and a block diagram after [9] illustrating the approximate locations of slip during the April 25 and May 12, 2015 ruptures and the aftershocks. The elongated area suffered severe damage.

Nepal (Fig. 1) is located in the central part of the Himalayan arc and extends between 80°04' and 88°12' east longitude, and 26°22' and 30°27' north latitude. The country approximates an oblong and occupies an area of 147181 km<sup>2</sup>. Its maximum length is about 825 km, and its width varies between 250 and 170 km from west to

The Kathmandu basin is an intermontane basin lying on the Kathmandu Nappe located in the Lesser Himalayan zone [6] (Fig. 1). It is filled with young semi-consolidated fluvio-lacustrine sediments of Pliocene to

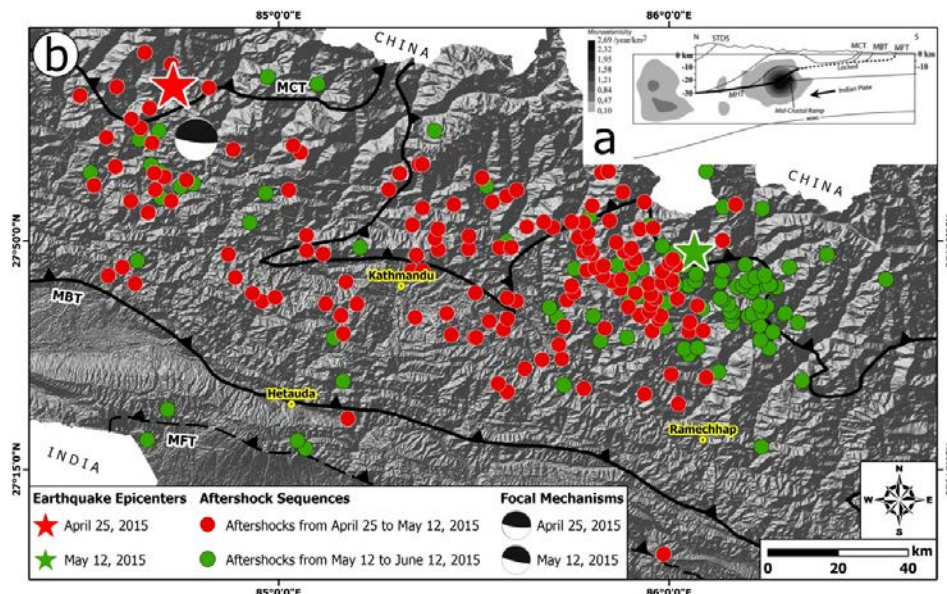
Fig. 2 – (a) Generalized N-S cross section through the Central Himalaya. The southern flat along the MHT is locked during the inter-seismic period resulting in elastic stress accumulation, which is released through microseismicity in Nepal Himalaya. The great earthquakes are generally originated along the northern flat just front of the Higher Himalaya [6]. (b) The epicenters, the aftershock sequences and the focal mechanisms of the main shock on April 25, 2015 and of its largest aftershock on May 12, 2015 respectively based on [21].

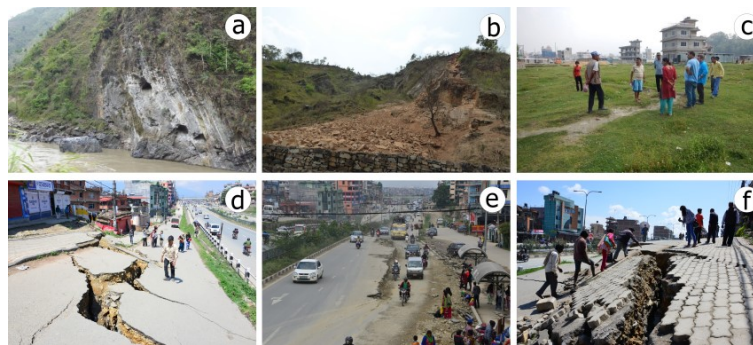
Fig. 3 – Typical EEE induced by the 2015 Nepal, Gorkha earthquake: (a, b) landslides along the road network of the affected area, (c) liquefaction phenomena in Guheshwori from [26] (d, e, f) ground cracks strongly related to liquefaction-induced lateral spreading along a segment of the Kathmandu-Bhaktapur road section of the Araniko Highway in the Lokanthali area.

Based on [23, 24, 26], primary effects directly linked to the surface expression of the seismogenic source were not detected in the field after the 2015 Nepal, Gorkha earthquake. Palaeoseismological studies suggest that the 1255 and 1934 earthquakes ( $M_w \geq 8.1$ ) ruptured the surface along the MFT south of Kathmandu [27], while field observations and related studies after the 2015 main shock suggest that the rupture extended only to the base of the MFT [23, 24, 26]. However, as mentioned above, a wide ground deformation zone in Araniko Highway could be attributed to thrust faulting directly located under the Kathmandu basin (Fig. 3a, b, c)

lateral spreading and in geotechnical unstable areas due to the generation of earthquake-induced slope movements. A characteristic example of cracks was observed along a segment of the Kathmandu-Bhaktapur Road section of the Araniko Highway in the Lokanthali area (Fig. 3d, e, f). Cracks with 2 m deep fissures and vertical offset up to 1.5 m were observed over a large area with gentle slope to a river channel and caused ground fissuring and subsidence, slope failures and sinking of the main and access roads, damage to reinforced and gravity retaining walls, settlement and tilting of buildings and damage to footbridges. Based on various field reports [23, 24, 26], these structures were associated with lateral spreading. However, taking into account the observed structures such as monoclinal escarpment, tension cracks and small-amplitude folds and the fact that these cracks are in agreement with preliminary models of co-seismic slip suggesting that the largest amount of slip on the fault was located just below the Kathmandu city, this highly deformed zone could be attributed to thrust faulting.

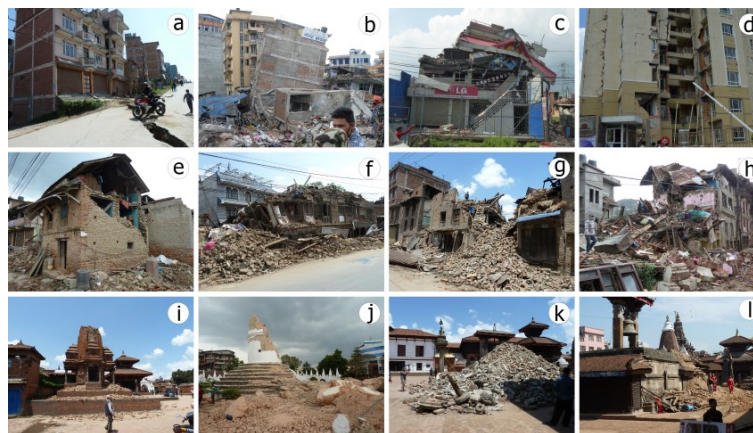
Fig. 4 – The first row illustrates damage on RC buildings: (a) Tilting close to ground cracks strongly related to liquefaction-induced lateral spreading, (b, c) partial and total collapse, (d) moderate damage to non-structural elements of high-rise apartment building. The second row illustrates damage to masonry buildings: (e) partial collapses of the side walls, (f, g) partial collapse and (h) total collapse of masonry buildings close to undamaged RC buildings (f, g, h). The third row illustrates damage to old cultural heritage buildings of various construction types and especially partial (i) and total collapse of temples (j, k, l).

Well-constructed RC buildings sustained no to moderate damage. Poorly built and non-engineered RC buildings suffered minor, moderate and severe damage not only to non-structural but also to structural elements. Non-structural damage included cracks with multiple patterns in infill walls (e.g. diagonal cracks, horizontal cracks at the beam interface and vertical cracks at the column interface), detachment of large pieces of plaster from infill walls, detachment of infill walls from the surrounding RC frame and partial or total collapse of infill walls. Damage to structural elements of low- and mid-rise buildings comprised cracks and fracturing in beam and columns, shear failure or compression crushing of the supporting columns along with the elastic behaviour of beams, tilting (Fig. 4a, b), foundation failure resulting in overturning and partial or total collapse, soft story failure due to absence of infill walls and stirrups at the beam-column joint location, pounding of adjacent buildings resulting in partial collapse or tilting (Fig. 4b,c) as well as pan-cake type collapse due to heavy loads from the upper storeys and insufficient column sizes. Damage to high-rise buildings was observed to non-structural elements and comprised cracks in infill walls and detachment of large pieces of plaster in the lower storeys (first and second) followed by the medium storeys. Damage to RC buildings was due to poor geometric configuration (too long in one direction, extension of masonry wall beyond column line), poor quality of construction materials and concrete with comprehensive strength lower than the expected, non-seismic detailing and absence of earthquake resistant features, lack of implementation of proper ductile detailing of reinforcement even in recent constructions, lack of geotechnical provision and inappropriate foundation on slopes.

Damage to unreinforced masonry buildings include diagonal cracks often originating from the openings in the masonry load-bearing walls (doors and windows), vertical corner cracks along the mortar joints of the brick walls, partial collapse of multi-layered walls, collapse of the upper storeys of the buildings and roofs, while the lower storeys remained intact, out-of-plane failure of roof gable due to its location at the top of the building and to its vibration as a free standing unit, tilting due to foundation failure, damage due to pounding with heavier adjacent buildings and partial or total collapse of the building (Fig. 4e, f, g, h). Damage to unreinforced masonry buildings were due to the placement of construction materials in a random manner, the large thickness of the load-bearing walls along with heavy floors and roofs resulting in heavy structures attracting large inertial forces during large shocks, lack of interlocking connection between main and cross walls, poor connection between the wall and the diaphragm and absence of continuous horizontal bands for developing confining box action of walls.

Major destruction was observed at various square complexes, world heritage sites and many other historical structures of cultural and archaeological significance in Kathmandu valley. The observed damage varied significantly based on the construction age and the structural systems. It mainly comprised residual deformation of the ground floor level of the temple, cracks in masonry walls, partial or total collapse of masonry walls (Fig. 4i, k, l), sway of the timber frame and partial or total collapse of the structure. Damage to old cultural heritage structures were due to old construction age, unusual structural systems, fatigue of monuments from past earthquakes, lack of maintenance and poor quality restoration after the 1934 Nepal-Bihar earthquake.

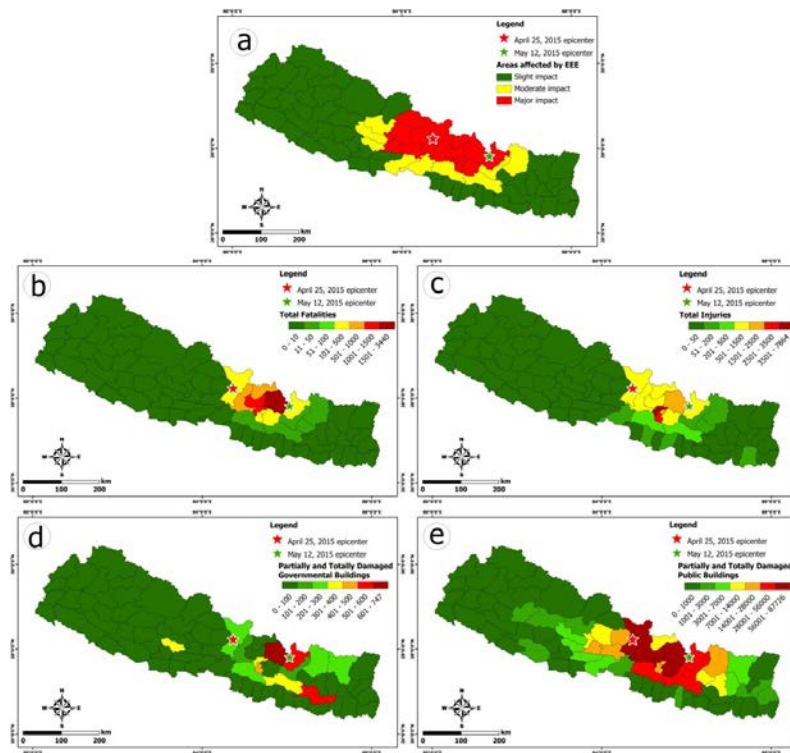
Fig. 5 – Distribution of (a) EEE, (b) fatalities, (c) injuries, (d) damaged governmental buildings and (e) damaged public buildings induced by the 2015 Nepal, Gorkha earthquake and its largest aftershocks to the Nepal districts based on governmental reports [30] last updated on June 05, 2015.
