Characterization of the out-of-plane behaviour of full-scale masonry infill walls with and without previous in-plane damage: experimental study

A. Furtado⁽¹⁾, H. Rodrigues⁽²⁾, A. Arêde⁽³⁾, H. Varum⁽⁴⁾

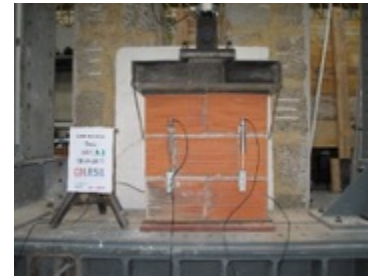
Fig. 4 – IM wallets characterization tests a) Compression strength tests; b) Diagonal tensile strength tests.

Further characterization tests were carried out on the mechanical properties of the IM wallets. For this, seven samples were subjected to compression strength tests and six samples to diagonal tensile strength tests, as illustrated in Fig. 4a and b respectively. The most common damage observed was top or bottom crushing and diagonal cracking of the wallets subjected to vertical compression strength tests and diagonal compression tests respectively. A mean compression strength of $f_m=0.531\text{MPa}$ with vertical elasticity modulus of $E_m=1417.6\text{MPa}$ were found. From the diagonal tensile strength tests was obtained the mean value of $f_m=0.303\text{MPa}$. The tests results are summarized in Table 2.

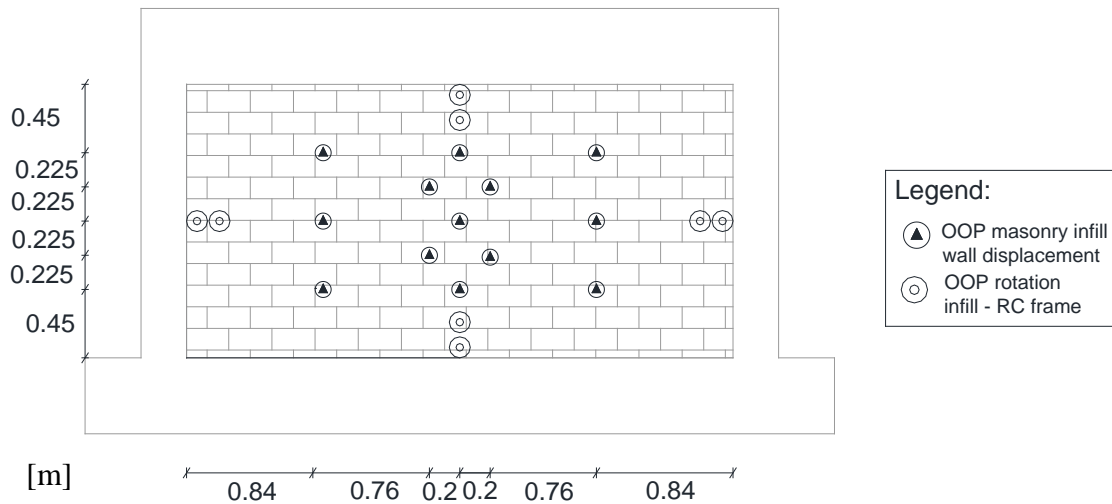
Fig. 6 – Layout of the out-of-plane test instrumentation (in meters).

The instrumentation of the experimental tests comprised a total of 23 displacement transducers, among linear variable displacement transducers (LVDTs) and draw wire transducers (DWTs), as illustrated in Fig. 6. The transducers were divided into 3 different groups according to the corresponding measurement objective: i) IM wall out-of-plane displacements (13 DWTs), ii) out-of-plane rotation between the infill panel and the surrounding RC frame (8 LVDTs) and iii) out-of-plane displacements of the RC frame (2 LVDTs).

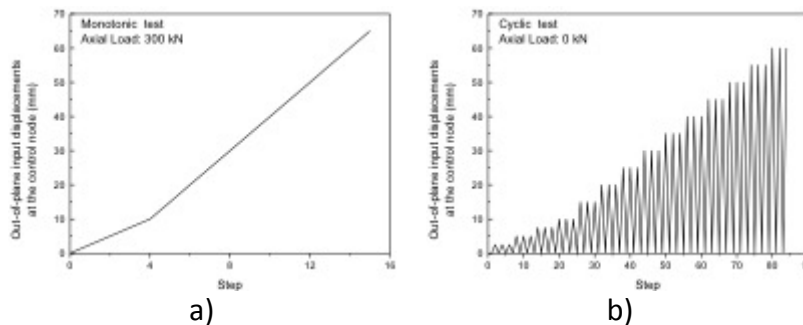
Fig. 7 – Loading condition for: a) monotonic test Inf_01 and b) cyclic test Inf_02 and Inf_03.

The third test Inf_03, comprising a double-leaf panel, was first subjected to an in-plane drift of 0.5%, and then the interior panel was removed and the damaged external wall was subjected to the out-of-plane test. The Inf_01 test was carried out by imposing monotonic increasing out-of-plane displacements in the IM panel. With regard to the Inf_02 and Inf_03 tests, cyclic out-of-plane displacements were imposed on the IM wall with steadily increasing displacement levels, targeting the following nominal peak displacements (in mm): 2.5; 5; 7.5; 10; 15; 20; 25; 30; 35; 40; 45; 50; 50; 55; 60; 65 and 70, as illustrated in Fig. 7. Three cycles were repeated for each lateral deformation demand level at the control node chosen as the central point of the IM wall where concentrated deformation is expected.

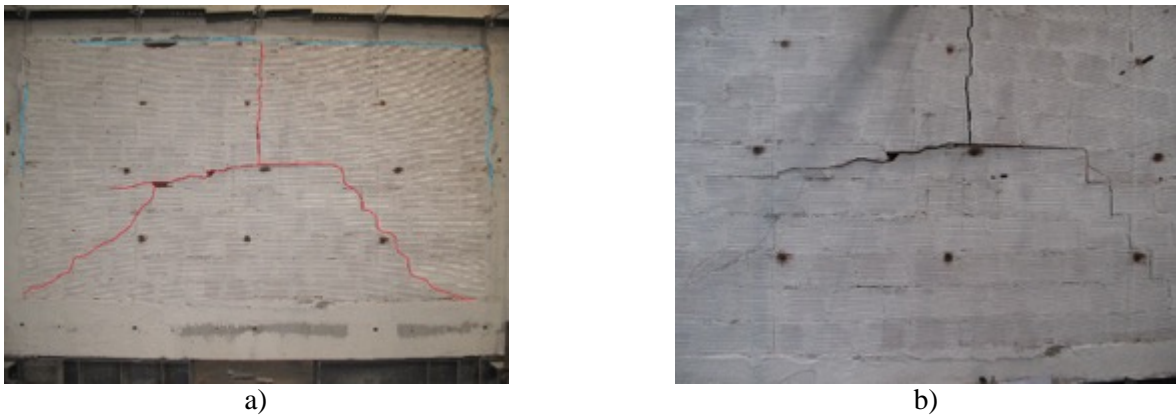
Fig. 9 – Inf_02: a) Cracking pattern; and b) Trilinear cracking pattern observed in the center of the panel.

The final cracking shape of Inf_01 was majority vertical and it was also observed detachment between the infill panel and the surrounding RC frame in the top and bottom joints as illustrated in Fig. 8. However, the Inf_02 test exhibited a trilinear cracking pattern with deformation concentrated in the mid-point of the wall, with slight cracking in the top joint, as illustrated in Fig. 9. In the third test with previous in-plane damage (Inf_03), it was only observed the detachment between the infill panel and the surrounding top beam and columns, a typical rigid body behaviour, illustrated in Fig. 10.
