## EXPERIMENTAL SEISMIC BEHAVIOUR OF A PRECAST INDUSTRIAL BUILDING AT THE CIVIL PROTECTION CENTRE IN FOLIGNO, ITALY

G. Bongiovanni<sup>(1)</sup>, G. Buffarini<sup>(1)</sup>, P. Clemente<sup>(1)</sup>, F. Saitta<sup>(1)</sup>,  
M. De Angelis<sup>(2)</sup>, A. Boccamazzo<sup>(3)</sup>, P. Felici<sup>(4)</sup>

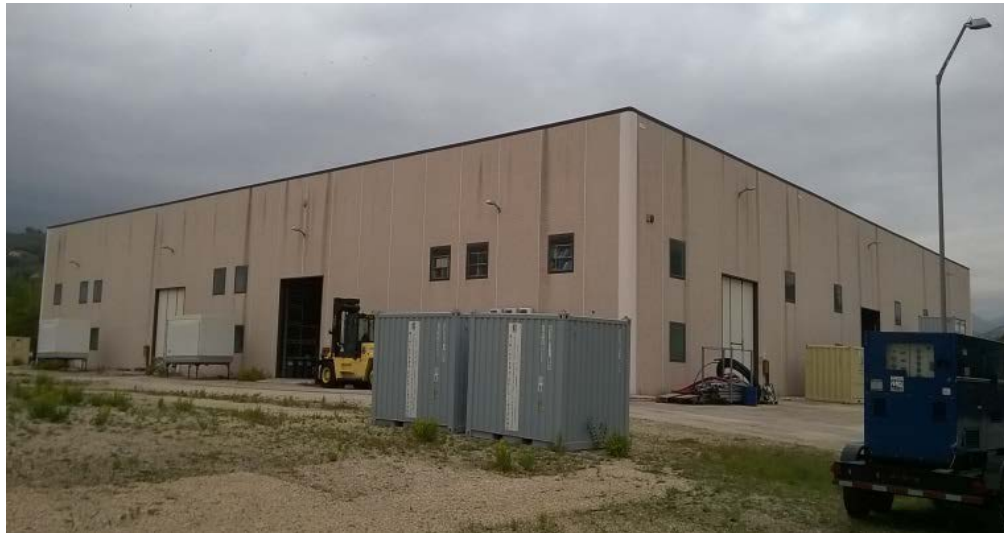
Fig. 1 – The building of the Civil Protection Centre in Foligno, Italy

The building under investigation has a squared plan of about 60 m size and a total height of 8.7 m, including the covering structure (Fig. 1). The carrying structure is composed by four frames; each of them has four spans of about 15 m. The precast columns are placed in pocket plinth foundations and have at the top a suitable shape to house the T shape precast beams, connected to them also by means of projecting rebars. The covering is not continuous but composed by concrete elements and alternate to plastic ones, supported by the beams (Figs. 2 and 3).

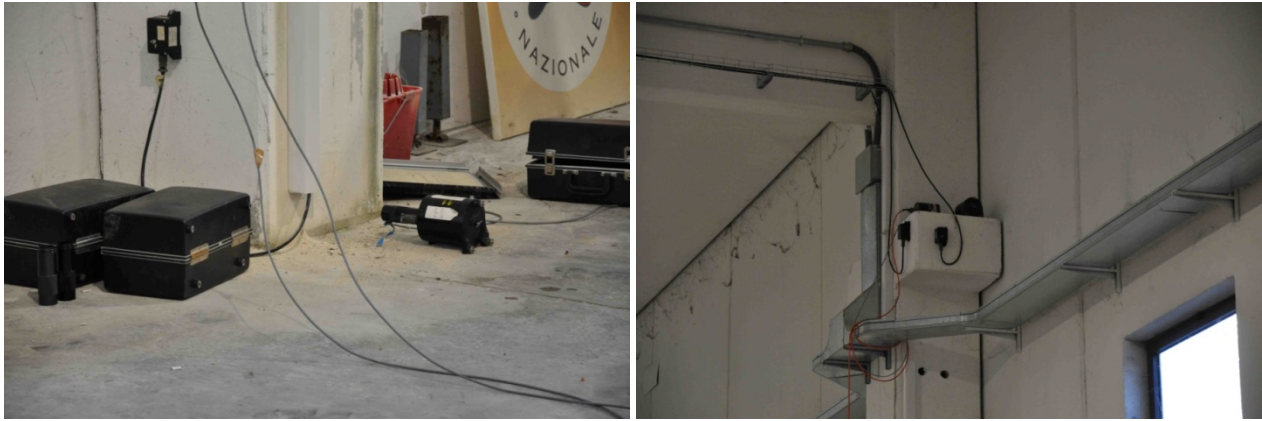
Fig. 5 – Location of accelerometer A11 and seismometer S11 (left) and location of accelerometers A08 and A09 and seismometers S08 and S09 (right) on frame F2.

In order to check the correct working of the accelerometer network, ambient vibrations were recorded also by means of a temporary seismometer array, which were composed of 24 Kinematics SS-1 connected to a Granite acquisition system. Ten seismometers (S01 to S08, S11 and S12) were deployed very close to the corresponding accelerometers (A01 to A08, A10 and A12). Furthermore, seven seismometers were deployed on frame F1 (at the base of columns C11 and C15 and at the top of columns C11, C13 and C15) and other seven on frame F3 (at the base of columns C31 and C35 and at the top of columns C31, C33 and C35), i.e., on an external and an internal frame. Fig. 5 shows the location of seismometer S11, close to accelerometer A11 at the base of column C21 (left), and location of accelerometers A08 and A09 with the corresponding seismometers S08 and S09 at the top of column C25 (right).

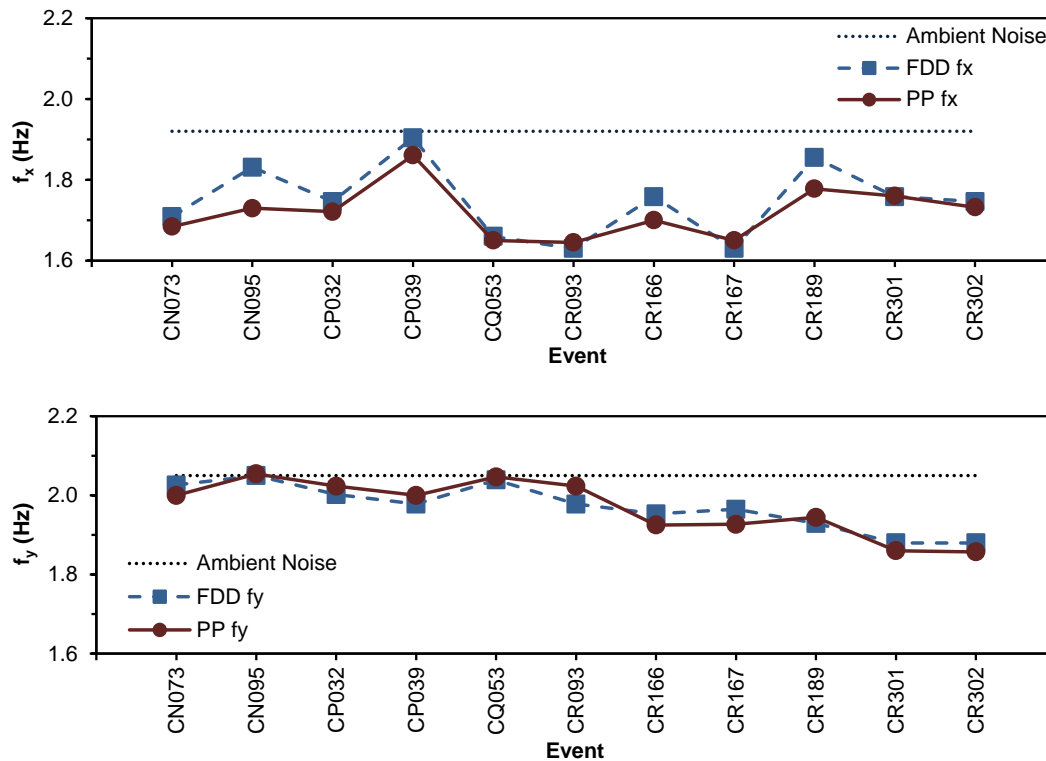
Fig. 7 – First transversal resonance frequency (up) and first longitudinal resonance frequency (down) in the recorded seismic events.

The frequency domain analysis allowed determining the first resonance frequencies in all the events. The values determined by using two well-known different methods, the Peak Picking and the Frequency Domain Decomposition [10], which gave very similar results. These are plotted in Fig. 7, for the frequency in transversal and longitudinal direction, respectively. The first varies from the maximum one, obtained in the ambient vibration test and equal to 1.92 Hz, to a minimum value of 1.65 Hz. The second varies from the maximum of 2.05 Hz relative to the ambient vibrations, to a minimum of 1.80 Hz. The resonance frequencies observed during the seismic events were always lower than those of the ambient vibration test. Each event gave different reduction of the two frequencies and the maximum reductions were not observed in the same event.

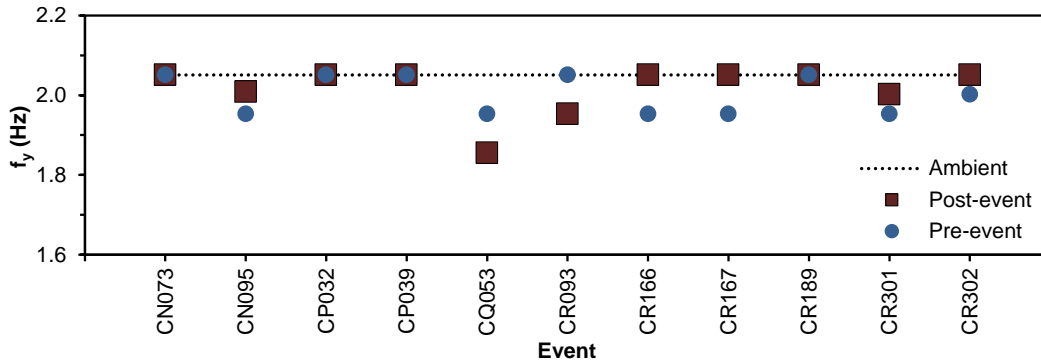
Fig. 9 – First longitudinal resonance frequencies in the pre- and post-events compared with that obtained from the ambient vibrations.

the time when  $I/I_A = 0.05$  and to end when  $I/I_A = 0.95$  [11]. In Fig. 8 the three parts are individualised for each event and in Fig. 9 the first longitudinal resonance frequencies in the pre-events and in the post-events are plotted. As one can see the resonance frequency in the post-event is always equal or very close to that of the ambient analysis. This occurrence implies that the effects of the earthquakes, probably related to nonlinear response under seismic actions, were reversible and the structure recovered the previous dynamic characteristics. The damping varied between the minimum one observed during the ambient vibration analysis (4.4% in the transversal x direction, 4.8% in the longitudinal y direction) up to about 9.5% observed in both the directions.

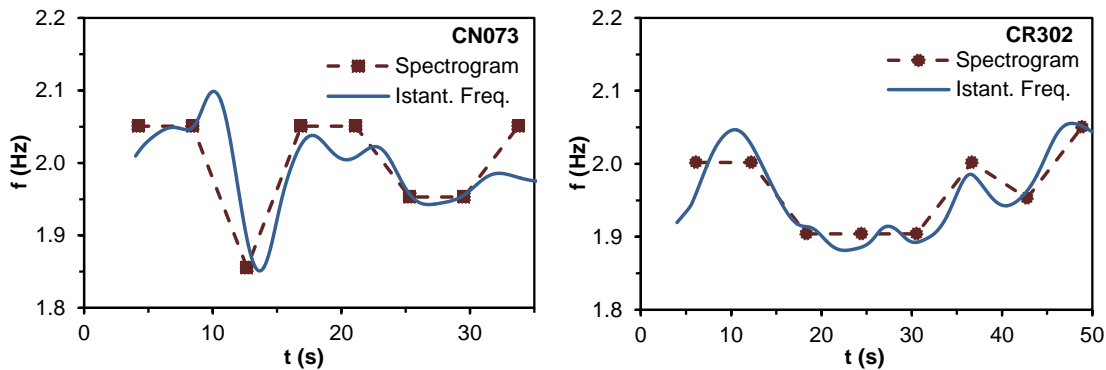
Fig. 10 – Variation of the first longitudinal frequency during event CN073 (left) and event CR302 (right).

On the time histories filtered in the range of interest [1.8, 2.2] the instantaneous frequency obtained by means of the Hilbert transform was calculated (Fig. 10) [12][13]. In the same figure also the spectrogram obtained dividing the time length of the recorded time history into eight portions is plotted.
