## RETROFITTING DESIGN AND CONSTRUCTION OF MIXED TYPE STRUCTURE WITH RC FRAME AND MASONRY IN DHAKA, BANGLADESH

M. R. Islam <sup>(1)</sup>, A. Inoue <sup>(2)</sup>, M. S. Rahman <sup>(3)</sup>

The model building considered for seismic assessment and retrofitting was utilizing as a fire service and civil defense station. The fire station building is a mixed type structure with RC frame and brick masonry. The building is located at Dhaka city. It was designed and constructed in 1963 without considering seismic load. Bangladesh National Building Code (BNBC) 1993 and also recent BNBC 2015 Final Draft don't cover the regulations of seismic assessment and retrofitting design of existing building. The fire station building has been retrofitted with the concept and practices of Japanese guideline and using seismic parameters of BNBC. Seismic evaluation, retrofitting design and construction steps have been introduced in this paper. This is the first project of seismic retrofitting of public building in Bangladesh. The total work has been done as part of the technical cooperation project namely CNCRP between Public Works Department (PWD) of Bangladesh and Japan International Cooperation Age

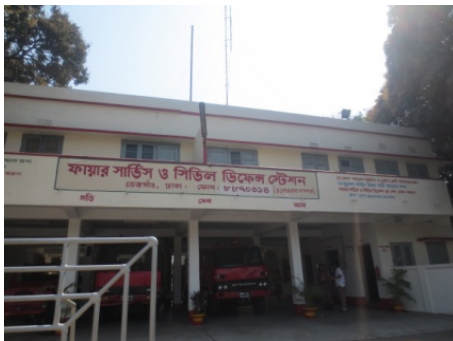
(a) Elevation before retrofitting

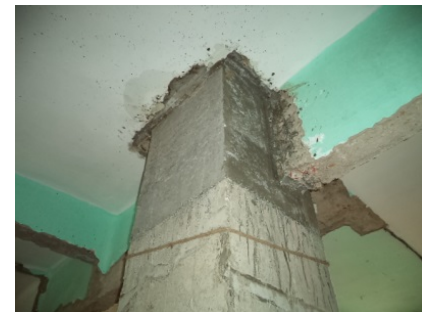
(c) Non-shrink grout mortar work at top of column, 1<sup>st</sup> story

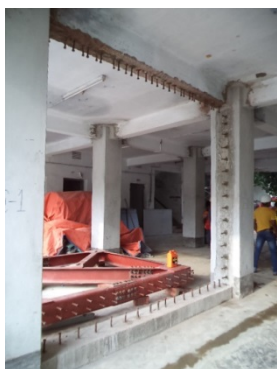
(d) Chemical anchor at beam and column

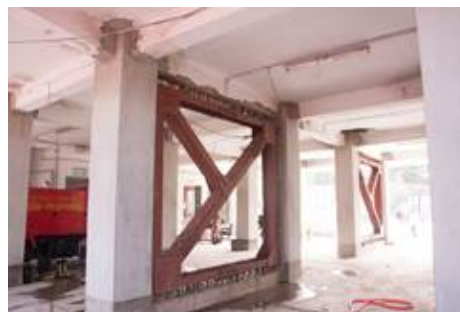
(e) Placing of steel framed brace

In transverse direction at center line (at grid E) of the building two steel framed bracings has been placed to increase stiffness and strength of the middle part. Typical elevation of the steel frame is given in Fig. 11.

- Since local construction company is no familiar with this type of specialized job, quality of work was not up to the mark, specially in case of steel framed bracing fabrication.

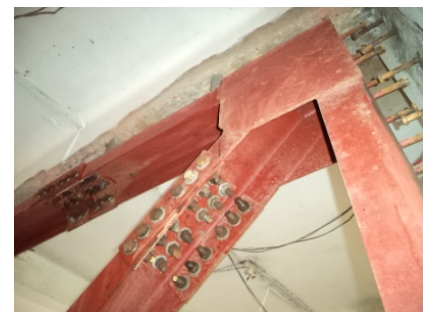
(f) Connection of steel framed brace

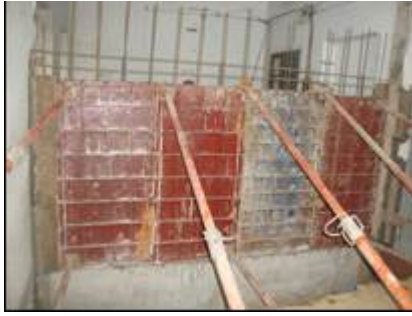
(g) Construction of RC wall at grid -4

Two new RC wall at each side of masonry block is provided (details shown in Fig. 10) to meet the shear demand at ground floor only. This new RC wall has a continuous footing at existing foundation level and is anchored to

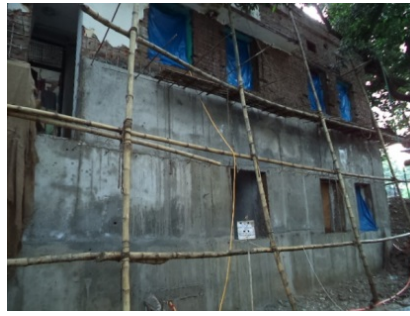
(h) Concreting work on perimeter brick wall

- (i) To increase shear strength, concrete jacketing with thickness of 100mm with single layer of reinforcing bars at outside of perimeter walls is provided. RC floor slab as well as brick wall is connected to RC jacketed wall at perimeter by chemical anchors. Vertical load is supported by existing brick masonry walls and lateral load is resisted by RC jacketed walls. Lateral strength of brick masonry is also considered in retrofitting design.

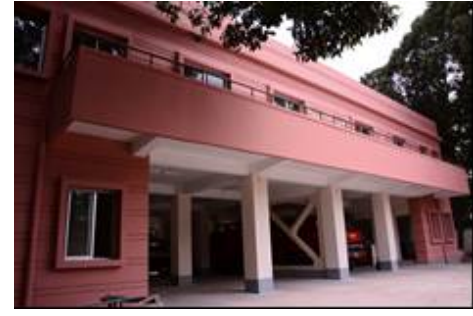
Fig. - 12 Retrofitting construction work (cont.)

(i) New look of fire station building after retrofitting

There are some experiences of re-strengthening work of private and public building in Bangladesh, but this pilot project is the first initiative of methodical retrofitting design and retrofitting construction work. This retrofitting work helped local engineers to understand applicability of retrofitting methods, cost of work, construction management etc. Some of the pictures of construction work are shown in Fig. 12. Following are the notable experience gathered during construction work.
