## Seismic Safety Evaluation Based on Muon Monitoring of Prambanan World Heritage Temple Damaged by 2006 Central Java Earthquake, Indonesia

*Keywords: Muon, Non-destructive Test, Masonry, Heritage Structure, Seismic Safety Evaluation*

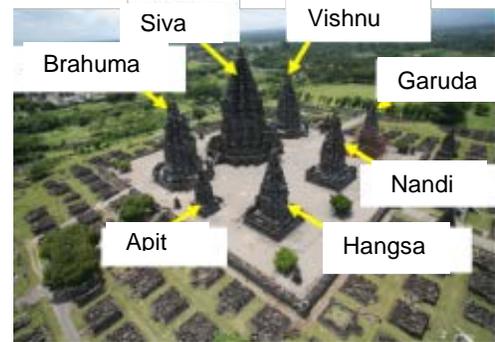
Photo. 1 - Prambanan Temple

The Prambanan Temples, the World Cultural Heritage of stone masonry structures were originally built in the 9th century in the suburbs at the historic city, Yogyakarta, in Java, Indonesia. Today, they are composed of existing 8 monuments, shown in Photo.1. Candi Siva, the object of the present research, is the largest structure in the site. Although they had ruined during their long histories, their structures were reconstructed in 20th century. Candi Siva was reconstructed first by Dutch engineers by introducing reinforced concrete structure in the middle of 20th century; the other buildings were reconstructed by Indonesian engineers during the end of 1980s and beginning of 1990s by employing the reinforced concrete technology introduced by Dutch engineers. In 1993, just after completion of reconstruction, those heritages were inscribed in World Cultural Heritage List. As mentioned above, the stone monuments were rebuilt by introducing inner concrete structures composed of reinforced concrete frames and infill rubble materials. The reinforced concrete frame was employed to confine infill rubble material structure for ensuring structural stability [1][2][3].

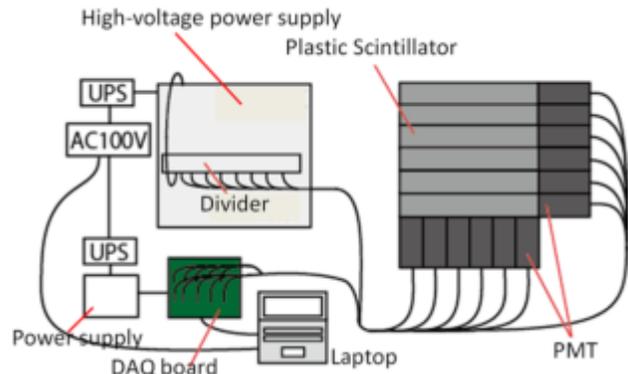
Fig.1 - Muon detecting system

Figs. 1 and 2 show the muon-detecting system utilized in the present study and how to detect the muon by scintillators, respectively. The muon-detecting equipment was installed at the NW corner of the central room on the base floor where the statue of Siva was enshrined, shown in Figs.2 and 3. Candi Siva was imaged muographically by utilizing a detector with an active area of 1764cm<sup>2</sup> and with an angular interval of 70mrad. Fig.4 describes the cross-sectional view of the structure and radiant angle from the equipment.

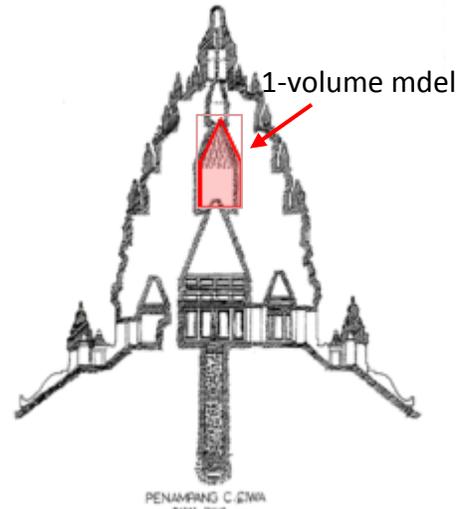
Fig.5 - 1-Volume model for simulation

In the present models, the basic 1-volume model was assumed as 5m cube with volume of 113m<sup>3</sup>, which was shown in the section roughly drawn when Candi Siva was reconstructed in the beginning of 1950's, shown in Fig.5. For examples, 0.5-Volume, 1-volume and 2 volume models are described in Fig. 7. In each model, path length (length of penetration of muon in structural material) should be evaluated, shown in Fig.6. For simulation, a grid of 0.5m cube was utilized to calculate the path length. Also, the bulk density of the structural materials was estimated by the following equation;

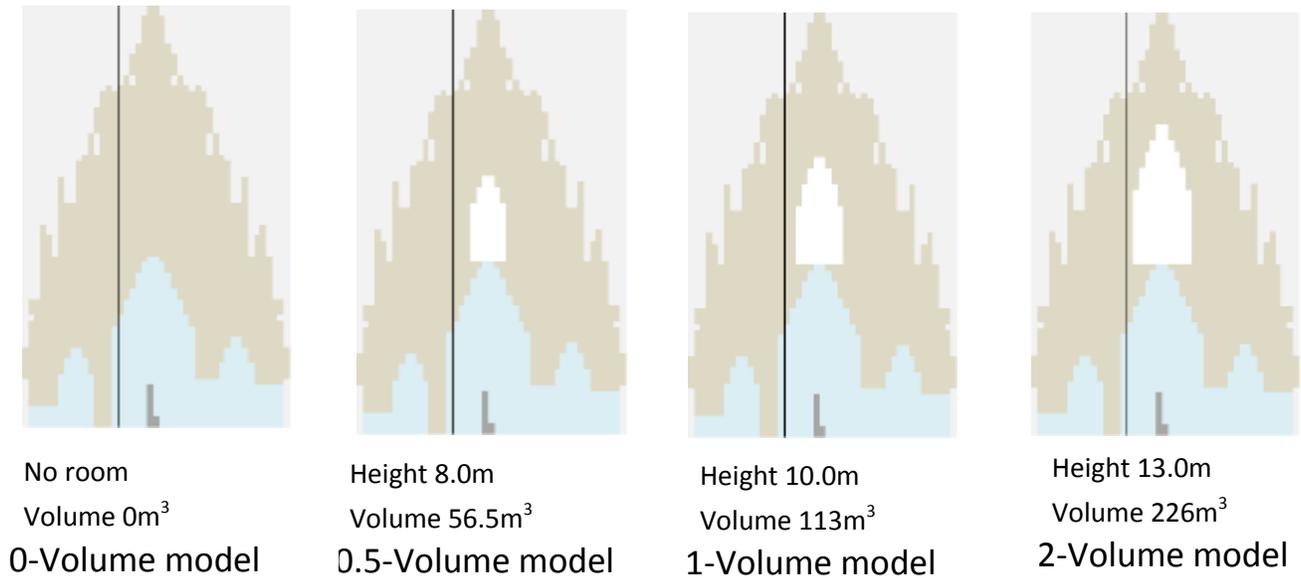
Fig.7 - Volume models assumed for simulation

- 1) There was no hidden room in the upper part of the structure (we called 0-volume model)
- 2) There was a hidden room with a half volume shown in the drawing of the section (we called 0.5-volume model)
- 3) There was a hidden room with the same volume shown in the drawing of the section (we called 1-volume model)
- 4) There was a hidden room with double volume shown in the drawing of the section (we called 2-volume model)
- 5) There was a hidden room with triple volume shown in the drawing of the section (we called 3-volume model)
- 6) There was a hidden room with 4 times volume shown in the drawing of the section (we called 4-volume model)

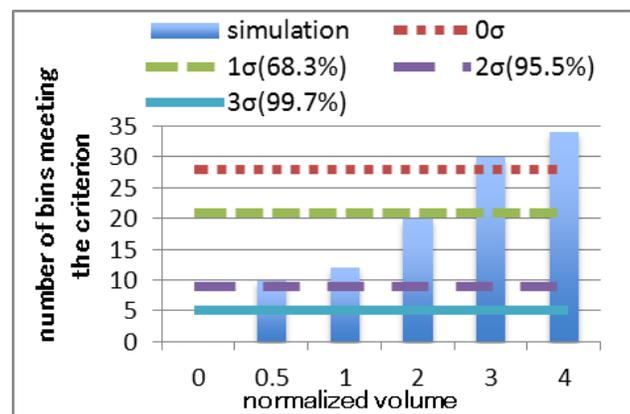
Fig.8 - Confidence level of data

As results, Fig. 8 shows the confidence level of recorded data in comparison with the simulation. The horizontal axis denotes the normalized volume of the assumed hidden room, while the vertical axis denotes the number of bins meeting the above-mentioned conditions. In Fig. 8,  $0\sigma$ ,  $1\sigma(68.3\%)$ ,  $2\sigma(95.5\%)$ ,  $3\sigma(99.7\%)$  denote reliability. This figure indicates that the possibility of existence of a hidden room being larger than 1-volume would exceed 90%. Furthermore, it should be noticed that the possibility of existence of a hidden room being larger than 2-volume model is in good agreement between simulation and record, which shows  $1\sigma$  standard deviation. This comparison means that the possibility of the existence of a hidden room being larger than 2-volume is approximately 70%. On the other hand, the possibility of existence of a hidden

room larger than 3-volumes was lower. It was concluded that the volume of the hidden room in the upper part of Candi Siva could be expressed by 2-volume model. Fig.9 displays the density profile of Candi Siva obtained from the muography in the present study. This new finding was taken into account to provide the analysis model for seismic evaluation in the next chapter.

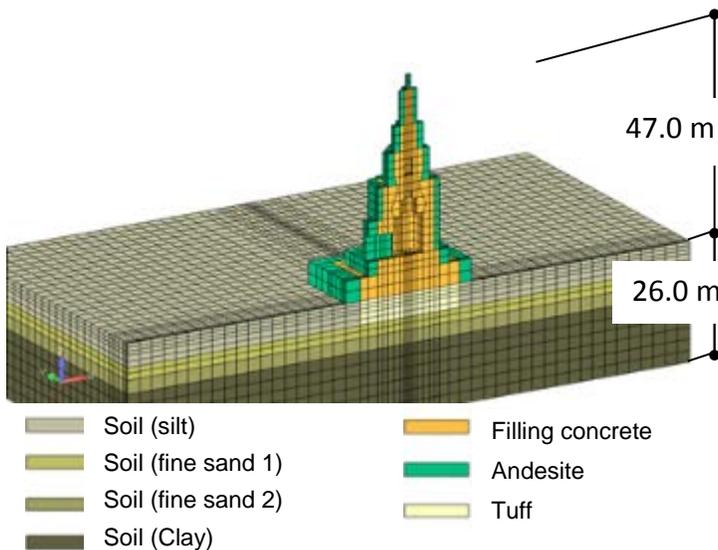
Fig.10 - 3-Dimensional finite element model of soil-structure system

In our past studies, both the simplified lumped masses model and the 3-dimensional finite element model (See Fig.10) were employed [2][3]. In both models, dynamic soil-structure interaction was taken into account, as the natural frequency observed during not only the earthquake but also the microtremore measurements was good agreement with the analysis model in which the soil-structure interaction was taken into account. As introduced in Introduction, reinforced concrete structure was used to reconstruct the monument. To evaluate the earthquake-induced stress in the reinforced concrete frame and the inner rubble concrete, it would be more useful to employ the finite element model. Therefore, 3-dimensional finite element model was utilized in the present paper. Shown in Fig. 11, the finite element model was revised on the basis of the muography. Hence, the volume of the hidden room in the upper part of Candi Siva was enlarged to double volume shown in the sketch of the section (See Fig.5). Table 6 shows material properties of the structure used for the analysis. (Computer Code TDAP III was used.)

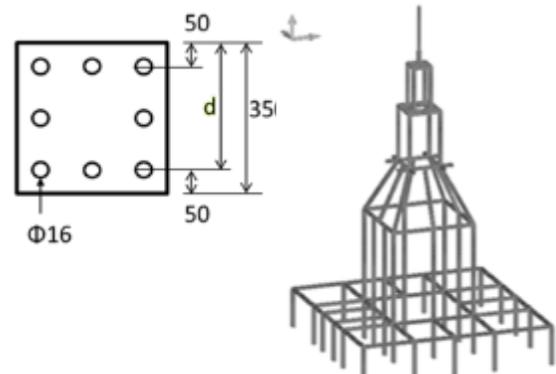
Fig.13 - Reinforced concrete frame

Figs. 12 and 13 show the soil profile at the site and the inner reinforced concrete frame, respectively. The soil profile shown in Fig.12 was based on the surface wave profiling test and the standard penetration test. The inner reinforced concrete frame shown in Fig.13 was provided from the drawings prepared for reconstruction of Candi Garuda, because the size of the frame was able to be found in the drawings of Candi Garuda.

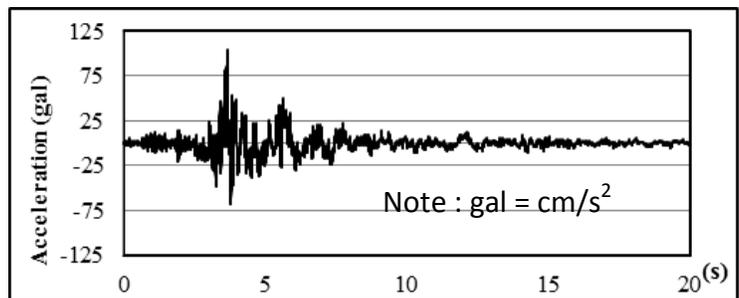
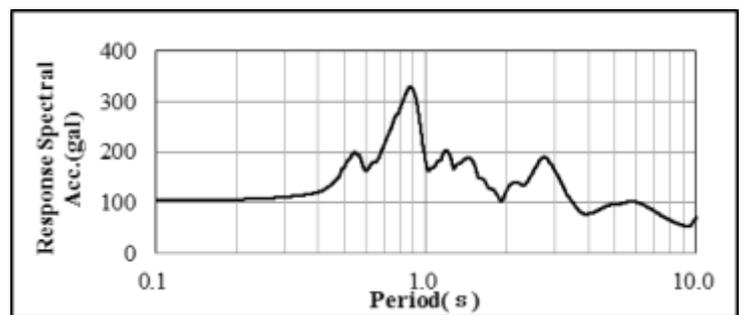
Fig.14 - Input ground motion

Note that earthquake ground motions should be essential for evaluation of seismic safety of heritage structures, however, the earthquake ground motions were not recorded in the vicinity of Prambanan Temple and in the epicentral area as well during the Central java Earthquake of 2006. Therefore, the ground motion level (PGV) was estimated to be approximately 10cm/s at the epicentral distance of 20-25km, being evaluated from the attenuation curve based on the earthquake records in the far-field. As the wave form utilized for the response analysis, the strong motions recorded during the past earthquakes of similar magnitude with severe damage to historical masonry buildings were appropriate to be used. The earthquake record of Athens Earthquake of September 7, 1999 was utilized in the present study [2]. Fig.14 shows the wave forms with the response spectrum of the input ground motion.

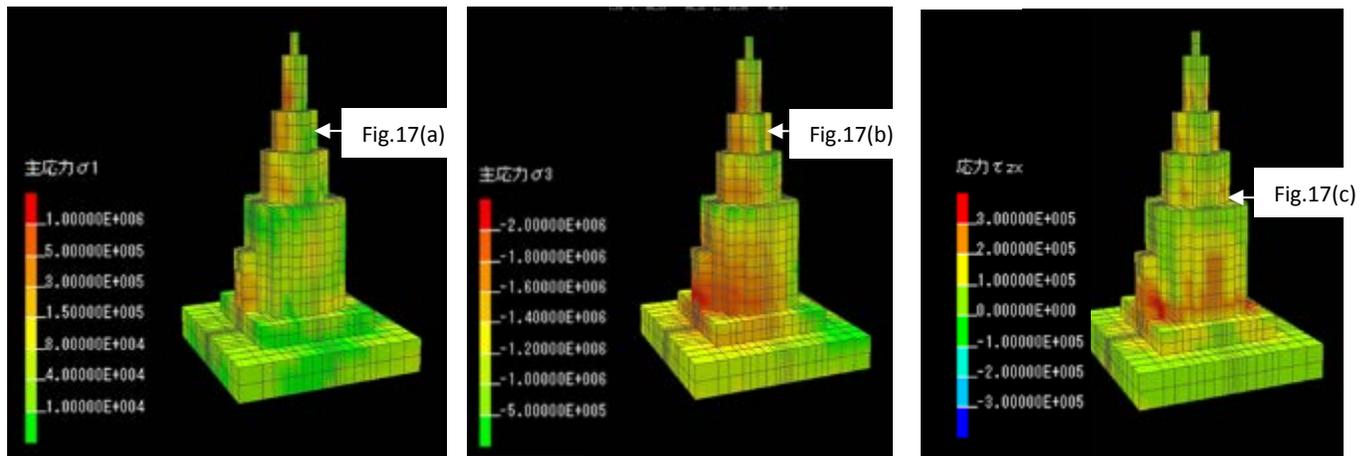
(a) Peak tensile stress      (b) Peak compressive stress      (c) Peak shear stress

Natural frequency of the soil-structure system of the revised model was 1.9Hz, being in good agreement of the microtremore record described in our past studies [1][2][3]. As results of the earthquake response analysis, Fig.15 shows the peak stresses ; tensile, compressive and shear stresses. The induced peak tensile stress was 1,270kN/m<sup>2</sup> at the base of the top roof. This peak tensile stress was less than the tensile strength of the andesite stones calculated to be 1,360kN/m<sup>2</sup> on the assumption that the tensile strength would be approximately 1/10 of the compressive strength evaluated from the material mechanical test using the new stones utilized for the restoration works. As well as, the earthquake-induced peak compressive stress induced, 2,220kN/m<sup>2</sup>, was less than the compressive strength of 13,600kN/m<sup>2</sup>. Those analysis results indicated that earthquake-induced stress was less than the inherent strength of the andesite stones, however, the tensile stress at some joints between stones might be subjected to the stress as high as the tensile strength during the earthquake, which might cause damage to the exterior walls. It should be also noticed in Fig. 15 that the earthquake-induced shear stress on the stone wall was concentrated at around the openings. On the other hand, it had been needed to judge if the inner concrete structure was damaged or not, for proposing structural restoration plan. Allowable flexural moment  $M_a$  was calculated from the following equation as ;

At the roof top where the so-called whipping phenomenon was observed, the earthquake-induced peak flexural moment was calculated to be 12.6kNm, being less than the allowable moment of 30.8kNm given by Eq. (2).

Furthermore, the stress induced at the corner of the hidden room is now focused and discussed. Fig. 16 shows the stresses induced at the elements around the hidden room, where stress of the elements arranged at the horizontal section are described at the height shown in Fig.15. Described in Fig. 16, compressive, tensile and stresses at the elements around the hidden room did not exceed their strength. Consequently, the earthquake-induced stress in the inner concrete structure and the inner hidden room were calculated to be less than the strength of the materials and allowable flexural moment, respectively. This finding given by the analysis indicated that it would not be needed to restore structurally the inner concrete structure and the stone walls around the hidden rooms.
