A CASE STUDY: APPLICATION OF THE HARDNESS METHOD TO ESTIMATE THE RESIDUAL CAPACITY OF REINFORCEMENT IN AN EARTHQUAKE DAMAGED BUILDING

G. Loporcaro⁽¹⁾, S. Pampanin⁽²⁾, M.V. Kral⁽³⁾

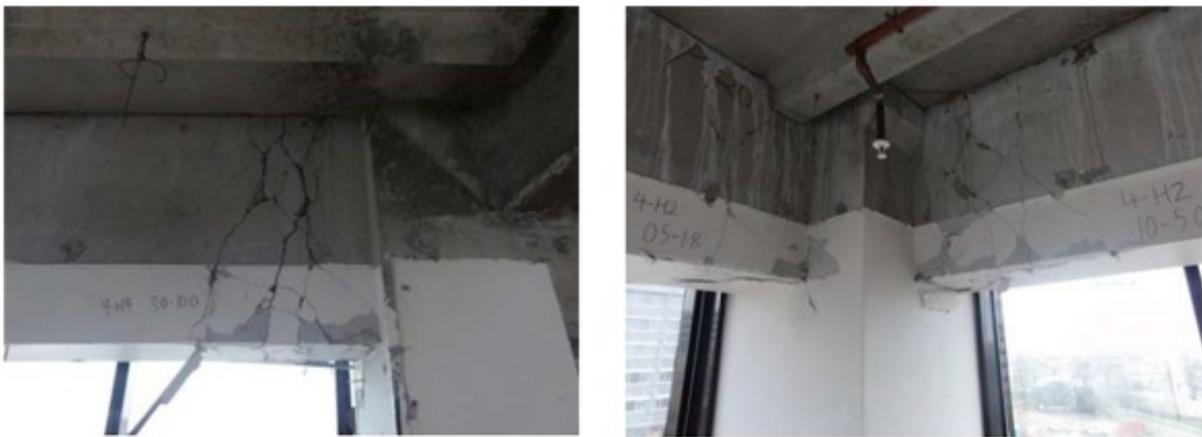
Fig. 1 Beam plastic hinges in a 22-storey reinforced concrete building constructed in mid-end 1980s [3].

In the 2010 and 2011 seismic sequence, RC buildings in the Christchurch CBD were subjected to high levels of seismic acceleration. The associated seismic demand was beyond that predicted for the 500-year return period design spectrum by the current standard NZS 1170.5:2004 [4] [2] [3] [5]. As result, many RC structural elements experienced large inelastic deformations [6] and in ductile RC concrete buildings plastic hinges formed in the expected structure locations: beams, coupling beams and at the base of columns and walls manifested as cracking and permanent plastic deformation of the steel reinforcement (see Fig. 1) [3].

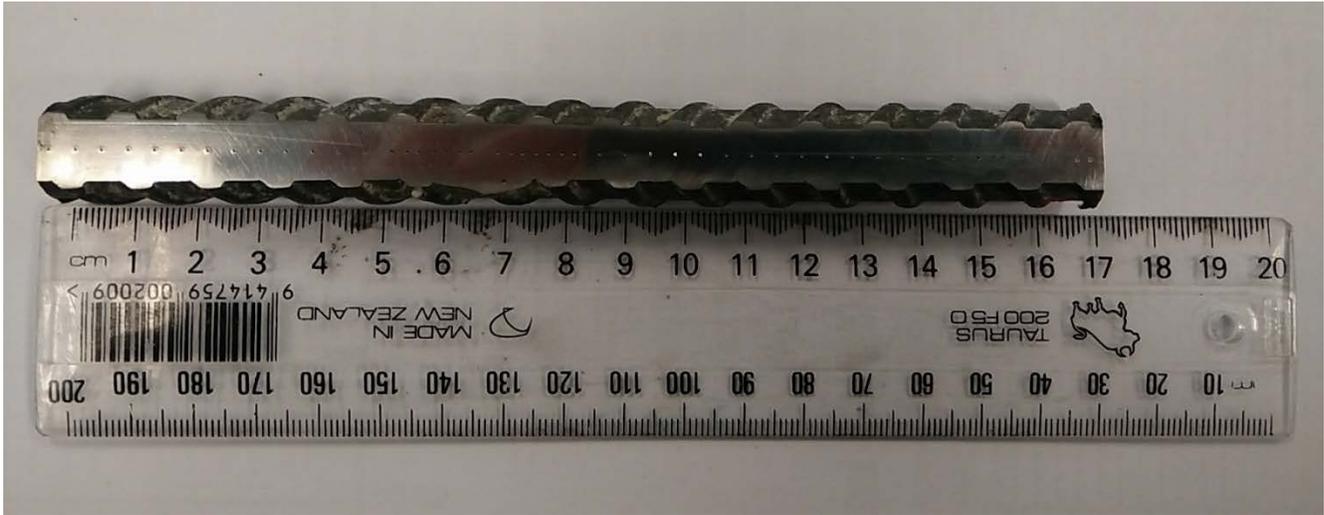
Fig. 6 - Vickers hardness indents shown on a typical polished surface.

approximately into 150 mm lengths, with the crack location in the centre, to facilitate the surface preparation. The undamaged portion of the same bar was set aside for the final tensile testing (Phase IV). Two opposite sides of each bar section surface were ground flat and parallel using a water cooled grinder, sequentially ground from 180 to 600 grit using silicon carbide papers, and then finally polished to a 9-micron finish. Vickers hardness measurements were collected along the longitudinal section of the steel bar at 4 mm spacing (see Fig. 6), this was reduced to 2 mm when a hardness rise was detected.
