COST-EFFECTIVE SEISMIC ISOLATION RETROFIT OF HERITAGE CATHEDRALS IN HAITI

HK Miyamoto(1), ASJ Gilani(2), A Wada(3)

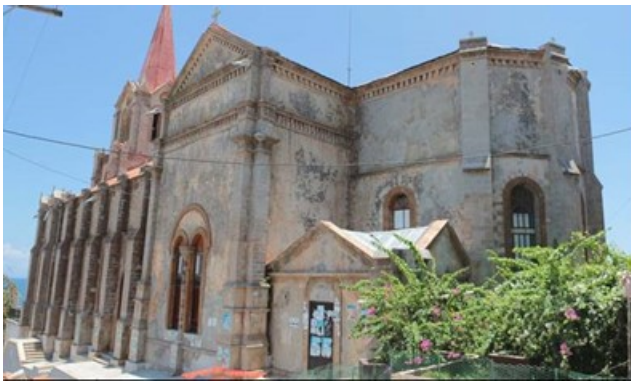
Fig. 1 Miragoane Cathedral

Saint John Baptist Cathedral of was originally constructed in 1880 and is one of the oldest Cathedrals in Miragoane— a coastal town approximately 80 km west of Port-au-Prince, the capital of Haiti. Figure 1 shows a photograph of the building looking east. Saint Jacques et Saint Philippe Cathedral of Jacmel; see Figure 2 was originally constructed in 1859 and is one of the oldest Cathedrals in Jacmel— a coastal town approximately 80 km southwest of Port-au-Prince, the capital of Haiti.

The buildings were constructed using concrete floors with an unreinforced masonry and stonewalls over stone masonry foundations. The roof structures were assembled with trusses that combine both wood and steel. The roofs are supported by the walls on the exterior and by uniformly placed columns along the interior. The front entrances of the cathedral have bell towers high. The tower is constructed with steel frames above the walls.

Both Cathedrals suffered minor damage, primarily minor cracking during the 2010 Haiti Earthquake. The damage to the building was minor because they were not located near the epicenter of the 2010 earthquake

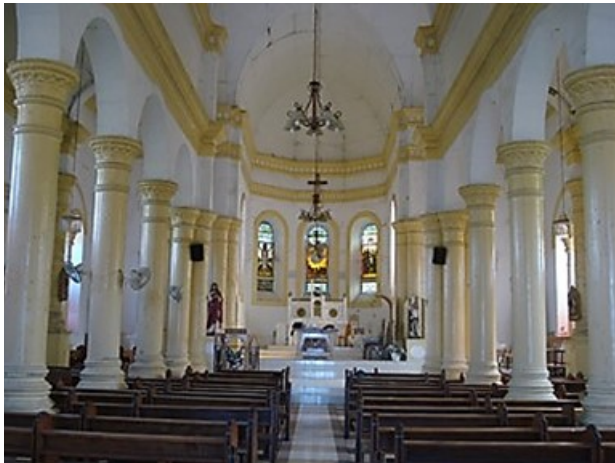
Fig. 3 Miragoane Cathedral

Fig. 3 and Fig. 4 present the interior of the cathedrals. As seen in these figure, these structures comprise a large number of architectural and heritage features. The retrofit solution for the buildings was selected to preserve the architectural features of the buildings. In addition. It was critical to maintain low accelerations for the buildings to reduce potential damage to such features. Seismic isolation retrofit was selected to achieve both of these goals.

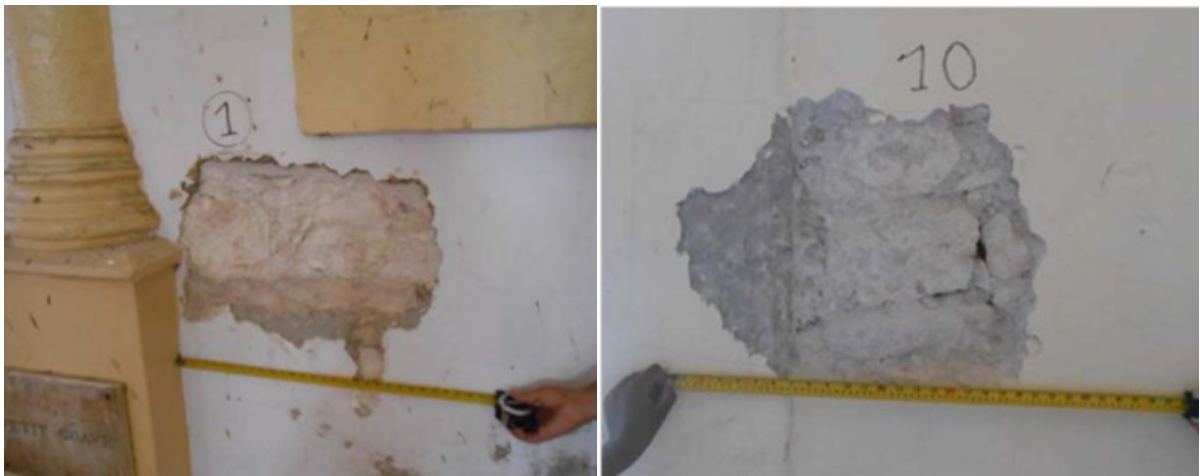
Irregular-shaped stones placed in the mortar Rectangular-shaped stone and debris in mortar
Fig. 7 Typical composition of exposed unreinforced masonry stone walls

The Cathedrals' unreinforced stone masonry (URSM) walls are the load bearing elements resisting the applied vertical and lateral load applied to the building. Fig. 7 depicts exposed sections of the walls with the wall plaster removed for investigation for the two structures. The composition of the wall is that of unreinforced masonry with irregular-shaped stones or with rectangular-shaped stones and debris placed in the mortar

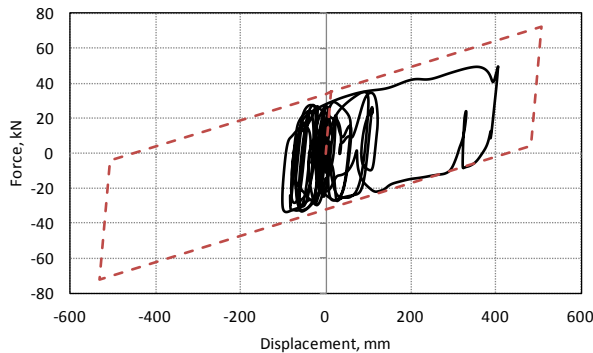
Fig. 14 Typical isolator response

Fig. 14 presents the force-deformation response of a typical isolator from a MCE analysis. Also shown in the figure are the nominal bi-linear backbone curve of the isolator obtained from the manufacturer data. It is seen that the loading and unloading response closely track the nominal response. Fig. 15 presents the bi-direction MCE displacement response of a typical isolator. Also shown in the figure is the displacement limit (500 mm) as specified by the manufacturer. As seen, the isolator MCE displacements are less than the capacity.
