## INVESTIGATING COMMUNITY RESILIENCE IN NEPAL: A HEALTHCARE FOCUS

**Keywords:** reconnaissance, resilience, Nepal

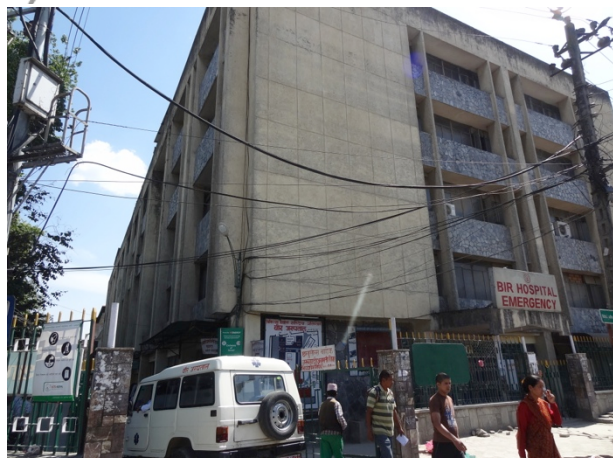
Bir Hospital's heterogeneous building stock suffered significant damage, resulting in four yellow tags and one red tag on its campus. Building 1, the Emergency Block (see Fig. 3a), did not suffer structural damage but did suffer significant damage to its masonry infill walls at the ground floor and to tiles in corridors and near elevators (see Fig. 3c), creating falling hazards for occupants and resulting in a yellow tag. Building 2, which comprises several large buildings (2a - 2c) and one smaller one (2d), did not suffer structural damage; the larger buildings were considered safe (green tag) for occupancy after the earthquake, while the smaller building 2d was assigned a (local) yellow tag for severe damage (out of plane rotation) to a masonry infill wall caused by pounding with Building 1. The seismic gap between Buildings 1 and 2d is only 80mm, which is not sufficient to prevent pounding during strong ground shaking. Building 3, the surgical block, did not suffer structural damage, but like the other buildings on campus, it suffered significant damage to its nonstructural masonry walls at the ground floor, resulting in a yellow tag. Buildings 4 and 5 are unreinforced masonry (URM) buildings that were vertically augmented from 3 to 5 stories and from 1 to 3 stories, respectively. Building 4 was green tagged after the earthquake and suffered damage to a stairwell connecting it to Building 3. Building 5, which had diaphragm discontinuity between ground and first floors, suffered significant structural damage in the bottom two floors and widespread nonstructural damage; this building has since been demolished. Building 6, which housed the kitchen, maintenance section, general store, and medical store, suffered floor settlement and significant nonstructural damage; this building has since been partially demolished.

Fig. 3 – (a) Street entrance to Building 1, the Emergency Block, (b) example of cracking in masonry infill walls, (c) example of tile cracking and (d) damaged CT machine (photos: Hari Kumar and Judith Mitrani-Reiser).

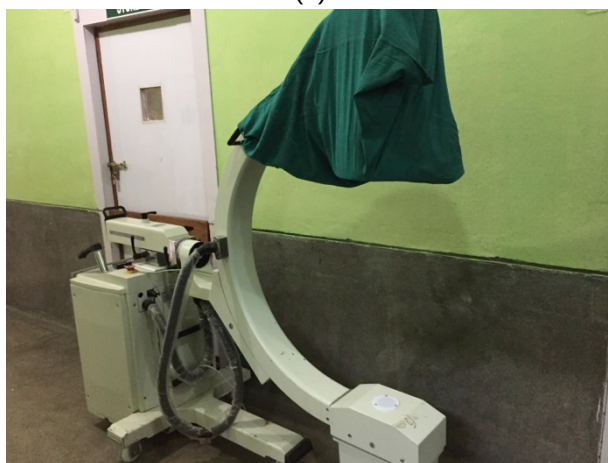
(d)

The hospital did not suffer significant damage to medical equipment or disruption of medical gases and supplies. One computed radiography (CR) machine (shown in Fig. 3d) fell off a table during the earthquake, damaging the equipment. The hospital's oxygen is supplied using cylinders that are delivered every day; these cylinders were not restrained at the time of the earthquake and many fell, creating loud crashing noises that frightened occupants. There was no disruption in oxygen delivery after the earthquake. The hospital's medical care supplies were supplemented by NGOs and the WHO for three weeks after the earthquake.
